**CITY OF SAINT PAUL  
HERITAGE PRESERVATION COMMISSION STAFF REPORT**

FILE NAME: 208-210 Bates Avenue  
DATE OF APPLICATION: February 6, 2014  
APPLICANT: Saint Paul Housing and Redevelopment Authority (HRA)  
OWNER: HRA  
DATE OF PUBLIC HEARING: February 27, 2013  
HPC SITE/DISTRICT: Dayton's Bluff Historic District  
CATEGORY: Pivotal  
CLASSIFICATION: Demolition Permit  
STAFF INVESTIGATION AND REPORT: Christine Boulware  
DATE: February 24, 2014

**Report of:** Phase I Environmental Site Assessment  
208 and 210 Bates Ave., St. Paul, MN 55106  
**Reported to:** City of St. Paul  
Planning & Economic Development, St. Paul, MN 55102

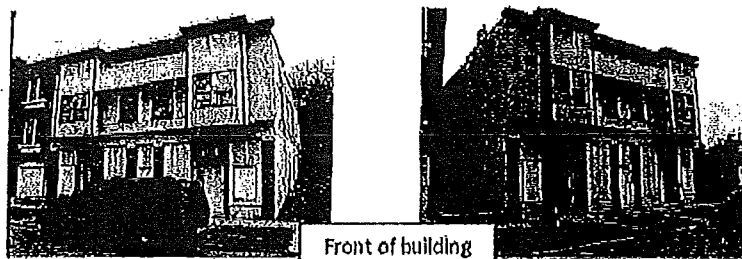
**Structural Condition****A. Exterior brick****Observations:**

- 1) A large portion of the brick along the north-west wall has fallen off from the wall. The exterior wood sheathing was still in place.
- 2) The south-east wall brick has been secured with wood planks securing the brick from falling off the building.
- 3) Wall sheathing boards were pulled away from the 2x4 wall studs in one location observed.

The existing brick was originally secured to the sheathing with box nails working as ties. Over the years these nails have deteriorated and vanished, thus leaving the brick with no lateral support. Without lateral support, the brick is susceptible to falling from the building, creating a hazardous situation for anyone in the vicinity.
