**CITY OF SAINT PAUL  
HERITAGE PRESERVATION COMMISSION STAFF REPORT**

FILE NAME: 445 Smith Avenue North  
DATE OF APPLICATION: August 4, 2015 (additional materials 8-11, 8-17, 8-20)  
APPLICANT: Thomas Schroeder  
OWNER: Thomas and Ann Schroeder  
DATE OF HEARING: August 27, 2015  
HPC SITE/DISTRICT: *pending* Limestone Properties Thematic Nomination (P.O.S. 1850-1899)  
CATEGORY: Contributing  
CLASSIFICATION: Building Permit  
STAFF INVESTIGATION AND REPORT: Amy Spong  
DATE: August 19, 2015

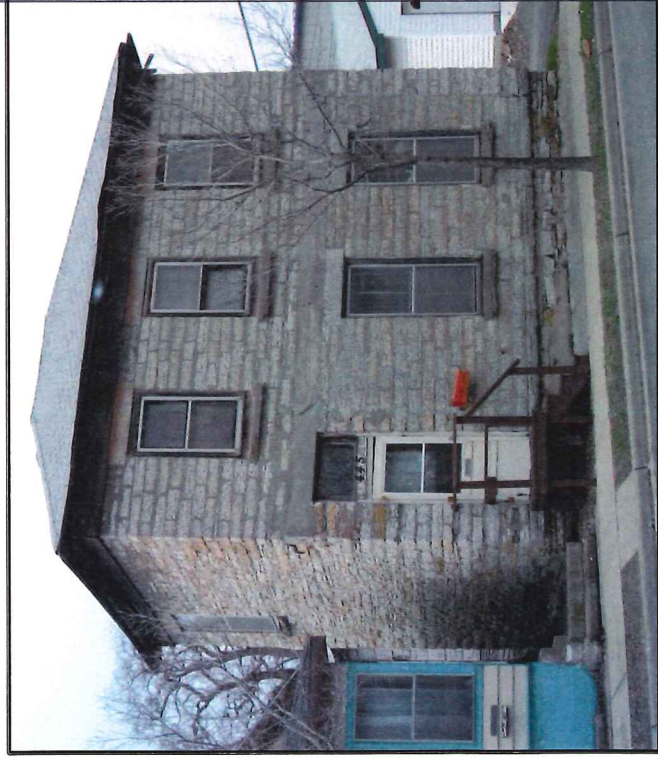
Anthony Waldman House/Stone Saloon (1857)  
2011 and 2015

For historic context, when the Stone Saloon was initially built it was positioned along the original overland route running along the Mississippi river bluff between Saint Paul and the Fort Snelling Ferry. This unimproved but frequently trafficked route was known as the Old Fort Road. West 7<sup>th</sup> Street did not yet exist. By the close of Minnesota’s Territorial Period, a number of businesses lined the Old Fort Road, including a large limestone livery stable along Old Fort Road near the city limits, a major brewery, and several saloons. The latter included Henry Shearn’s Head Quarters Saloon on Leech Street near Ramsey Street; William Schimmel’s saloon on Wilkin Street near the Saint Paul College; Alexander Erb’s saloon and grocery at the corner of Smith (now Forbes) and Forbes (now Smith); John Fetzer’s one-story home and lager beer saloon on Forbes (now Smith) immediately across the alley from the Stone Saloon to the north; and the Cave House Saloon just past the city limits near Richmond and Old Fort Road. All of these establishments have long since vanished. While perhaps not relevant to modern land use planning, the Stone Saloon is one of the last remaining vestiges of the Old Fort Road. As such, its restoration and proposed (re)use helps define the West 7<sup>th</sup> Street neighborhood’s special identity, because it points to what came before. We take our historic assets where we find them—and if understood and used wisely, they have even greater value there.
