**CITY OF SAINT PAUL
HERITAGE PRESERVATION COMMISSION STAFF REPORT**

FILE NAME: 767 Fourth Street East
DATE OF APPLICATION: September 15, 2015
APPLICANT: Saint Paul Housing and Redevelopment Authority (HRA)
OWNER: HRA
DATE OF PUBLIC HEARING: October 8, 2015
HPC SITE/DISTRICT: Dayton's Bluff Heritage Preservation District
CATEGORY: Contributing
CLASSIFICATION: Demolition Permit
STAFF INVESTIGATION AND REPORT: Christine Boulware
DATE: October 6, 2015

Project No.: 15539.00
Re: Structural Condition Review of the building at 767 4th St. E.

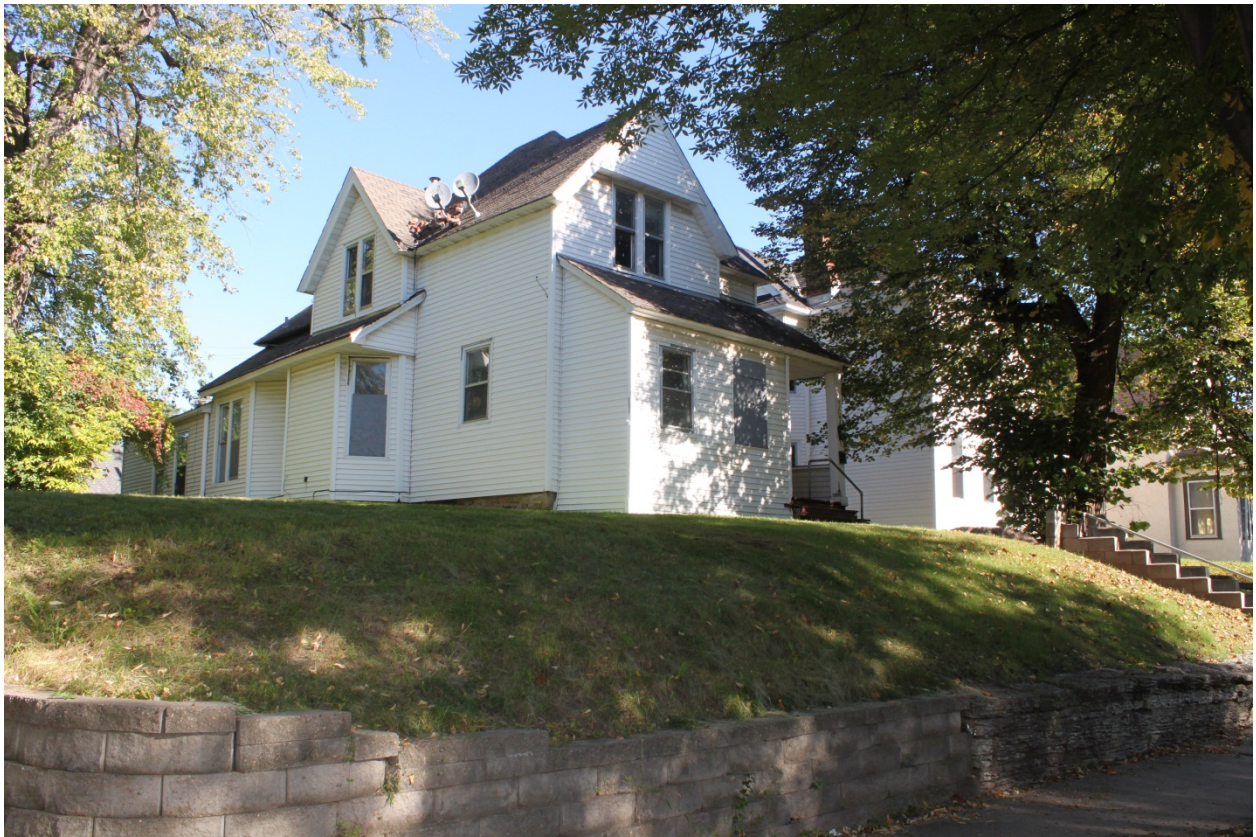
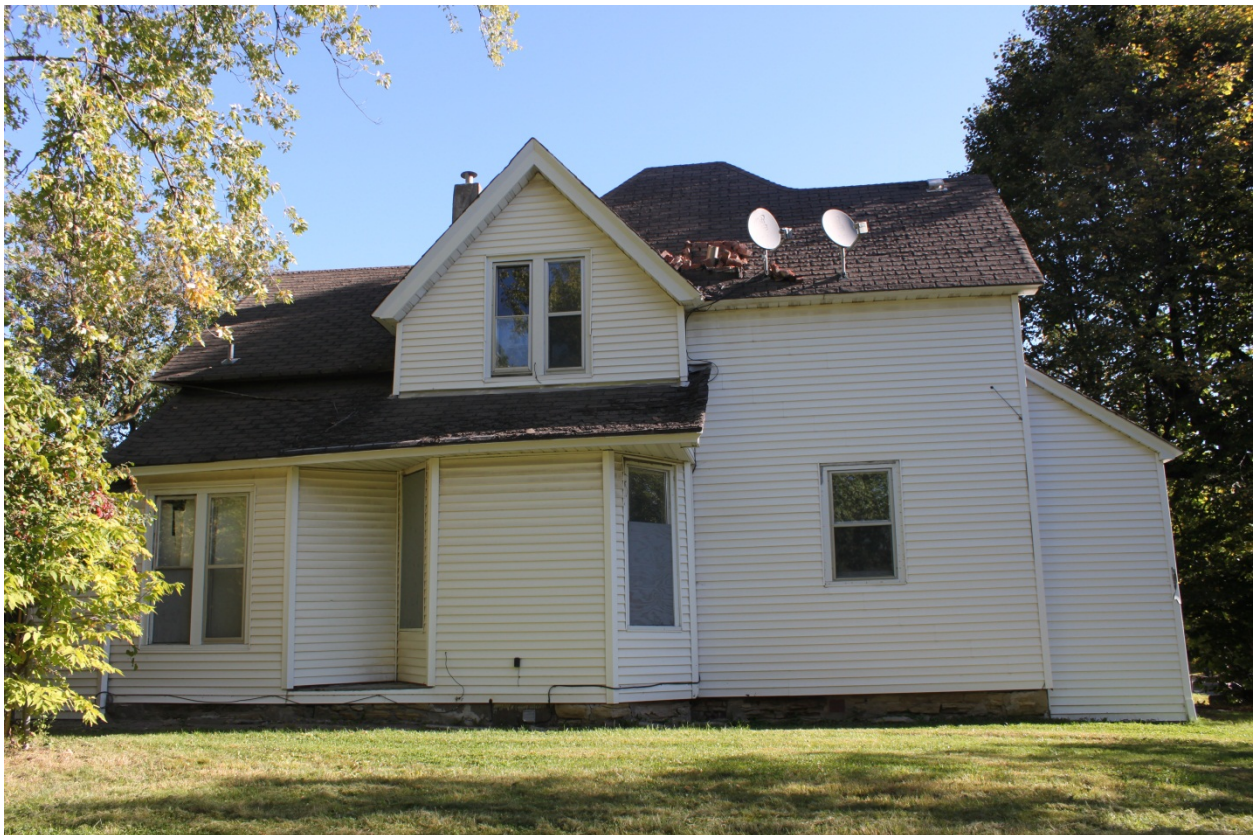
767 4th St E southwest elevations
(above) and west elevation (below)

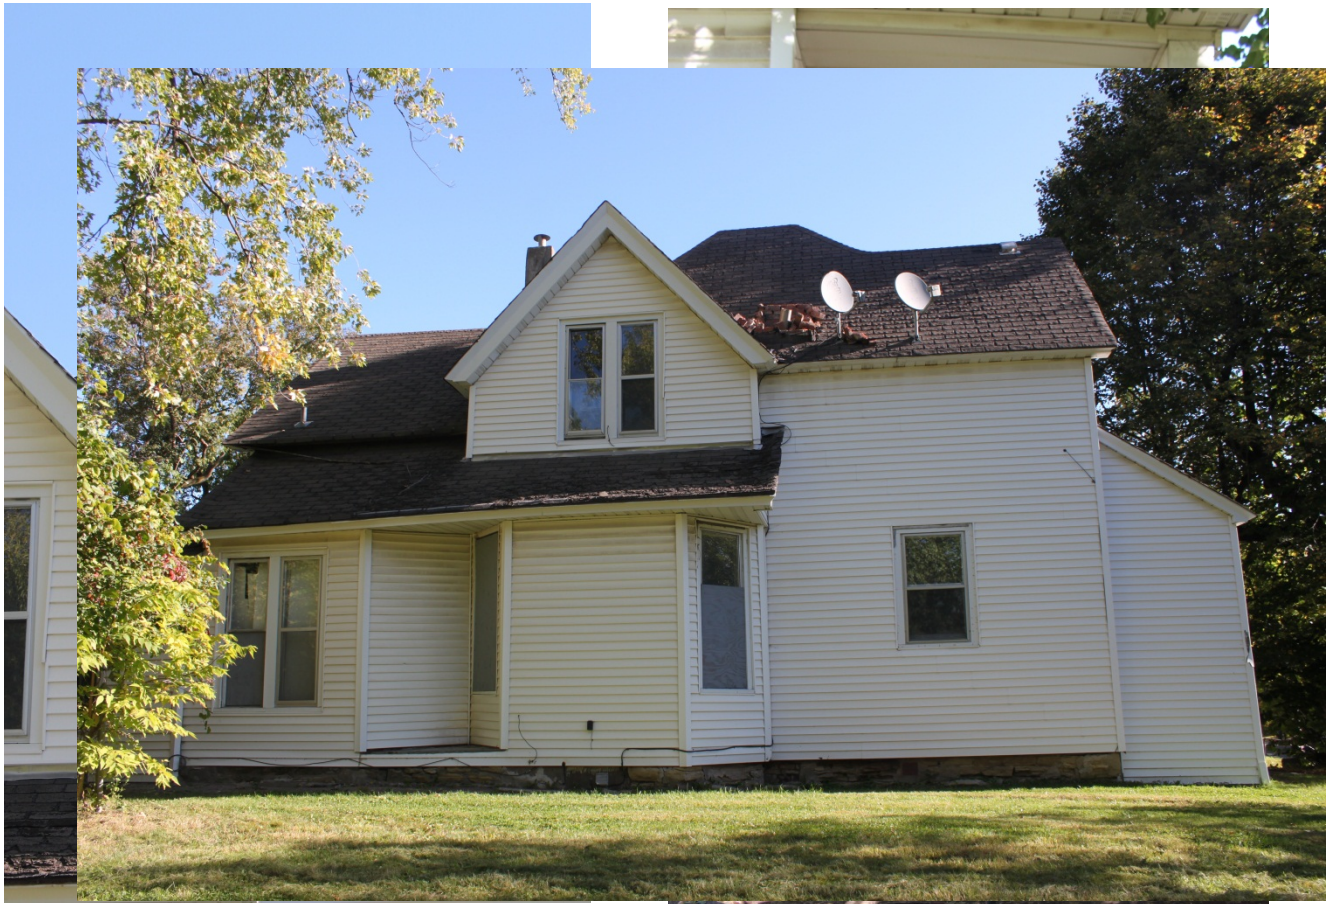
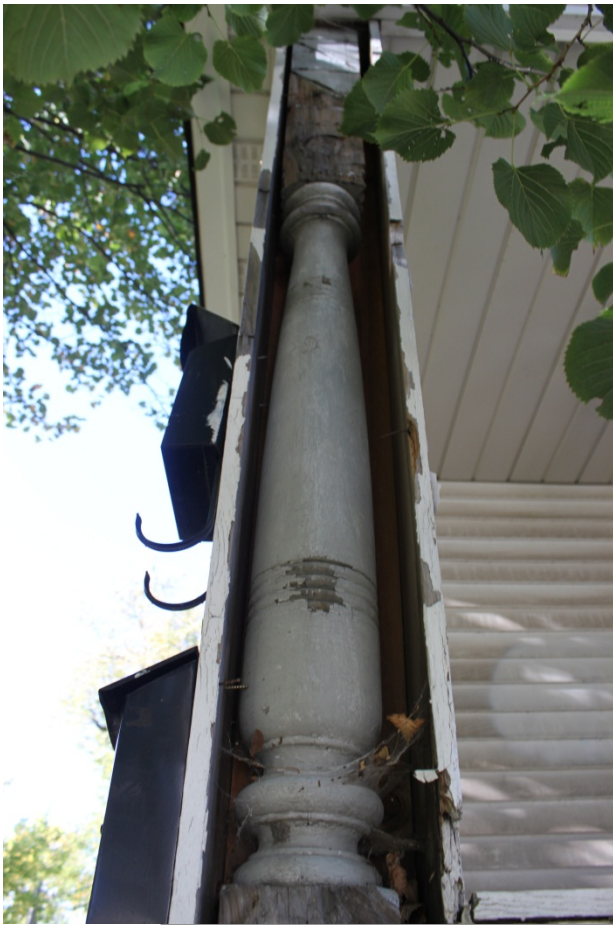
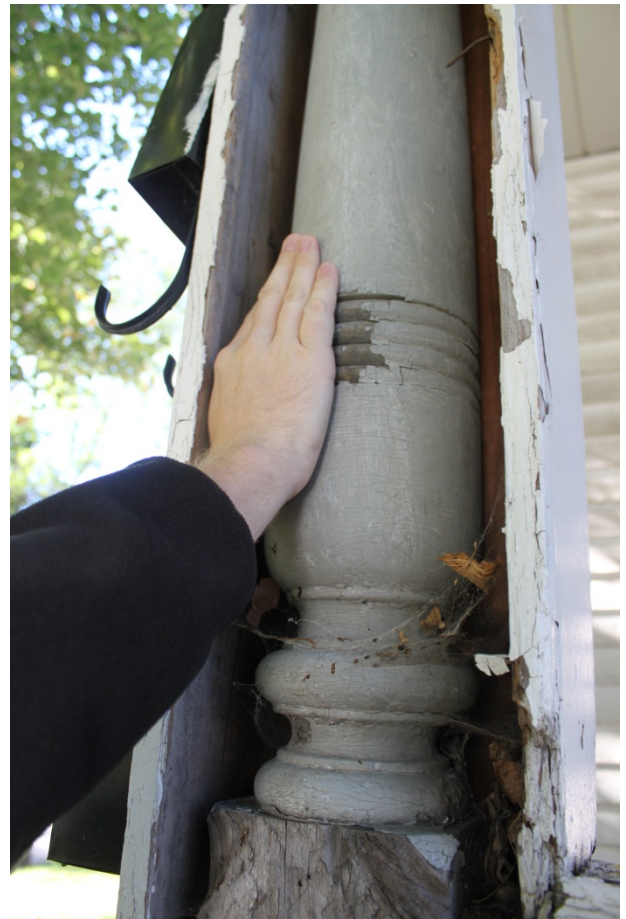
767 4th St E northeast elevations (above), west chimney (below left) and exposed portion of front porch (below right)

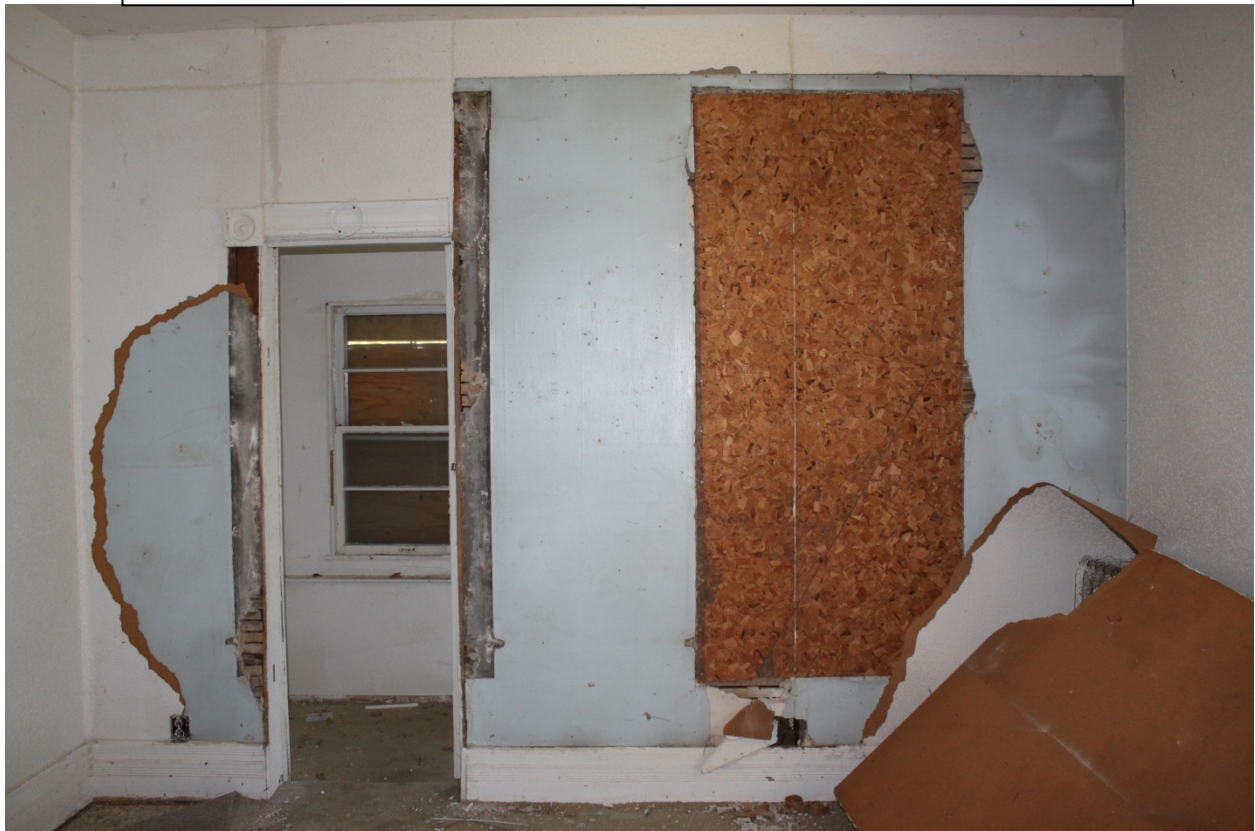
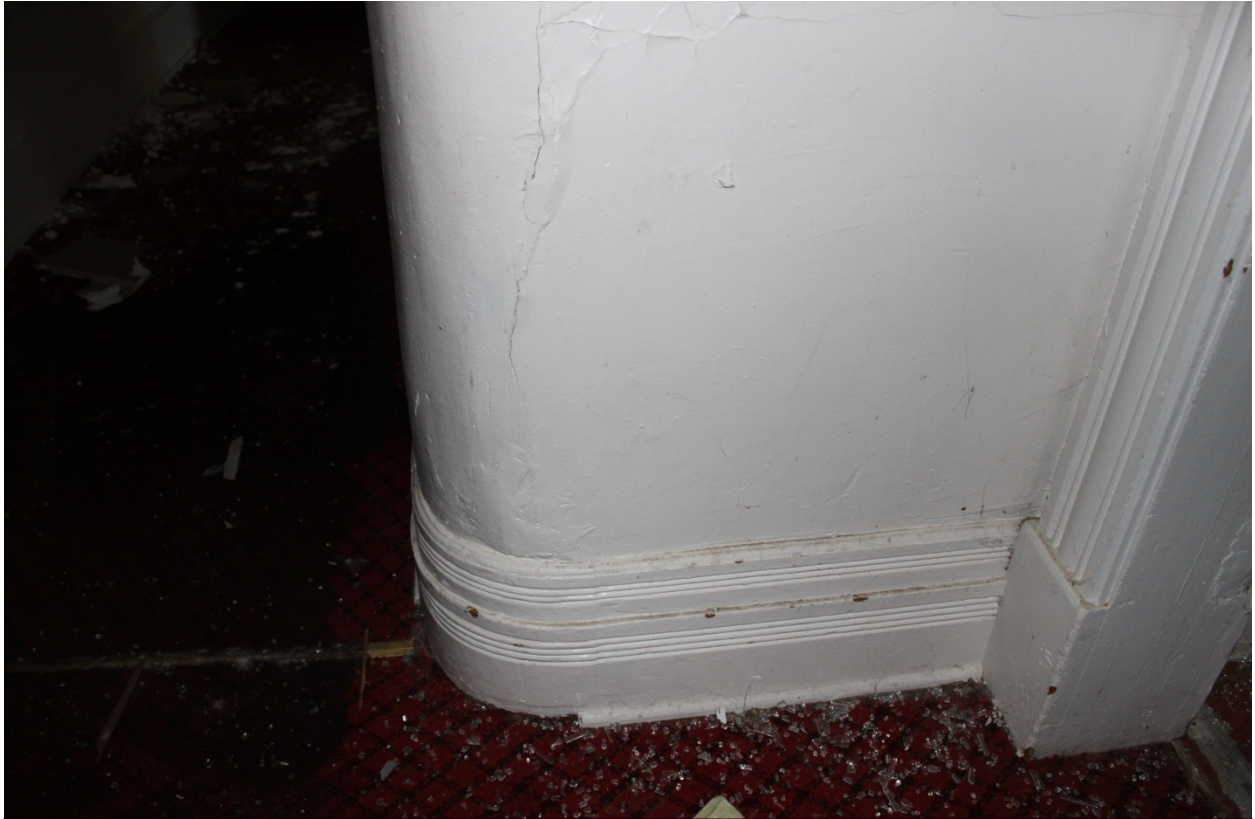
Exposed section of enclosed turned spindlework from original front porch
(above), south wall of front room looking into enclosed front porch (below)

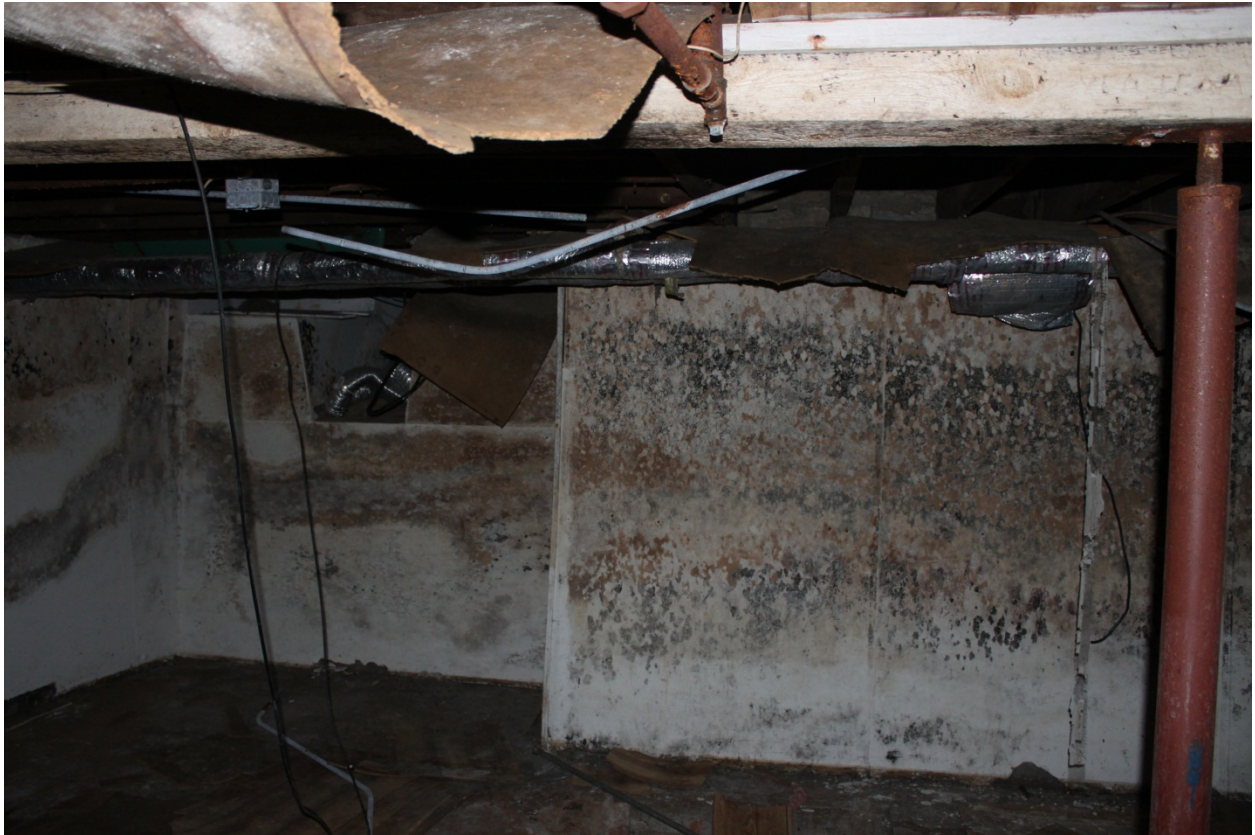
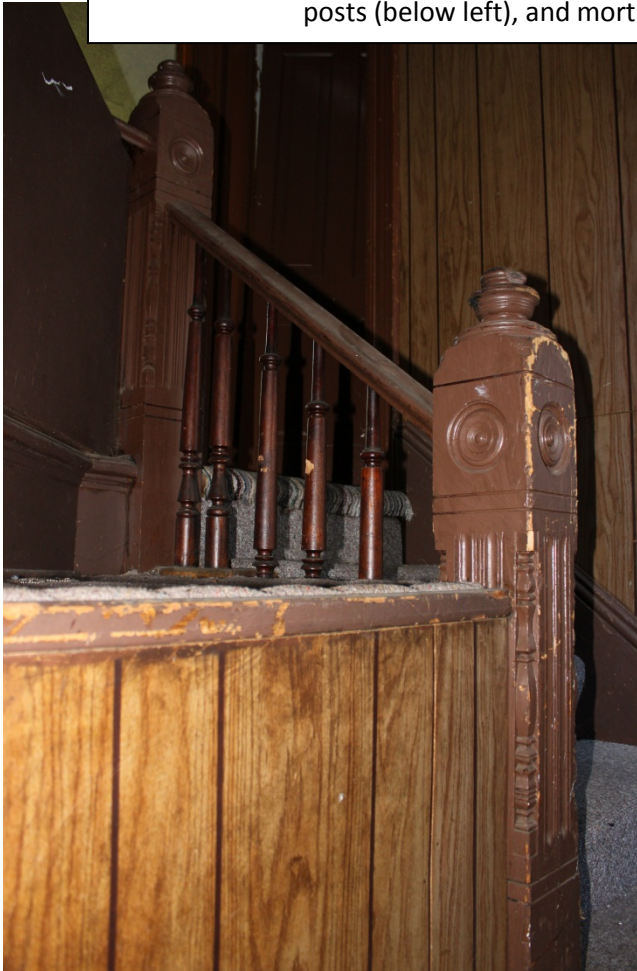
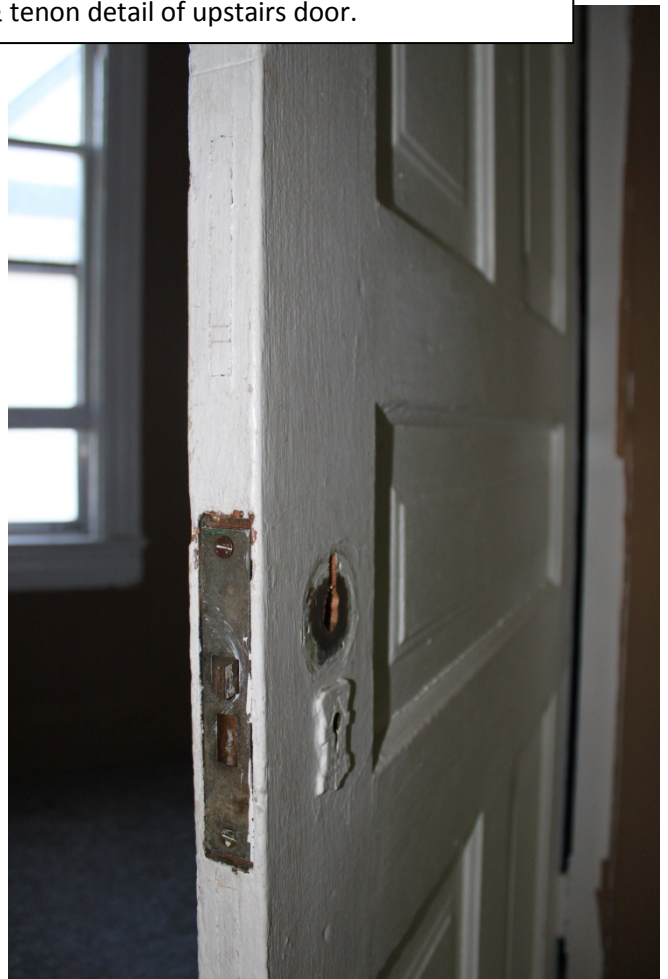
Basement conditions (above), exposed section of original Eastlake style balusters and newel posts (below left), and mortise & tenon detail of upstairs door.
