## Executive Summary

The Brickyard Area of Lilydale Regional Park is an area of both historic and recreational significance for the City of St. Paul. From the 1890s to the 1970s this area was used as a clay-mining and brick-making site. Evidence of that history remains in the three quarry areas (East, Middle, and West Clay Pits) and the ruins of a brick oven. Adjacent to the brick oven is Echo Cave, a man-made feature carved into the white Cambrian sandstone rock. In the early 1900s this rock was mined for its high silica content (used to make glass), supporting the demand for glass bottles from nearby breweries. Four fossil beds near the clay pits offer clues to an even earlier history and are popular with fossil hunters. Recreational features of the Brickyard Area include the popular Brickyard Trail, the Bruce Vento Scenic Overlook, several water falls, and the Middle Clay Pit bluffs which are often used for ice climbing.

to hire Barr Engineering Co. (Barr) to study erosion and slope-stability issues in the area. The primary objective of this study was to develop concept-level stormwater management, erosion-control, and slope-stability recommendations for City use. Specifically

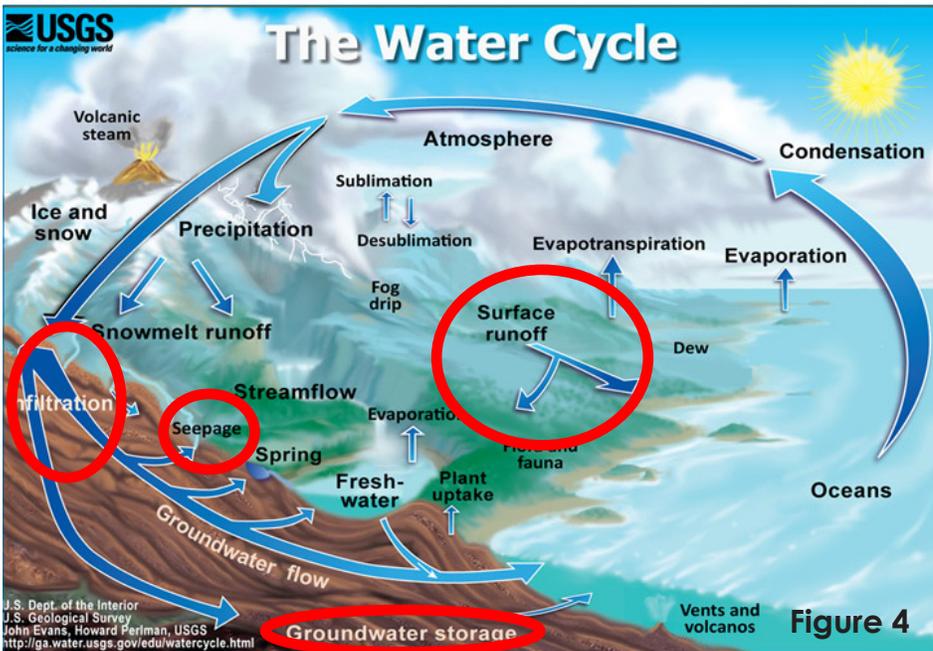
- **Surface runoff**—Precipitation that does not infiltrate and contributes to erosion at the toe of the slope (Figure 5)
- **Channelized surface water**—Surface runoff that channelizes in the ravines
- **Groundwater (seepage)**—Precipitation that infiltrates but “seeps” back out when it reaches an impermeable rock layer

**Changing geometry**—Runoff that erodes the toe of the slope may cause unstable conditions by changing the slope's geometry.
