## **Brickyard Area of Lilydale Regional Park**

### ***Stormwater Management and Slope-Stability Analysis***

Prepared for  
City of St. Paul Department of Parks and Recreation

January 28, 2015

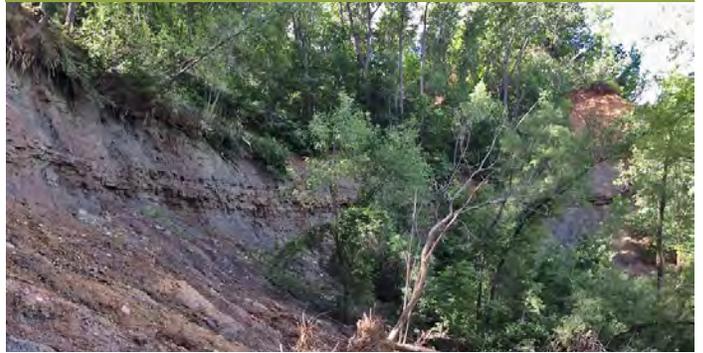
*Photo: Middle Clay Pit wall with fresh soil scarp in upper-right corner. The slopes above the pits are fairly steep with former scarps evident at numerous locations. Soil slopes at the corners of the clay pits seem prone to instability and failure.*

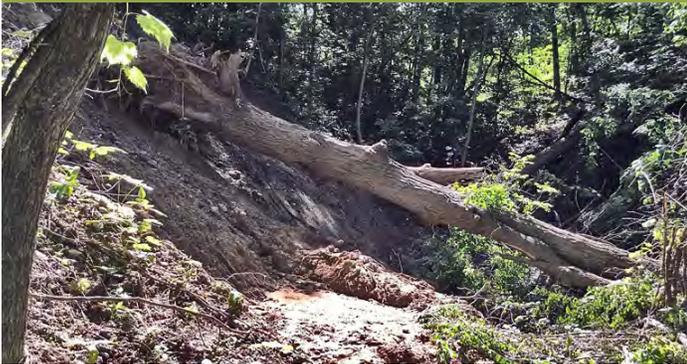
*Photo: Ravine slope failure. Significant erosion was observed along the ravine side slopes; there are several active slope failures in the ravine.*

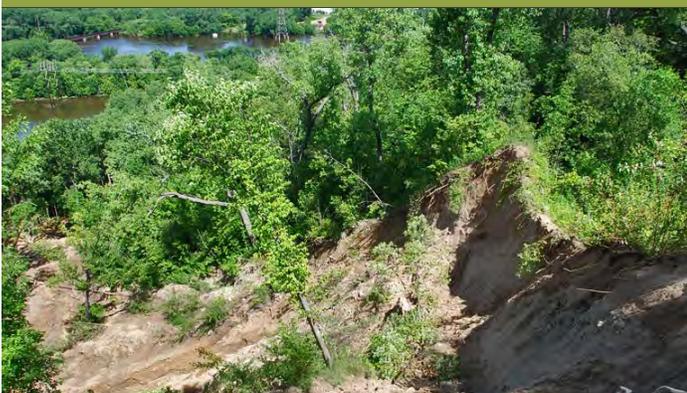
*Photo: Large slope failure from above. Evidence of historic slope failures was observed. One failure was "reactivated" during a wet period in June 2014; this failure had enough force to topple mature trees along the lower section of the Brickyard Trail.*

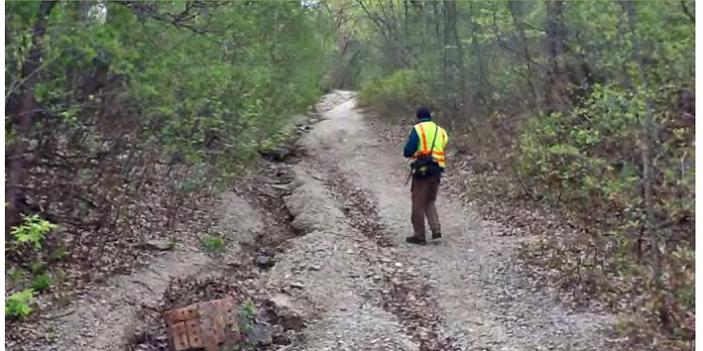
*Photo: Erosion on the Brickyard Trail—Fossil/Brick Oven Section. Moderate-to-severe erosion from concentrated stormwater runoff along the straight and steep sections of the Brickyard Trail was observed. A steep slope adjacent to the trail showed evidence of slope failure that was reactivated during a wet period in June 2014.*

1. Install Geoweb (examples shown in Photo 5-4, Photo 5-5, and Photo 5-6) to stabilize and reinforce the trail (planning-level cost range: \$77,000–\$164,000).
2. Repair the trail and install waterbars (conceptual drawing shown in Figure 5-1) to deflect water off the trail and reduce future erosion (planning-level cost range: \$42,000–\$90,000).
3. Install a “side channel” (reinforced ditching) along the side of the trail and resurface this area (planning-level cost range: \$79,000–\$170,000).

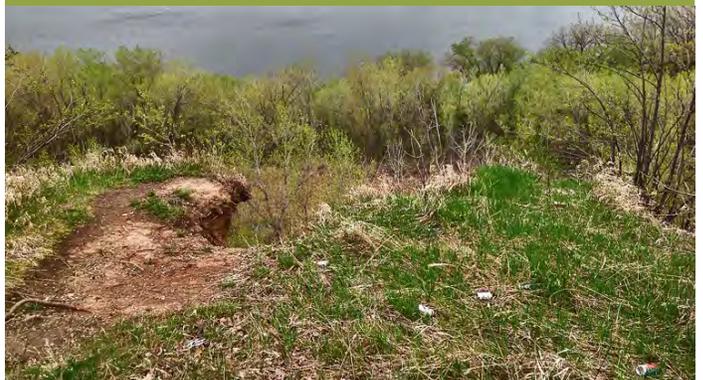
*Photo: Soil overhang, from above, at Bruce Vento Scenic Overlook. A mass of overhanging soil, supported by vegetation/root zones was observed. There is potential for this area to fail when the roots eventually give way.*

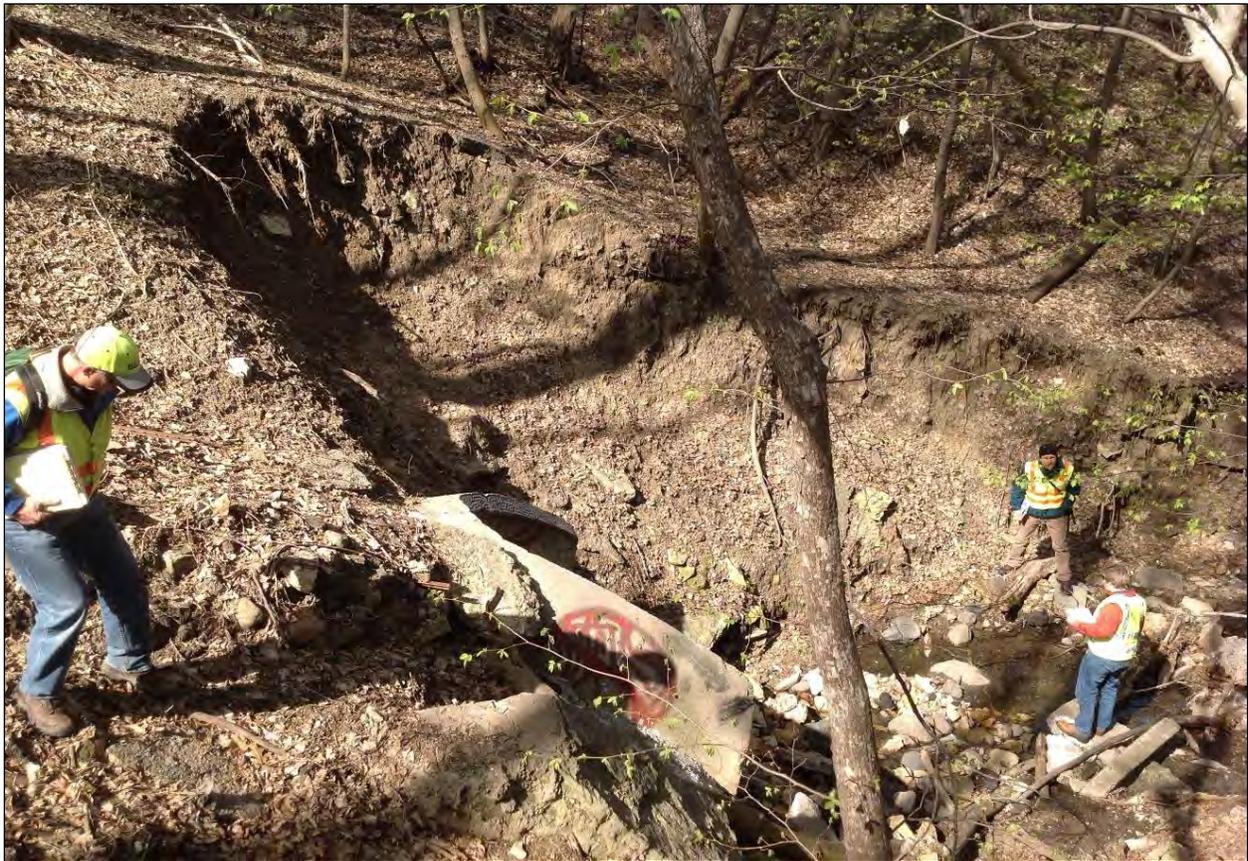
Drainage from portions of Cherokee Heights Regional Park and the adjacent residential area discharges through a 60-inch-diameter reinforced-concrete culvert that extends underneath Cherokee Heights Boulevard and into a ravine (Cherokee Heights Ravine on Large Figure 1-2, Photo 2-2). The ravine extends approximately 300 feet to a waterfall near the horseshoe-shaped East Clay Pit. Observation of the ravine reveals significant erosion along the channel invert and side slopes. This is most likely due to high flow rates and velocities in combination with erodible, sandy soils. At the downstream end of the ravine, the channel bottom has been scoured down to the underlying Decorah Shale bedrock.

**Photo 2-2** Erosion adjacent to the storm sewer outlet in Cherokee Heights ravine (May 2014 site visit)

The Cherokee Heights Ravine, starting at Cherokee Heights Boulevard (including the culvert) and extending downstream approximately 300 feet, is being addressed through the *Cherokee Heights Culvert Analysis and Erosion Control Feasibility Study*, commissioned by the Lower Mississippi River Watershed Management Organization. The goals of that project are to reduce erosion potential by stabilizing the approximately 300 feet of channel between the 60-inch Cherokee Heights Culvert and the water fall and reducing peak flow rates and velocities, as feasible. Therefore, no recommendations for this portion of the Cherokee Heights Ravine are provided in this report. However, it is important to note the difference between the slope-stability issues in this area and the ravine/channel erosion due to stormwater. It is our opinion that even if erosion due to stormwater runoff is addressed in this stretch of the Cherokee Heights ravine, the potential for slope failure still exists, as reflected in Large Figure 3-2.

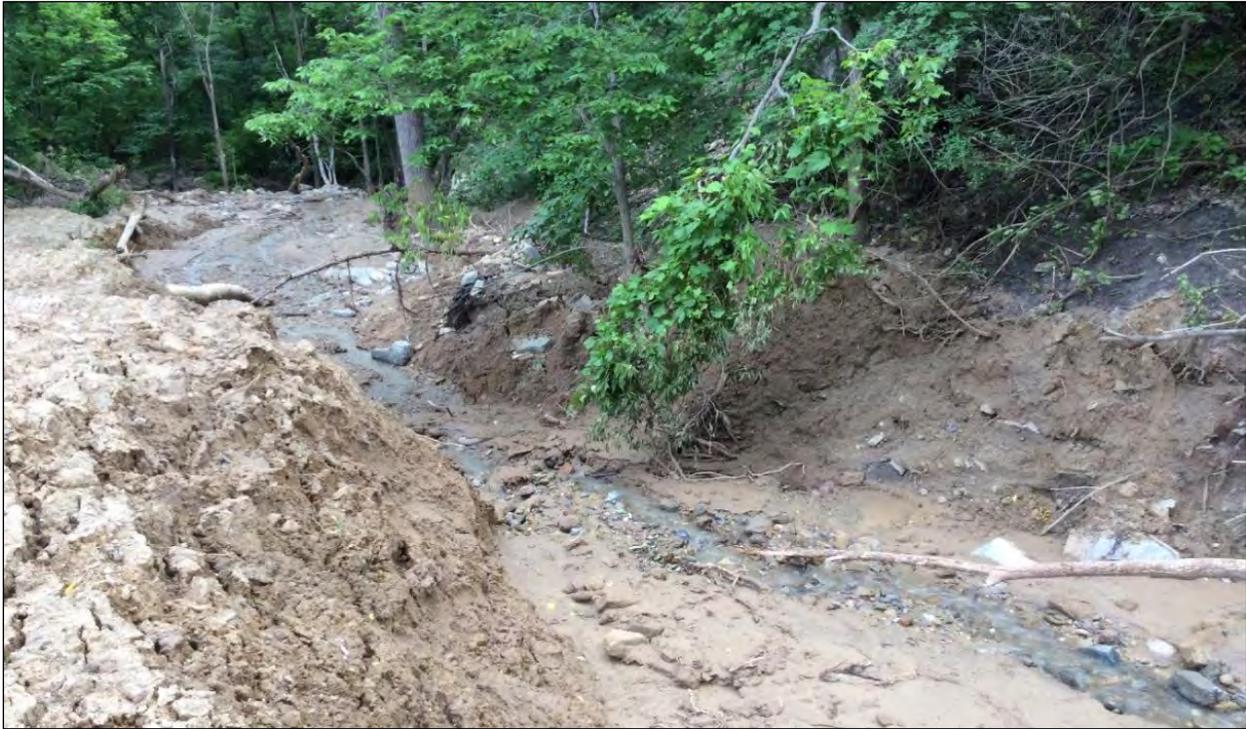
**Photo 2-8** Soil deposited at base of slide and newly eroded stream channel (July 2014 visit)

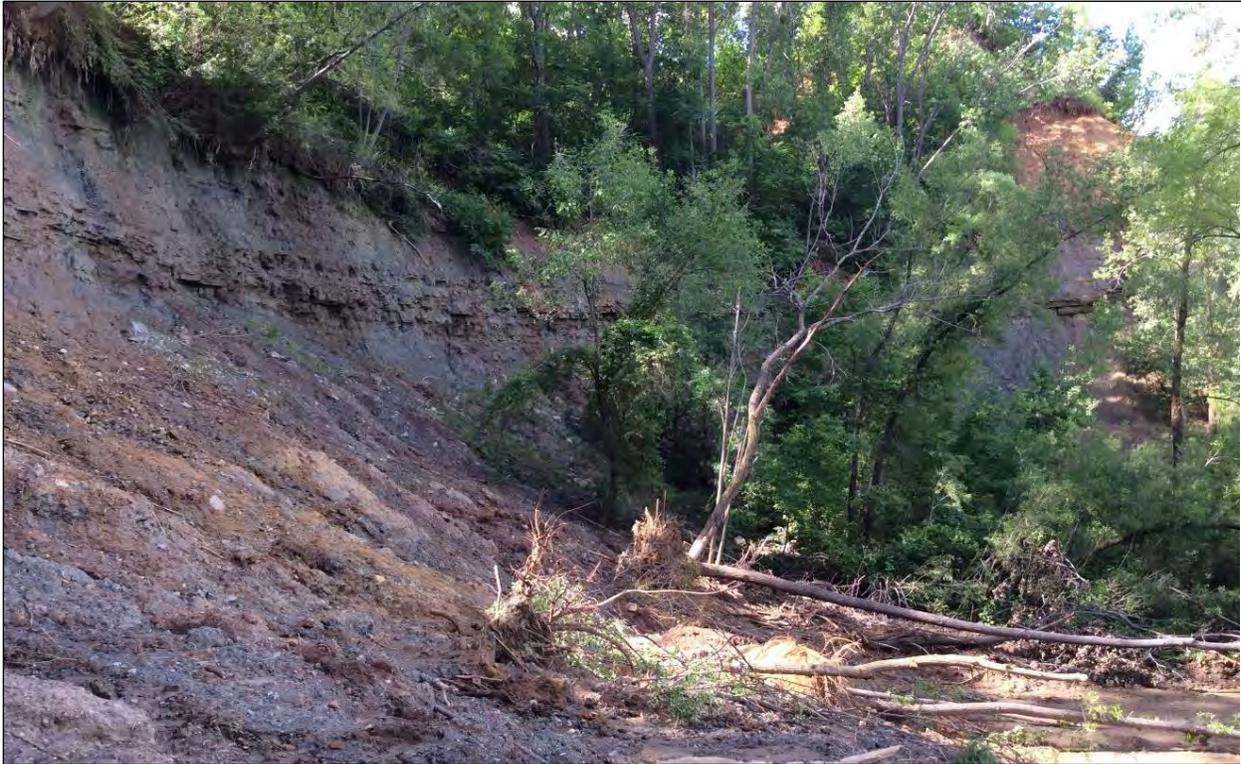
**Photo 2-13 Middle Clay Pit wall—with fresh soil scarp in upper right corner (July 2014 site visit)**

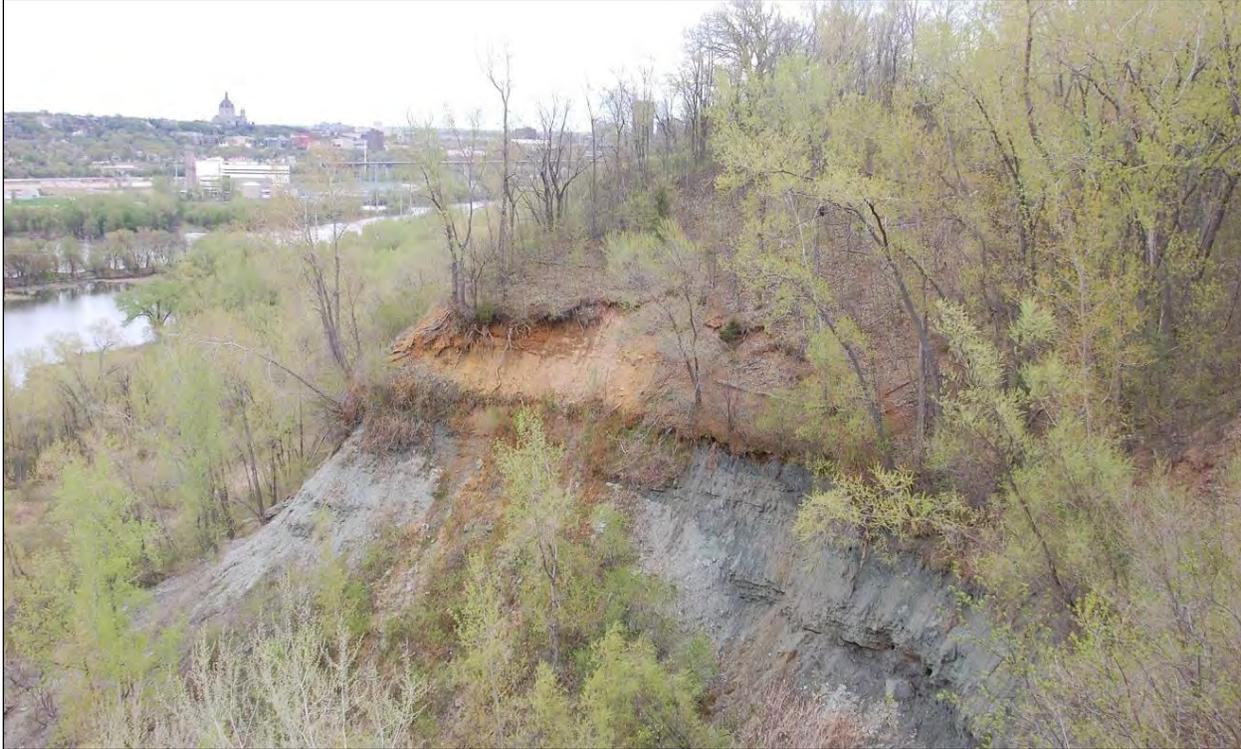
There were obvious areas of overhanging root mats/vegetation above the clay pit walls (Photo 2-14 and Photo 2-15). This condition was most apparent in the area of the Bruce Vento Scenic Overlook and is discussed in greater detail in Section 2.5.

**Photo 2-14 Silty sand soil over shale bedrock in West Clay Pit (May 2014 site visit)**

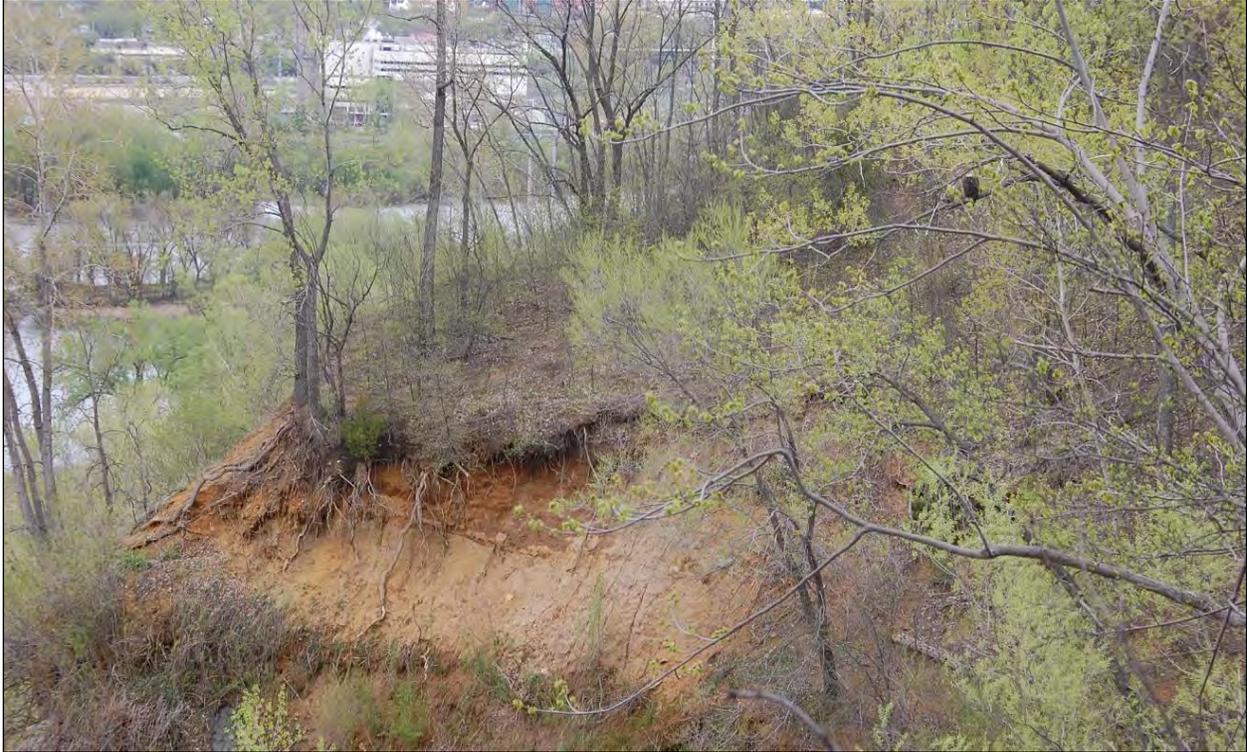
**Photo 2-15** Close-up of overhanging soil and root zone in West Clay Pit (May 2014 site visit)

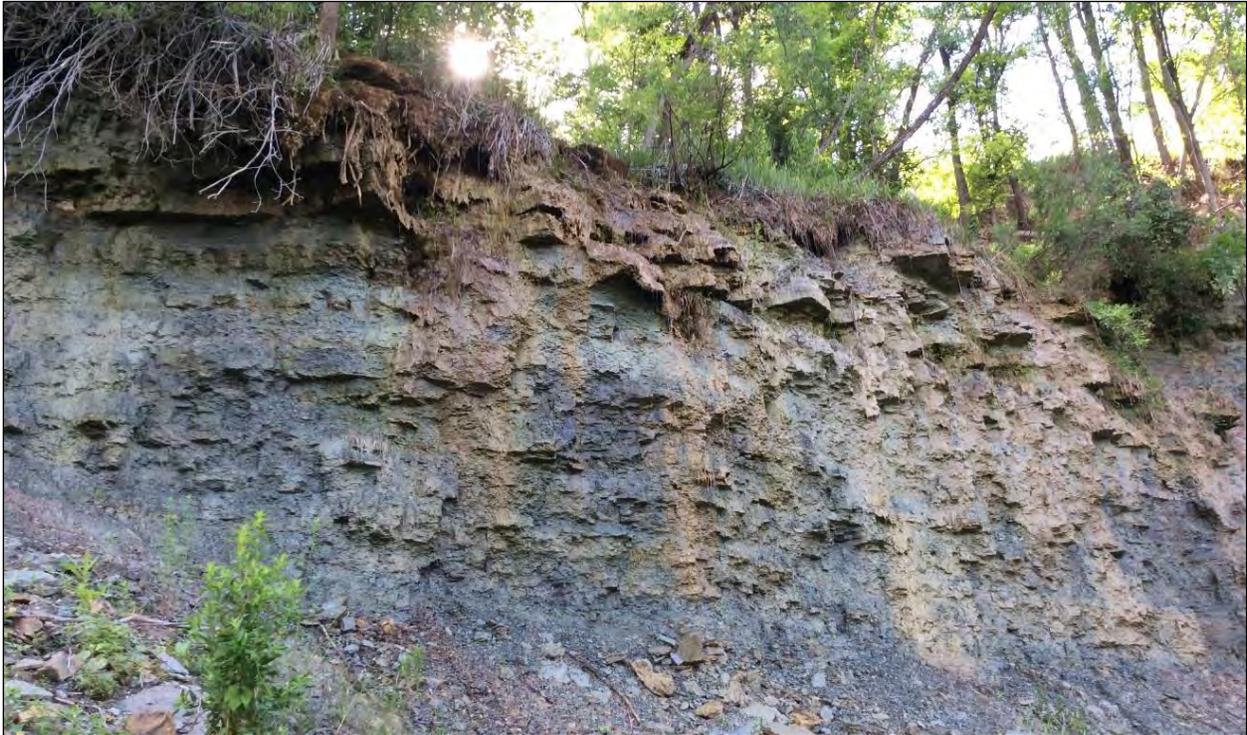
During both the site visits, water was observed seeping from the slopes at the upper soil/bedrock interface, particularly in the Middle Clay Pit (Photo 2-16). This seepage, which freezes in the winter to allow ice-climbing activities in the Middle Clay Pit (Photo 2-17 and Photo 2-18), illustrates that groundwater infiltrates through the soils but does not readily penetrate the low-permeability shale. Instead, it tends to flow along the surface of the bedrock to the face of the bluffs. The amount of seepage appeared to vary from location to location and is likely influenced by drainage area, upstream collection/piping, general groundwater conditions (i.e., high or low, wet or dry), and bedrock topography.

**Photo 2-16** Seeping rock outcrop in Middle Clay Pit (July 2014 site visit)

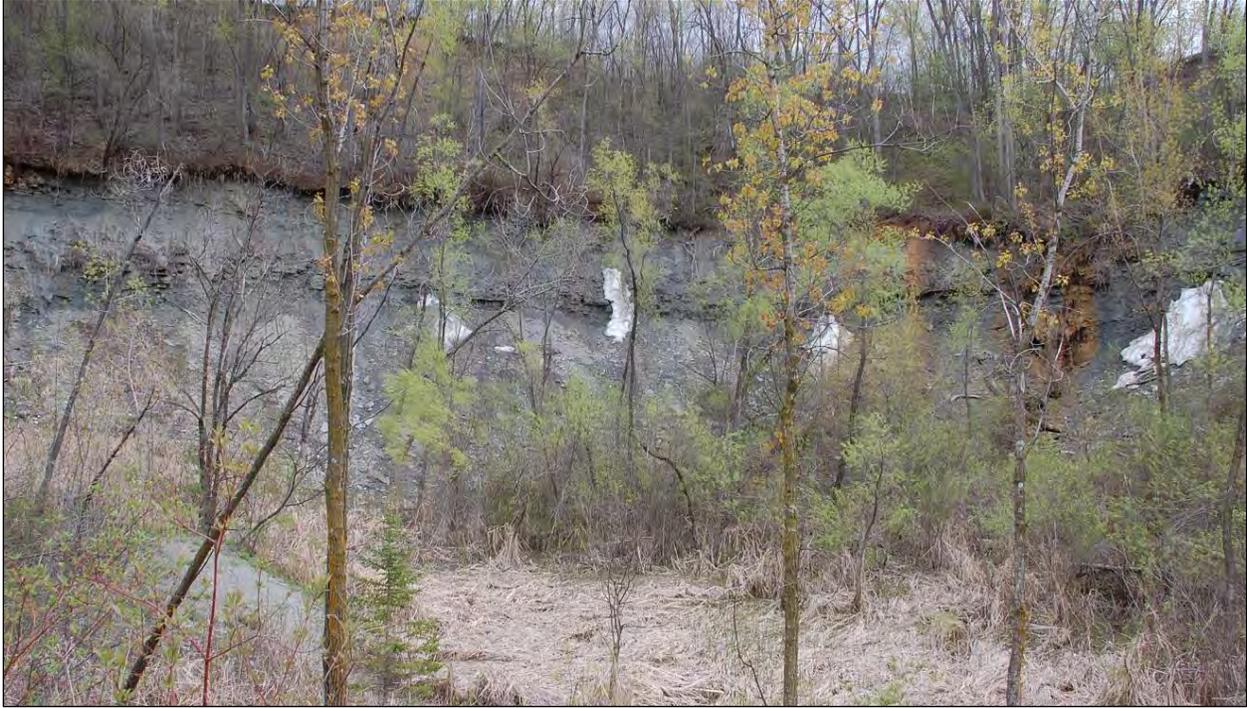
**Photo 2-17 Middle Clay Pit with snow/ice (from seepage) on face of shale (May 2014 visit)**

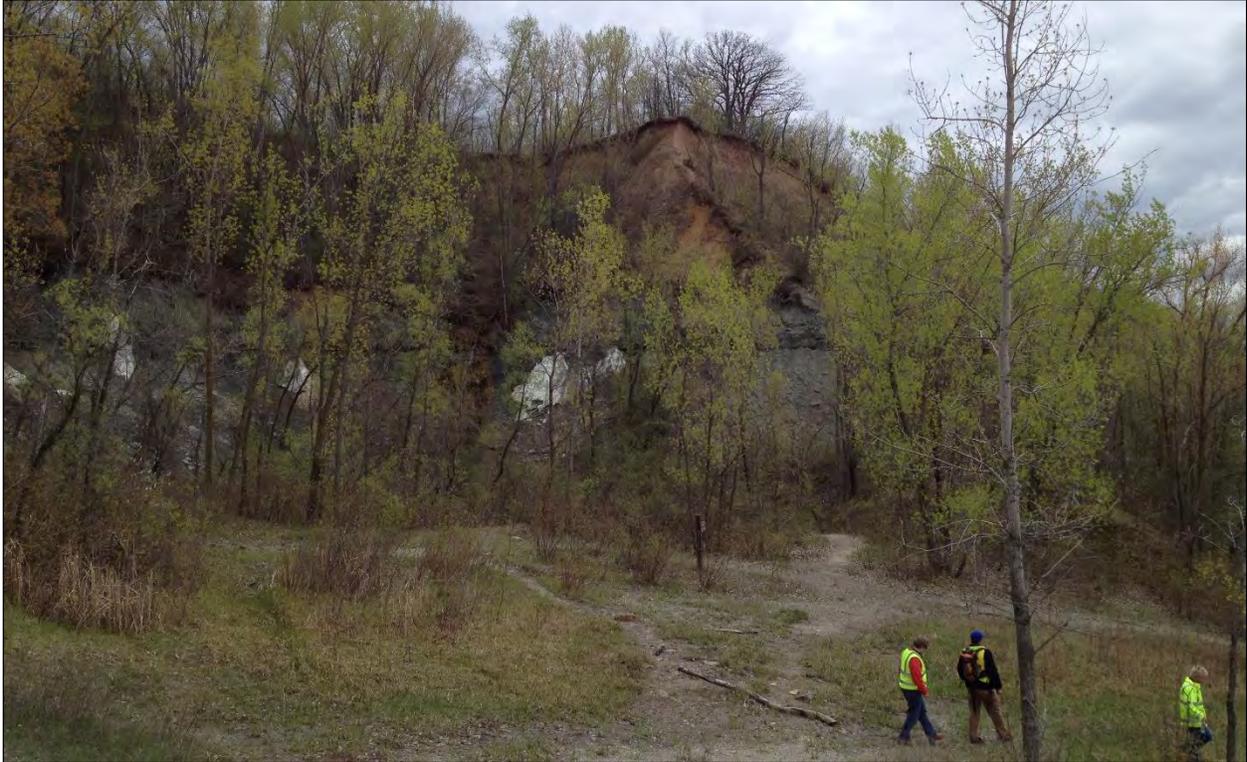
**Photo 2-18 Middle Clay Pit with snow/ice (from seepage) on face of shale (May 2014 site visit)**

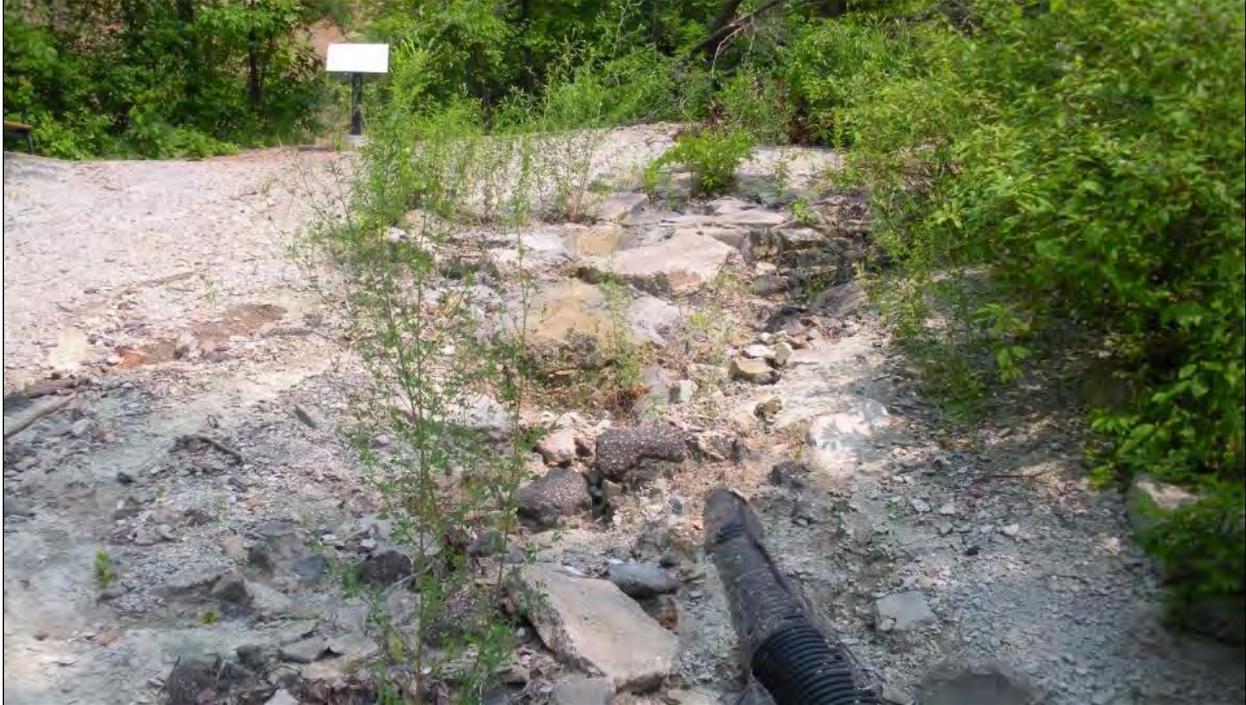
**Photo 2-20** Brickyard Trail–Fossil/Brick Oven Section, plugged and exposed drain file and erosion (July 2014 site visit)

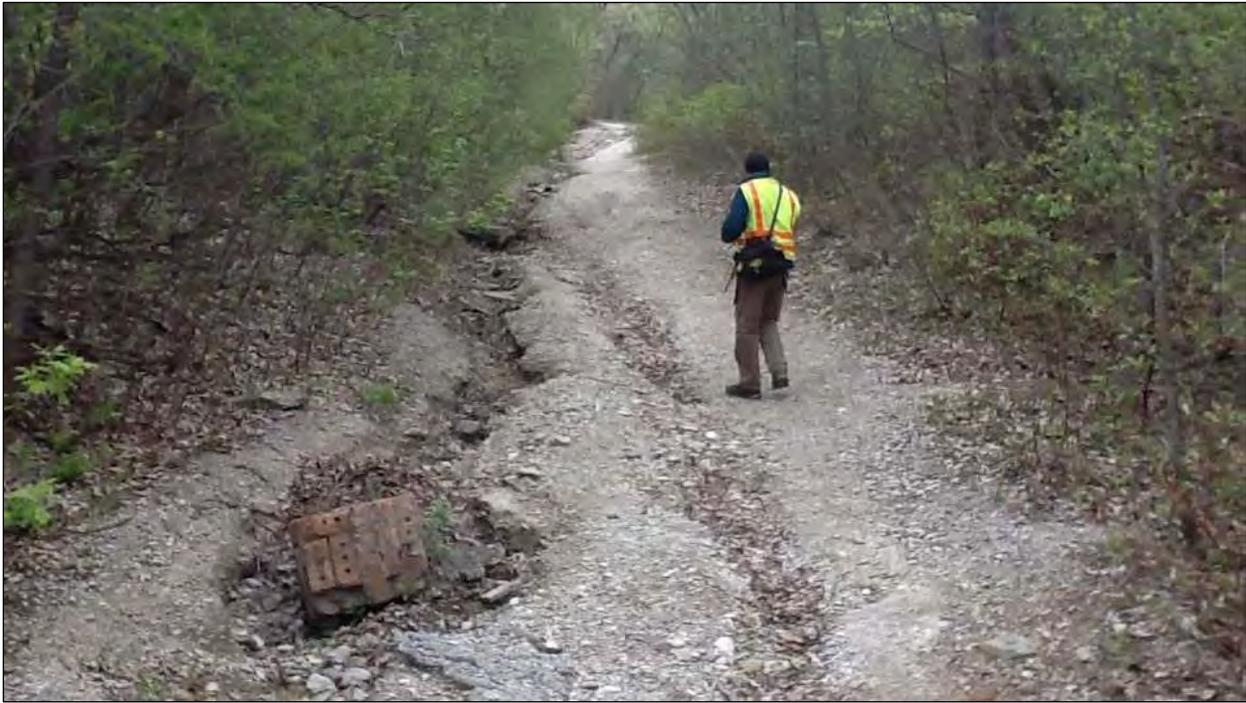
**Photo 2-21** Erosion on the Brickyard Trail–Fossil/Brick Oven Section, looking uphill from the bottom of the trail (May 2014 site visit)

The most significant erosion on the Brickyard Trail is a portion of the Fossil/Brick Oven section highlighted in solid red on Large Figure 5-1. This section stretches from the lower portion of the Brickyard Trail to the “connector” section of the trail. It has steeper slopes than other portions of the trail and is located such that stormwater drains on and along the trail. While considered a low-risk area for slope failure, it has been impacted by erosion caused by stormwater runoff. Since this section of the trail is part of the main thoroughfare—connecting the lower portion of the park to the upper/bluff portion—we recommend stabilizing it and encouraging park patrons (using signage, fencing, or other measures) not to leave this trail. One or more of the following options is recommended for stabilizing, reinforcing, and/or reducing future erosion of this portion of the trail. Continued maintenance is important for all options.

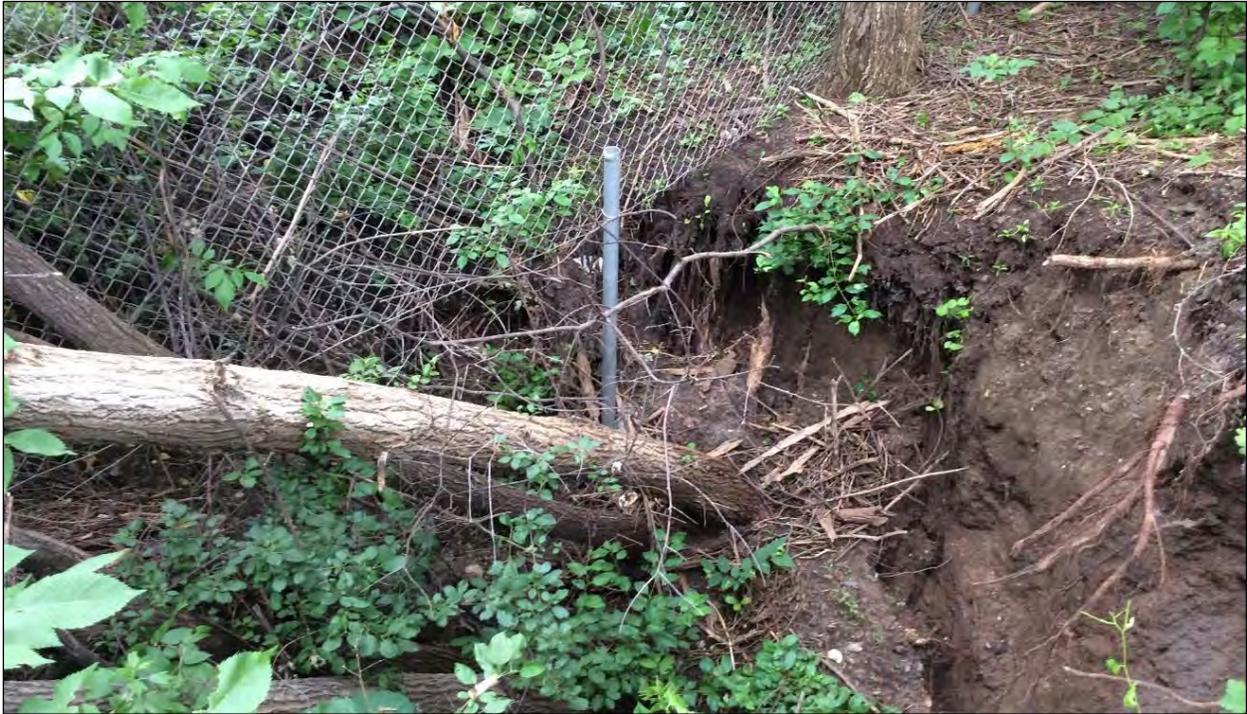
bluff. The sinkhole along the trail appears to be due to a defect or failure of the storm sewer pipe, allowing soils to infiltrate the pipe. This infiltration removed soils from above/around the pipe and, over time, lessened support of the overlying soils. The overlying soils bridged the infiltrated materials until the cavity grew too large to span. It is our understanding that the Minnesota Department of Transportation is working on repairing this pipe and the associated sinkhole.

**Photo 2-27** "Sinkhole" along Brickyard Access Trail–Bluff Section; note sunken fence post (July 2014 visit)

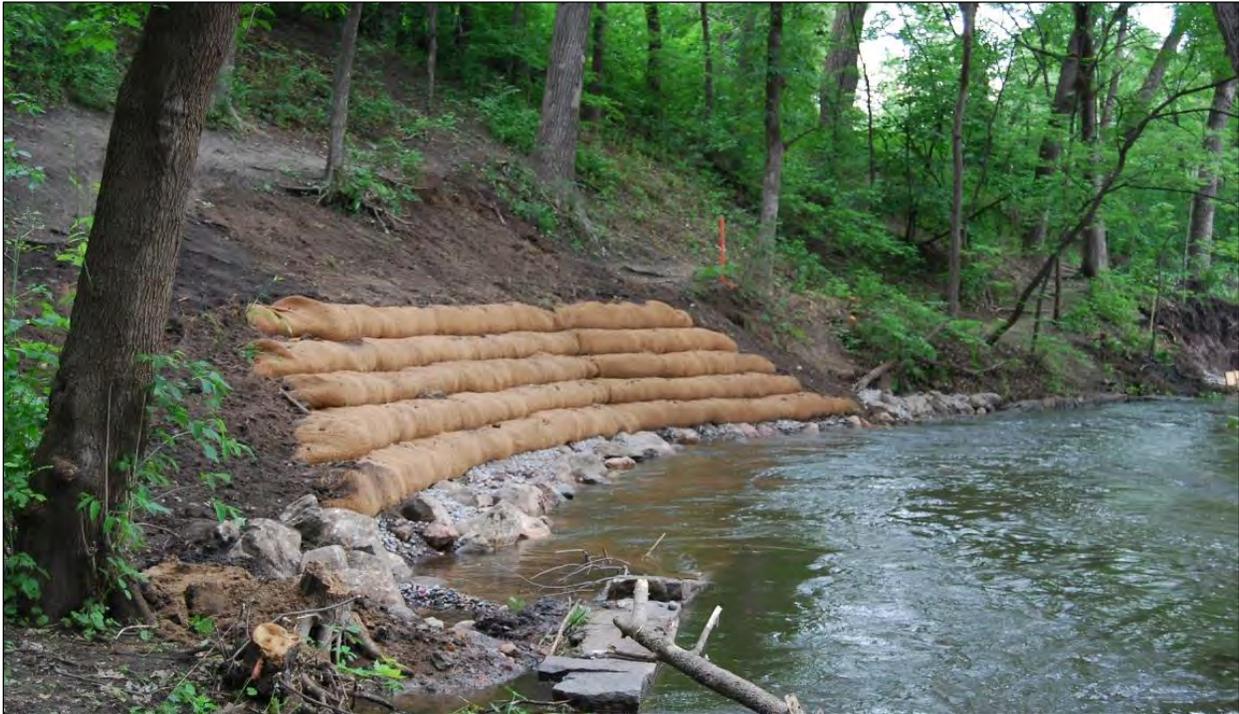
**Photo 5-9** Example of vegetated reinforced soil slope (VRSS) before vegetation reestablishes

There are also steep slopes that run between the Middle and East Clay Pits, crossing the connector section of the Brickyard Trail. This area is not part of a clay pit; it does not contain cliff faces/drop-offs and is not downslope of a high-risk area. It does, however, exhibit a steep enough slope to lead to less severe slope failures. For this reason, it is considered a medium-risk area (shown in yellow on Large Figure 3-2). While this is not part of the recommended “restrict access” area, a portion of the connector section of the Brickyard Trail (location shown on Large Figure 2-1, Photo 2-24) is located downslope of a medium-risk area. We recommend stabilizing that particular section of slope. In the interim, we also recommend removing or relocating the park bench along this section of the Brickyard Trail.

This steep slope could be stabilized using vegetated reinforced soil slopes (VRSS). VRSS is well-suited to trail edges; but, because natural materials are used, sunlight is required to support plant growth. Examples of VRSS are shown in Photo 5-9, Photo 5-10, and Photo 5-11. There may be sufficient space in this area to grade the uphill slopes to a stable angle, similar to the “grading-to-stable-slope” option recommended for the North Knob Area and discussed in the next section.

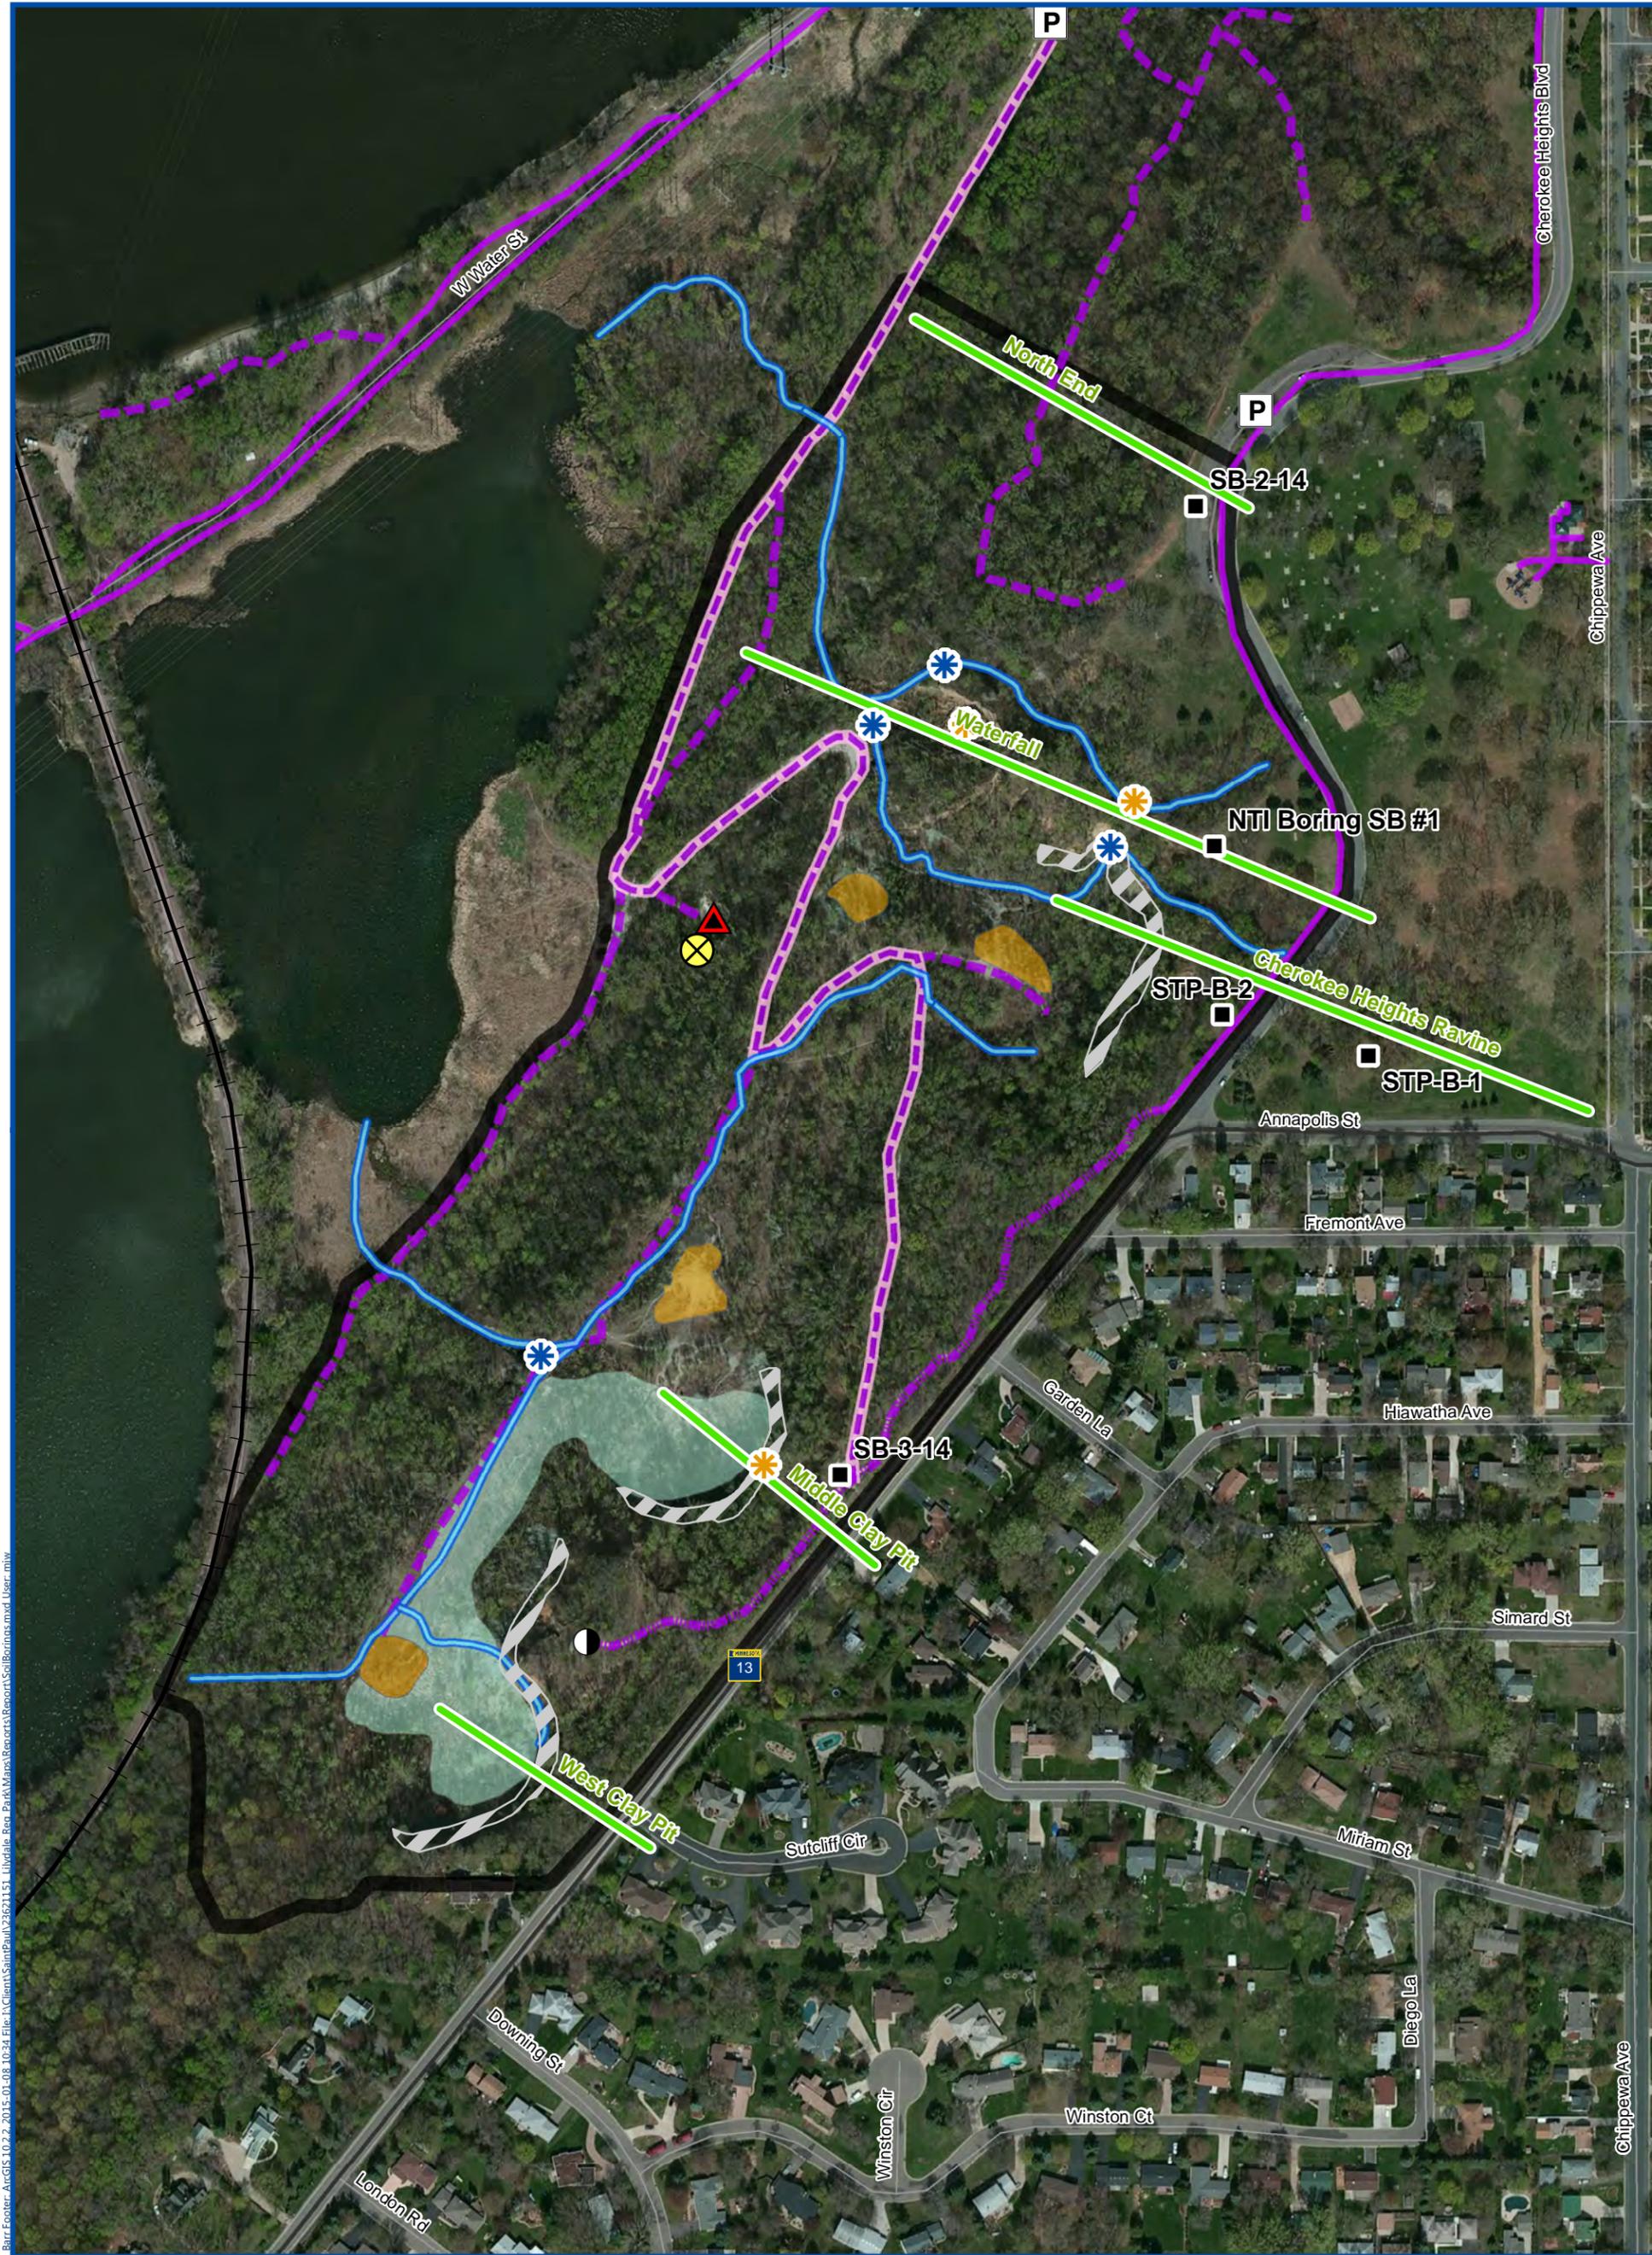
**SOIL BORINGS AND  
 MODELED GEOTECHNICAL  
 CROSS-SECTIONS**  
 Brickyard Area of  
 Lilydale Regional Park  
 St. Paul, Minnesota  
**FIGURE 3-1**

Large Figure 3-1 of the Main Report shows the boring locations. Boring location coordinates and elevations were surveyed by Barr for the project.

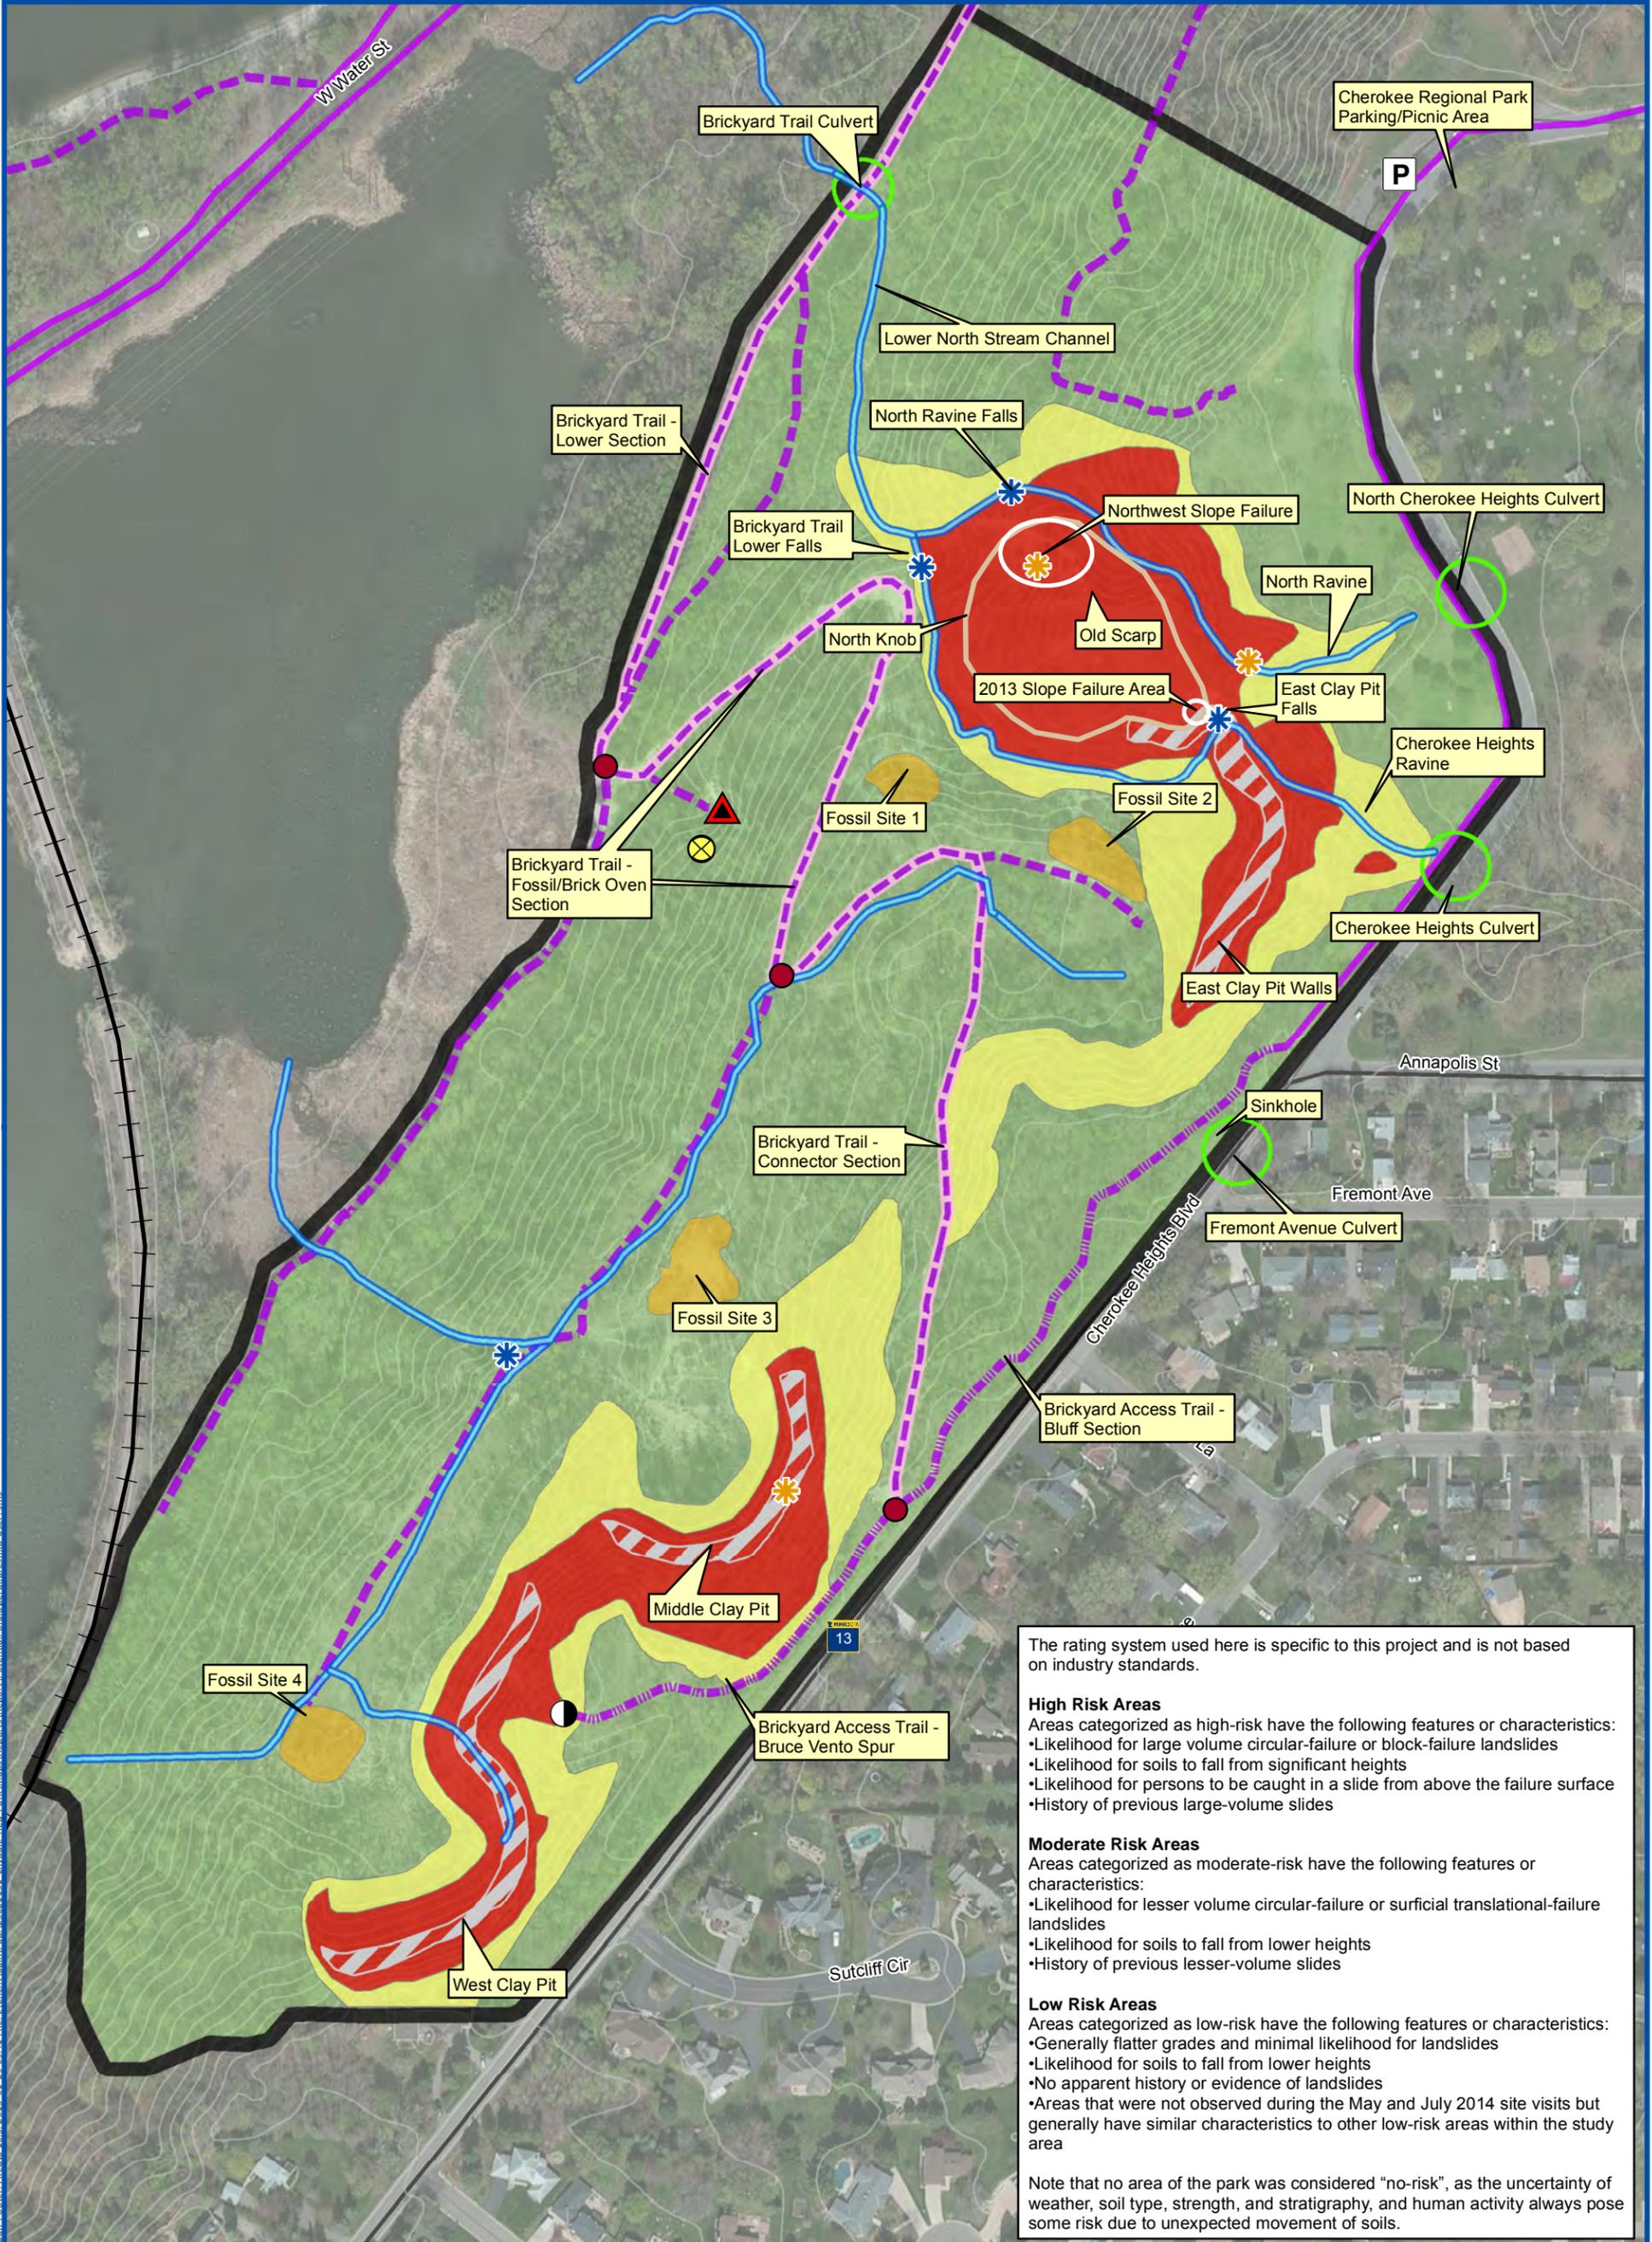
FIGURE 3-2

We recommend that access to the portion of the northern Brickyard Area outlined on Large Figure 5-1 (red-dashed line) be restricted. This is generally a high- or medium-risk area downslope of a high-risk area (Large Figure 3-2). This appears to be an active slide area and is considered unstable; recent slides have resulted in significant amounts of material moving downslope. Restricting access could be accomplished with signage, fencing, or a combination. In addition, the Lower North Stream Channel could be reestablished and stabilized, as long as the upstream ravine areas (including the North Knob area) are inspected consistently for additional erosion and/or are stabilized (see Section 5.5.3 for more specific slope-stabilization recommendations). Once the Lower North Stream Channel is stabilized, the Brickyard Trail Culvert should be replaced with a small span bridge or oversized box culvert. This would be less restrictive of flow and less prone to plugging or washing out, while still providing a stable trail crossing for

The Bruce Vento Scenic Overlook (described in Section 2.5) is considered a high-risk area due to the potential instability of the steep slopes on the west side of the overlook (Large Figure 3-2). We recommend that this area be closed or the slopes below the trail be stabilized due to the potential risk of slope failure. Another option would be to relocate the overlook further back toward Cherokee Heights Boulevard (Highway 13) in the wider area of land between the Middle and West Clay Pits and restrict access closer to the edge of the bluffs. While there appears to be enough stable area to relocate and reconstruct the overlook, it is possible that the slope failures may eventually encroach. Therefore, it would be important to continually monitor the area to track encroachment of unstable slopes. If the overlook is relocated, we recommended that the Bruce Vento Spur of the Brickyard Access Trail also be stabilized or a new access trail constructed.

**POTENTIAL FOR SLOPE FAILURE**  
 (BASED ON JULY 2014 SITE CONDITIONS)  
 Brickyard Area of Lilydale Regional Park  
 St. Paul, Minnesota

- **Update information**—Large Figure 3-2 (potential for slope failure under existing conditions) and other appropriate figures in this report should be re-evaluated and updated, as necessary, following each inspection.
