## **Brickyard Area of Lilydale Regional Park**

### ***Stormwater Management and Slope-Stability Analysis***

Prepared for  
City of St. Paul Department of Parks and Recreation

January 28, 2015

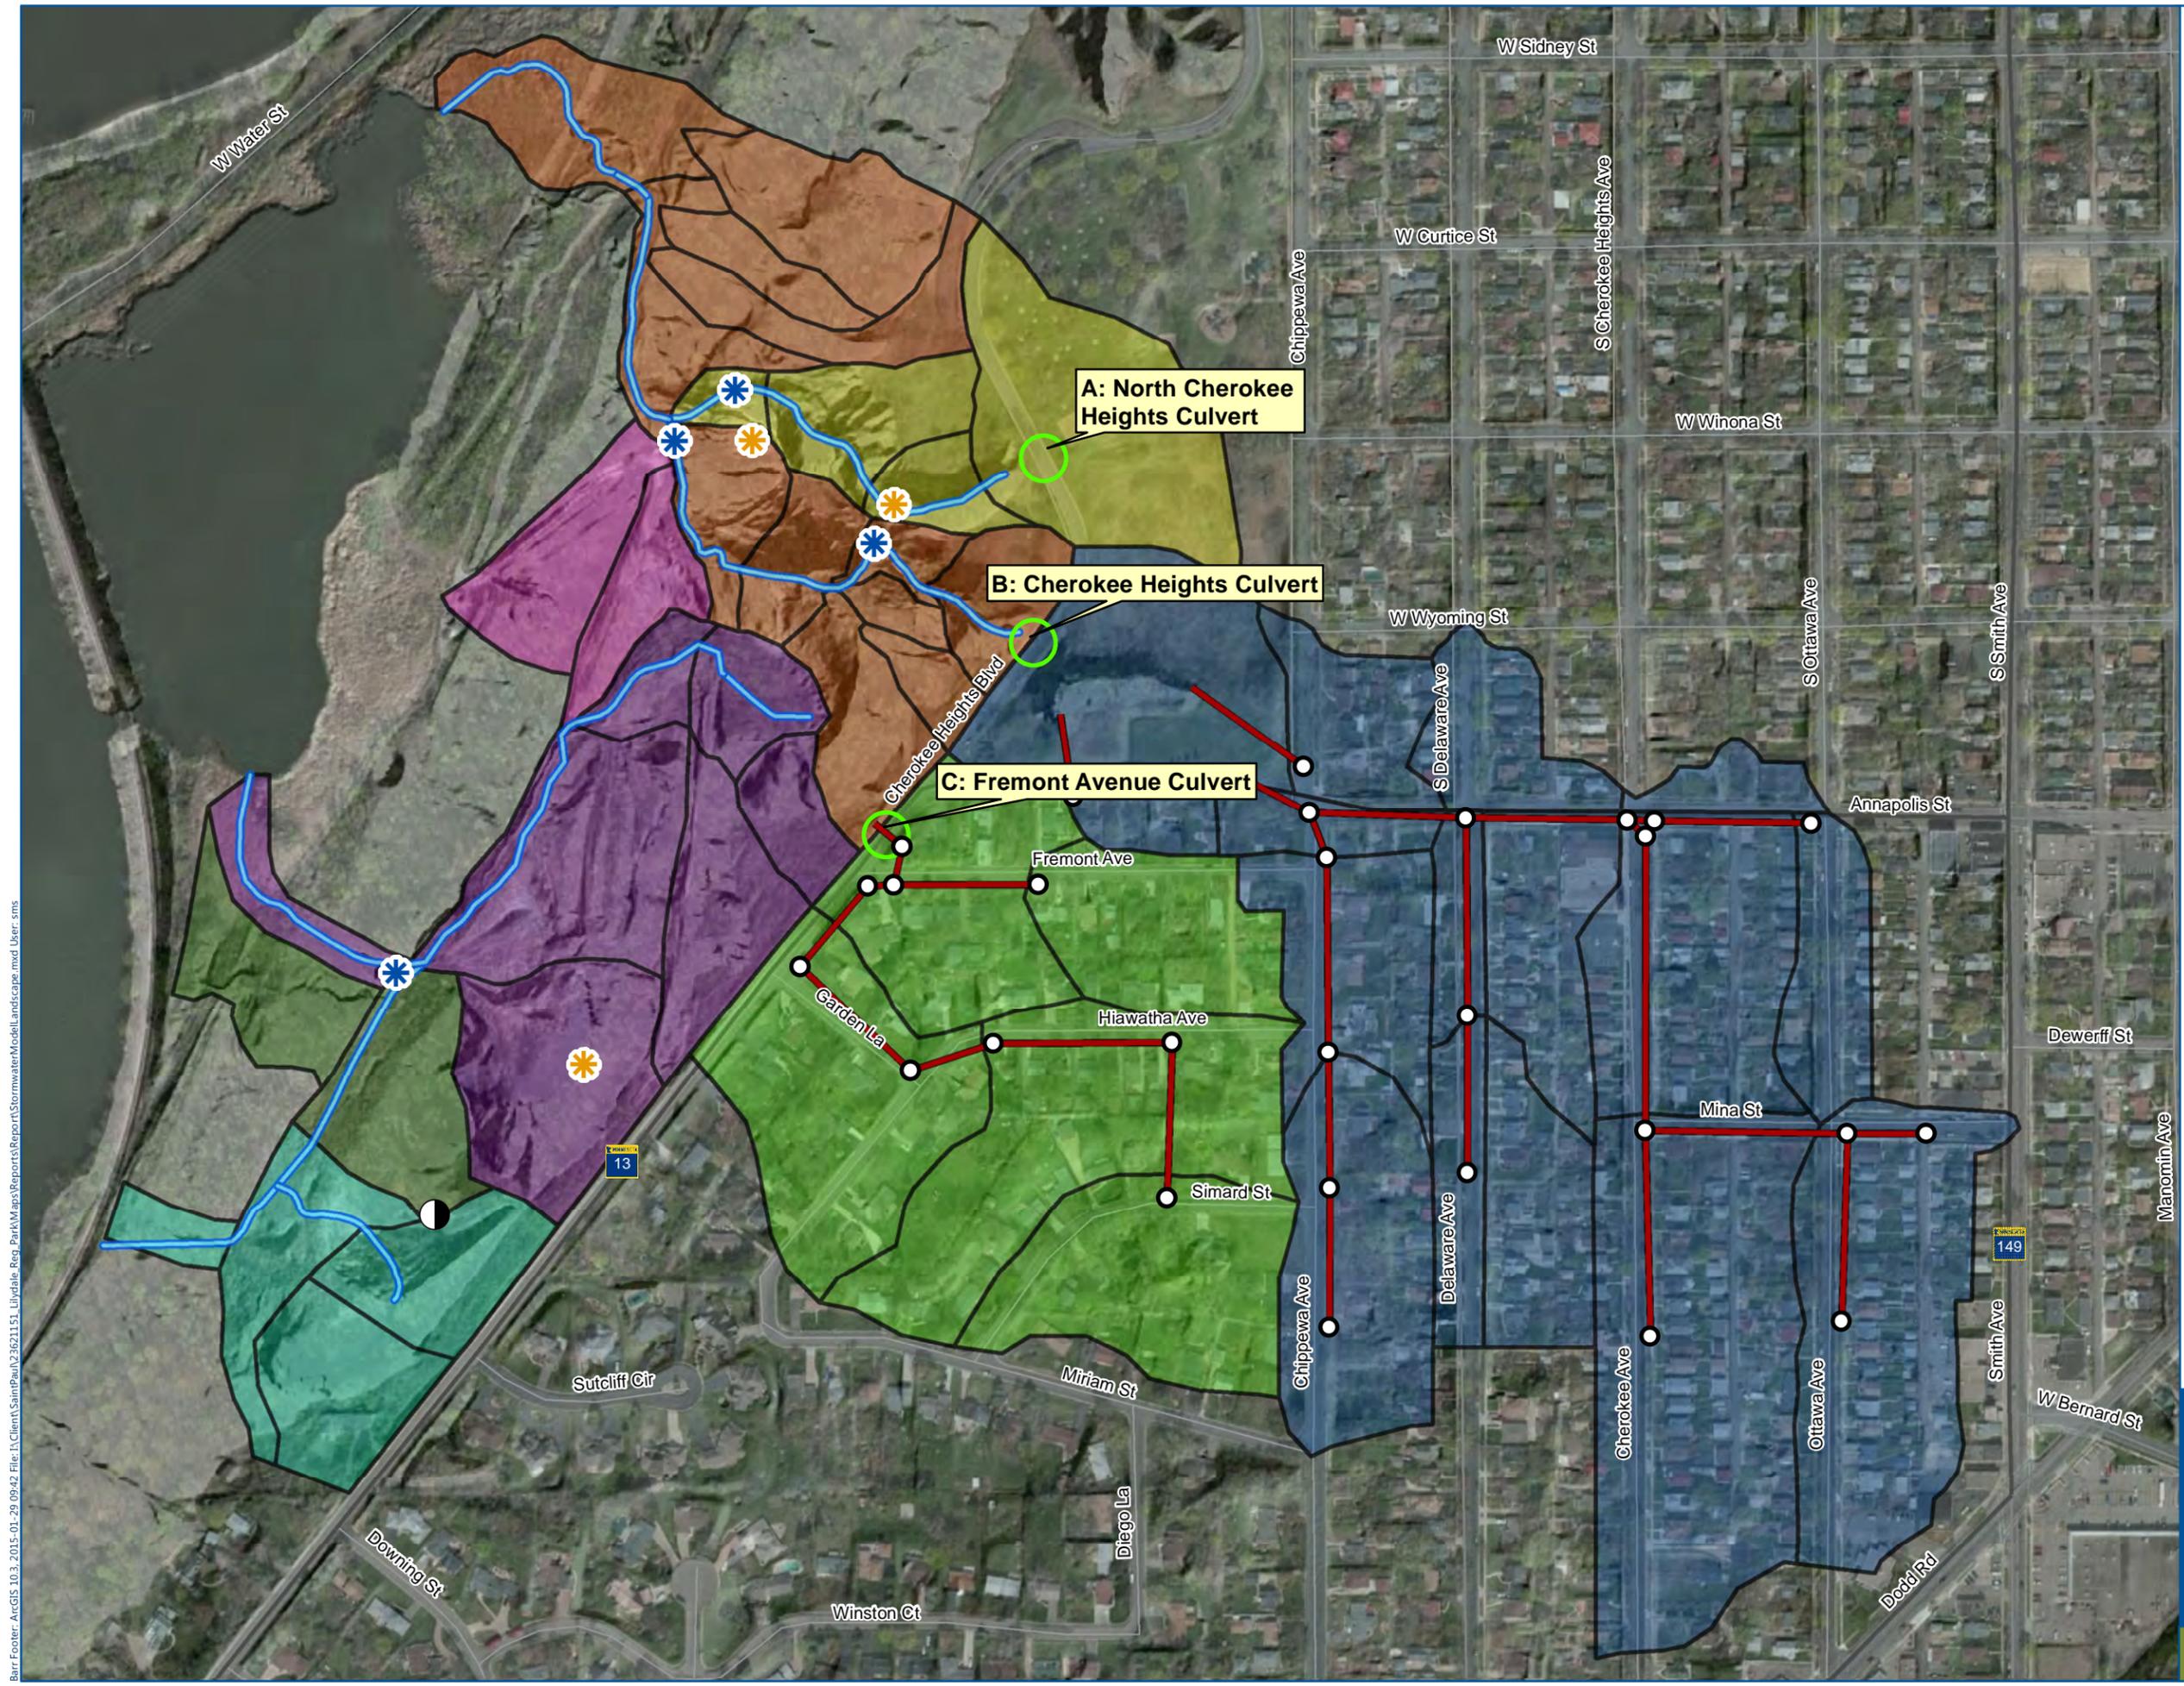
FIGURE 4-1

The peak flow velocities vary by reach, depending on contributing flow rate, channel shape, and channel slope. The highest predicted peak velocities generally correspond with the reaches observed to have the most significant erosion—specifically the 300-foot stretch of Cherokee Heights Ravine downstream of the Cherokee Heights Culvert, the Lower North Stream Channel, and just downstream of the Cherokee Heights Boulevard culvert near Fremont Avenue, all shown in Large Figure 4-1.

**STORMWATER MODELING**  
 Brickyard Area of  
 Lilydale Regional Park  
 St. Paul, Minnesota

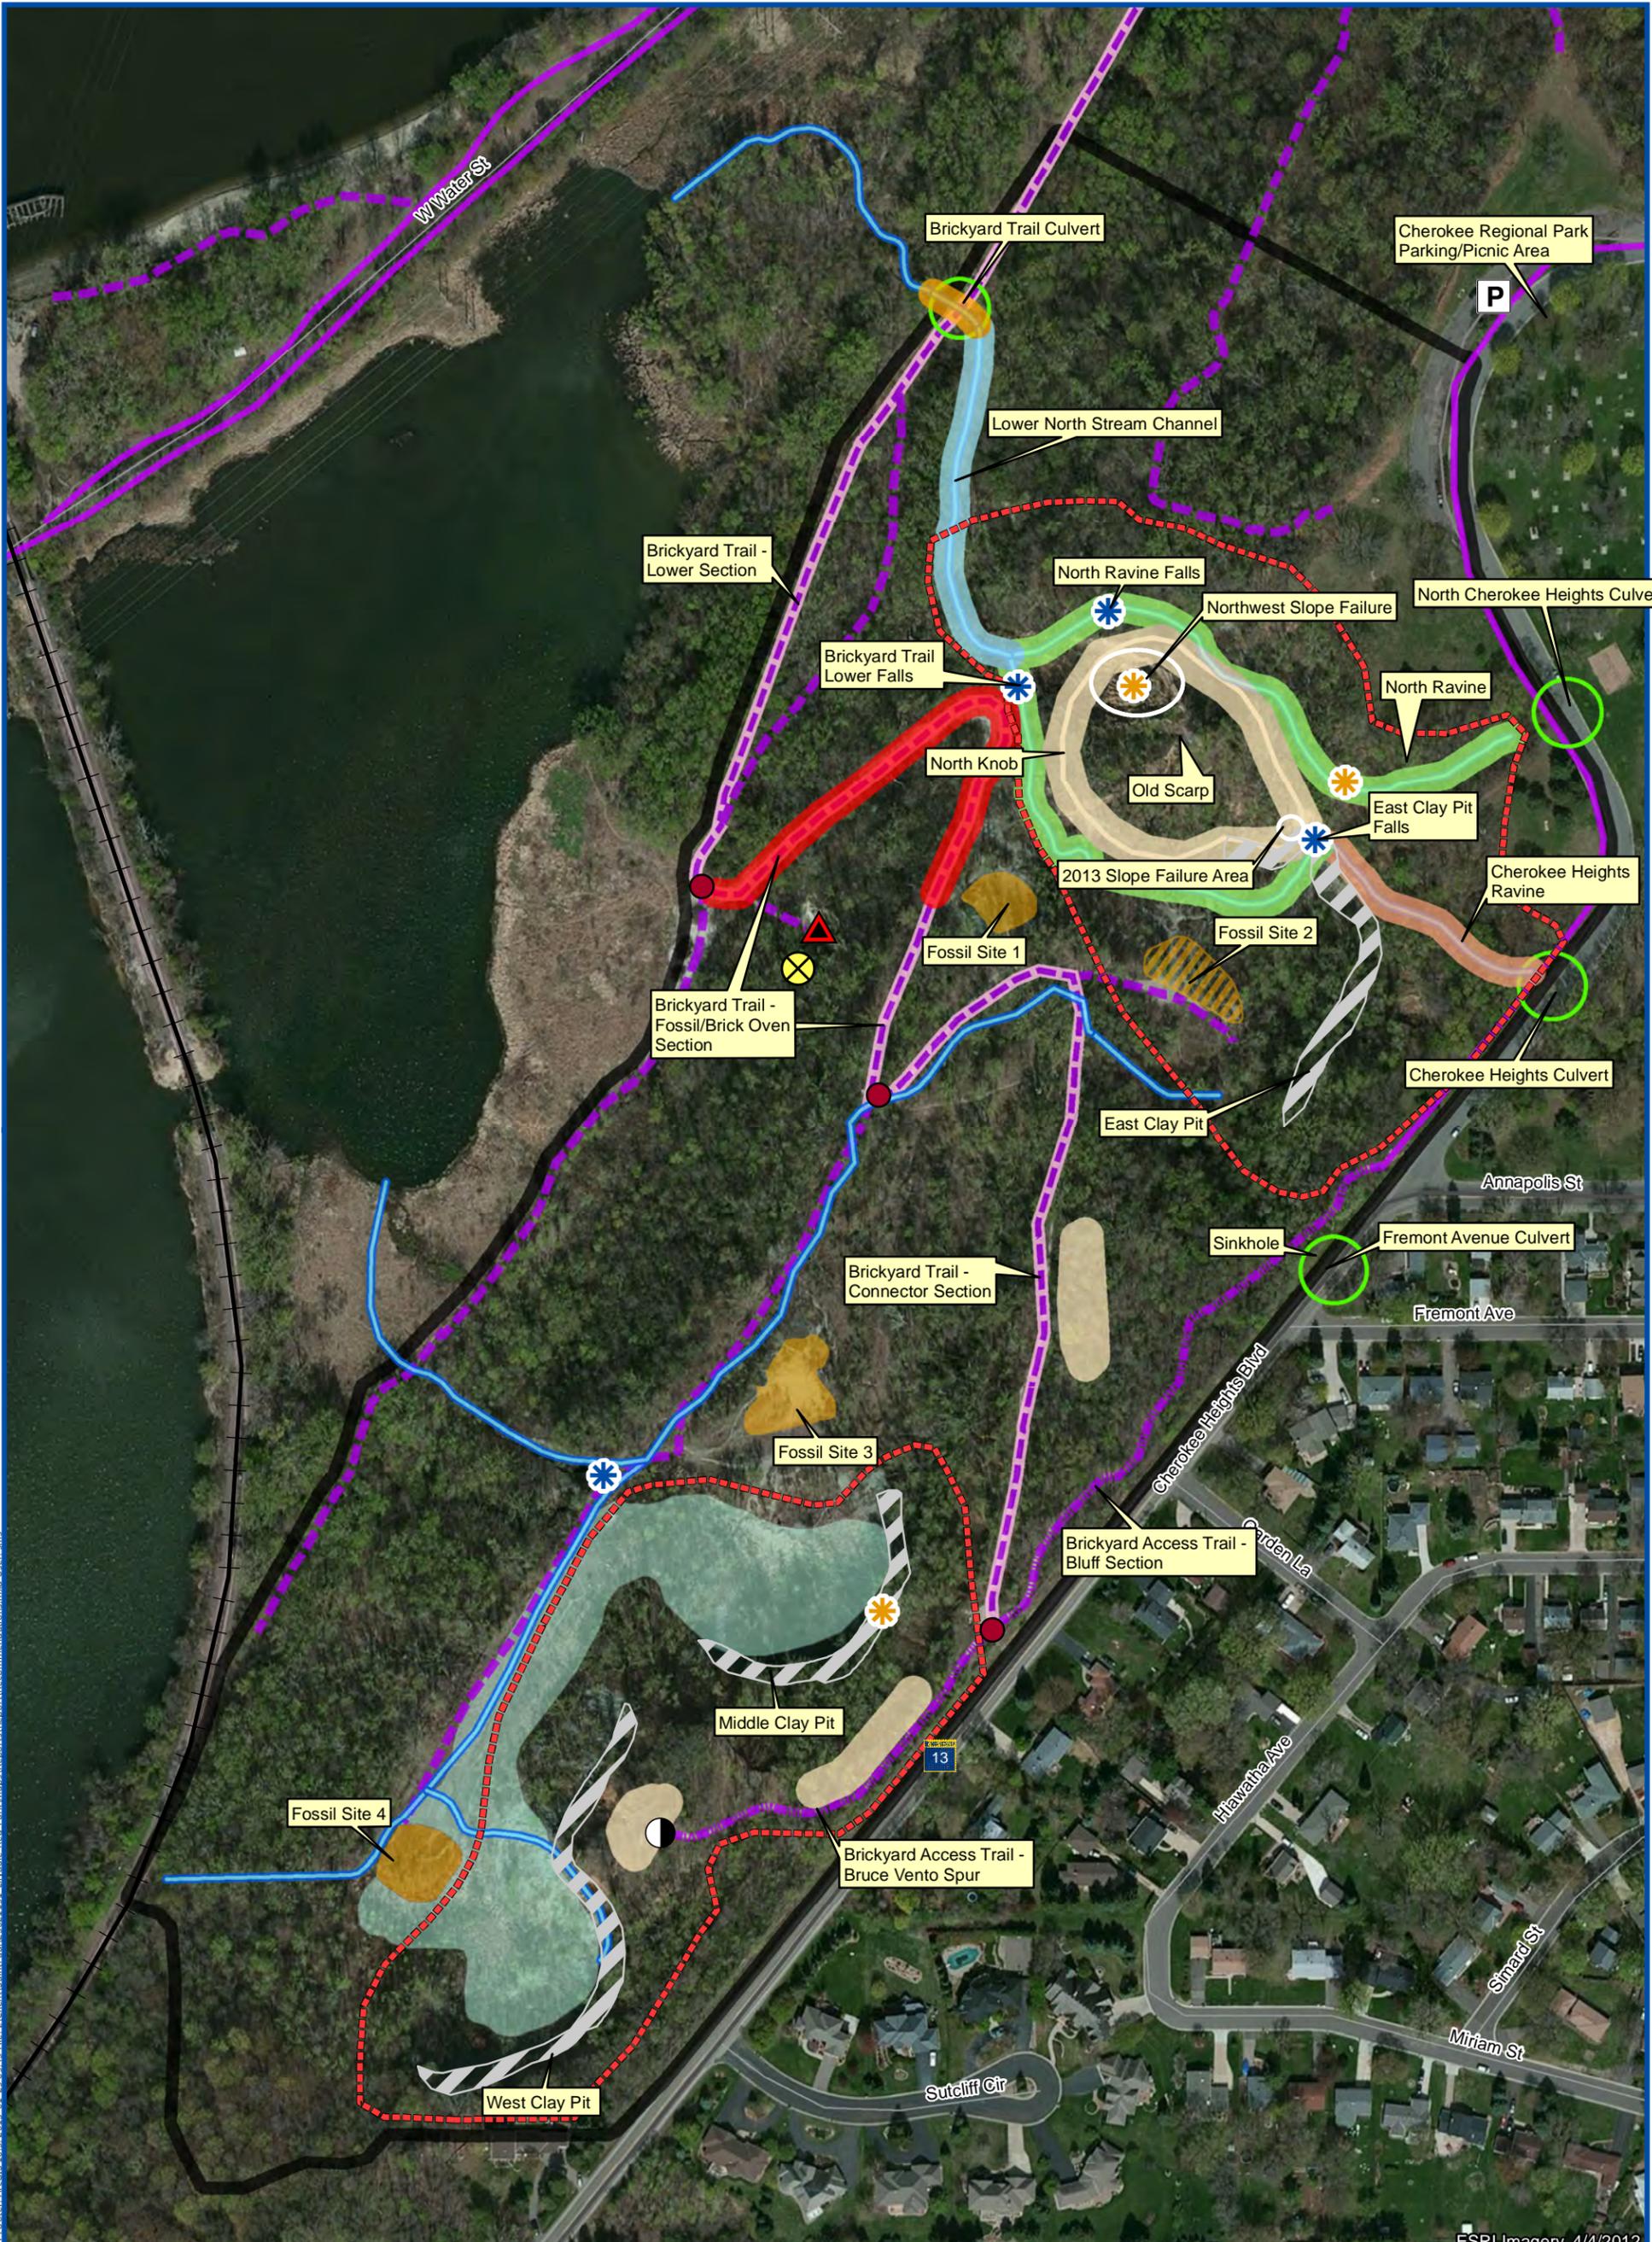
**RECOMMENDATIONS**  
 Brickyard Area of  
 Lilydale Regional Park  
 St. Paul, Minnesota

1. Restrict access to the Middle and West Clay Pit areas and the Bruce Vento Scenic Overlook (as shown in Large Figure 5-1). A planning-level cost range for fencing this area is \$84,000–\$180,000. (Costs are highly dependent on the actual length and type of fencing selected—this estimate assumes fencing for the entire length of the “restrict access” area shown for the southern portion of the Brickyard Area.) The “restrict access” area should be reassessed following implementation of the following steep-slope recommendations.

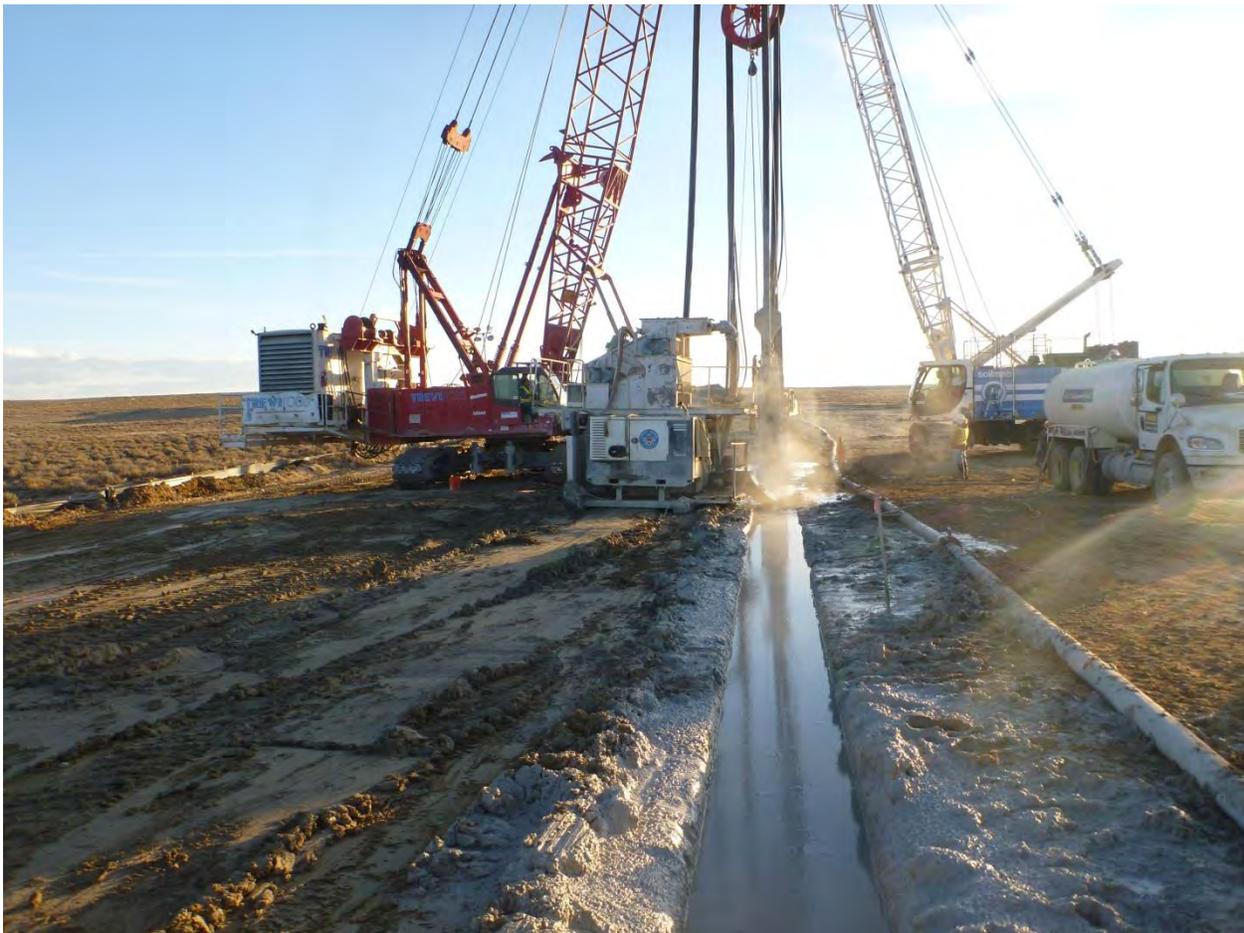
However, cutting off of groundwater flow from the higher areas above the bluff may help reduce some potential for slope instability, but since this technology will not prevent soil saturation from rainfall and infiltration downstream of the cut-off wall it may not be fully effective in reducing slope stability issues. Also, since the slurry trench is intended to reduce or eliminate flow across the trench, water which used to flow toward and over the bluffs may build up behind the wall and need to be drained or removed (or at least planned for where the water can be discharged without causing other problems).

For these reasons, a slurry trench or cutoff wall does not appear to be the best choice to reduce the potential for slope stability at this site.

Photo B-1 Photo of slurry trench

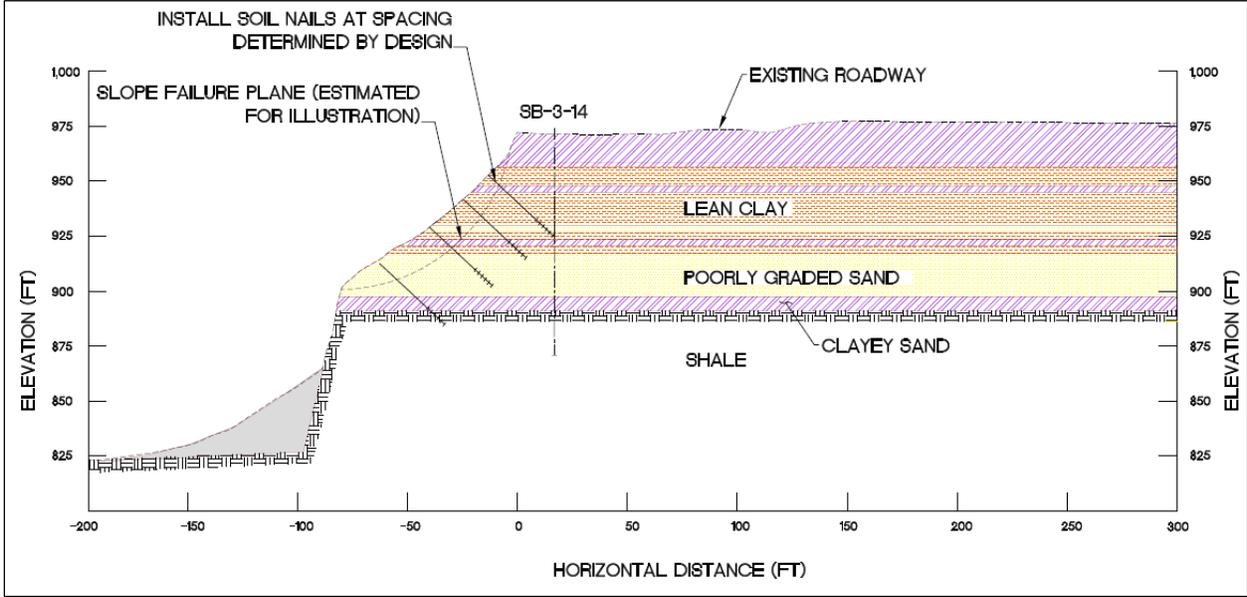
Soil nailing is another common method of active slope stabilization. With soil nailing, small diameter corrosion resistant elements (nails, helical anchors, etc.) are installed at an angle through the soils, extending far enough into the soil to penetrate past the failure plane. The resistance generated by the nail behind the failure plane pins the soil mass in place not allowing it to slide.

Figure B-2 Conceptual example of soil nailing

Costs associated with soil nailed can get high, especially with limited site access. However, there are some specialized rigs that can install soil nails from an extendable arm which can reach down from the top of the slope. This would reduce the need for grading in a working area at the base of the area, which would be somewhat difficult with the location of the steeper clay pits at the toe of the natural soil slopes. This work should typically be performed by a specialty contractor.

Once the soil nails are installed, some slope facing material is usually applied. This typically consists of a wire mesh held in place with shot-crete; however, in natural settings a turf-reinforcing mat which can allow for vegetation growth may be suitable depending on the design requirements.

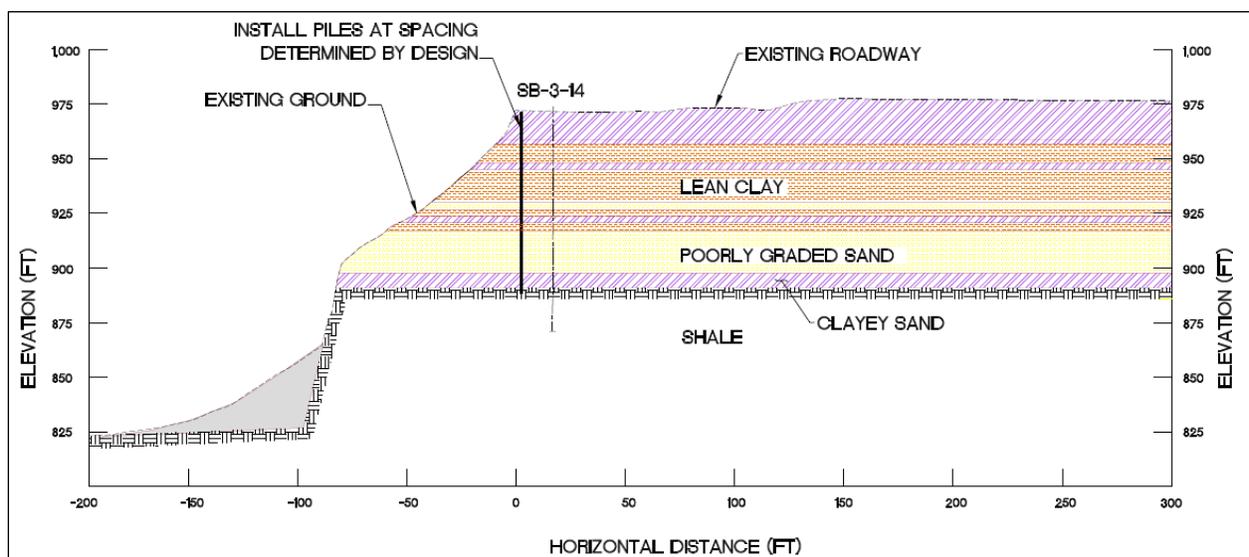
Soldier piling typically consists of steel piles spaced at 5 to 10-foot intervals along the slope and placed into more competent materials, such as very stiff clay, dense sand, or bedrock. The spaces between the piles are then filled with lagging (some form of concrete or wood plank walls) to retain the soil and prevent failures. For this study area, soldier piles would likely need to be socketed at least 10 to 15 feet into the shale bedrock to provide the capacity to retain the upper soils. However, additional site investigation must be performed to design the repairs.

Figure B-3 Conceptual example of soldier piling

Soldier piling work would typically be performed by a specialty contractor, and would have similar site access issues as soil nailing.

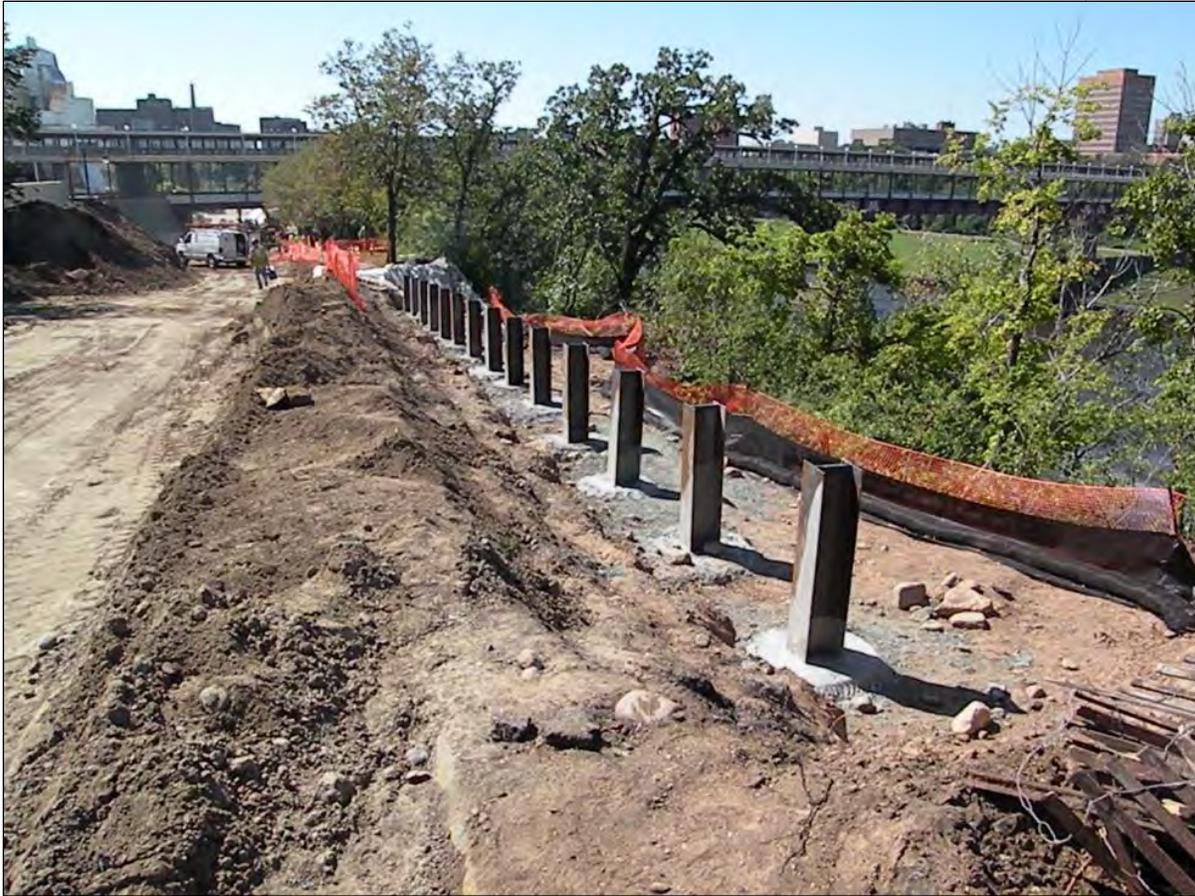
**Photo B-2** Photo of soldier piling along Mississippi River in Minneapolis

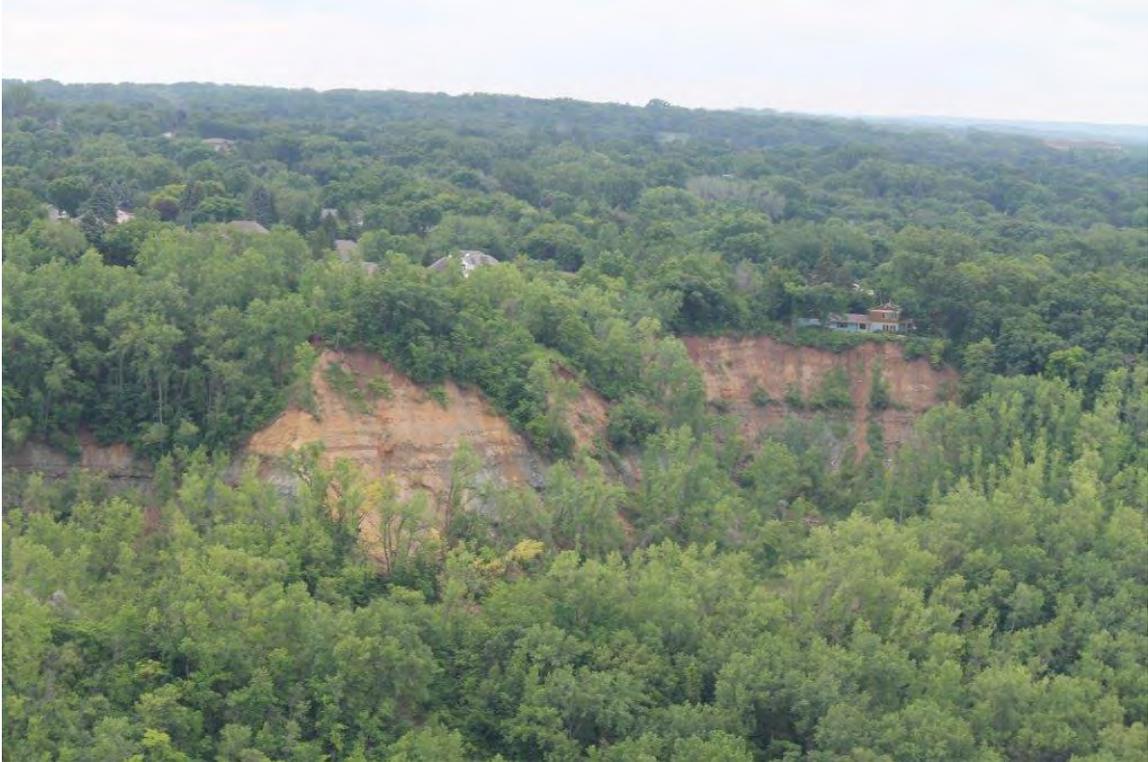
**Photo 1 West Clay Pit and area below Bruce Vento Overlook from the air (photo provided by the City)**

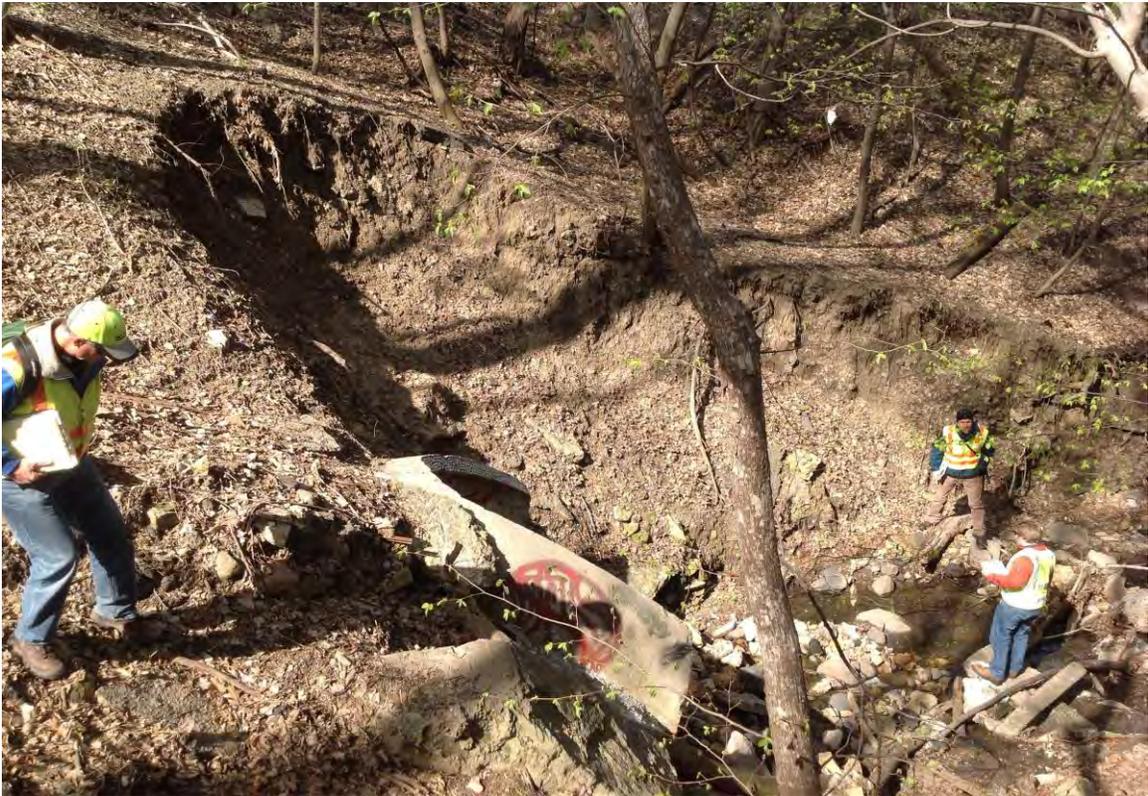
Drainage from portions of Cherokee Heights Regional Park and the adjacent residential area discharges through a 60-inch-diameter reinforced-concrete culvert that extends underneath Cherokee Heights Boulevard and into a ravine (Cherokee Heights Ravine on Large Figure 1-2, Photo 2-2). The ravine extends approximately 300 feet to a waterfall near the horseshoe-shaped East Clay Pit. Observation of the ravine reveals significant erosion along the channel invert and side slopes. This is most likely due to high flow rates and velocities in combination with erodible, sandy soils. At the downstream end of the ravine, the channel bottom has been scoured down to the underlying Decorah Shale bedrock.

**Photo 2 Scarp adjacent to storm sewer outlet in Cherokee Heights ravine (May 2014 site visit)**

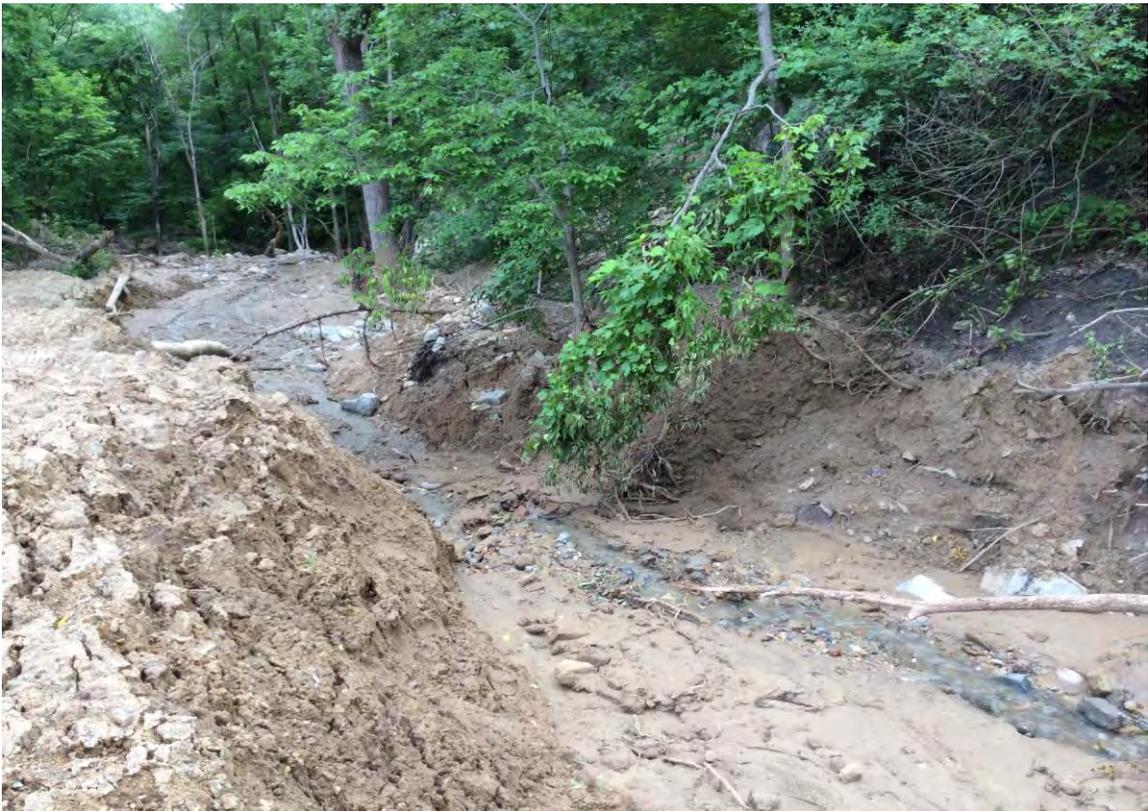
**Photo 8 Soil deposited at base of slide and newly eroded stream channel (July 2014 site visit)**

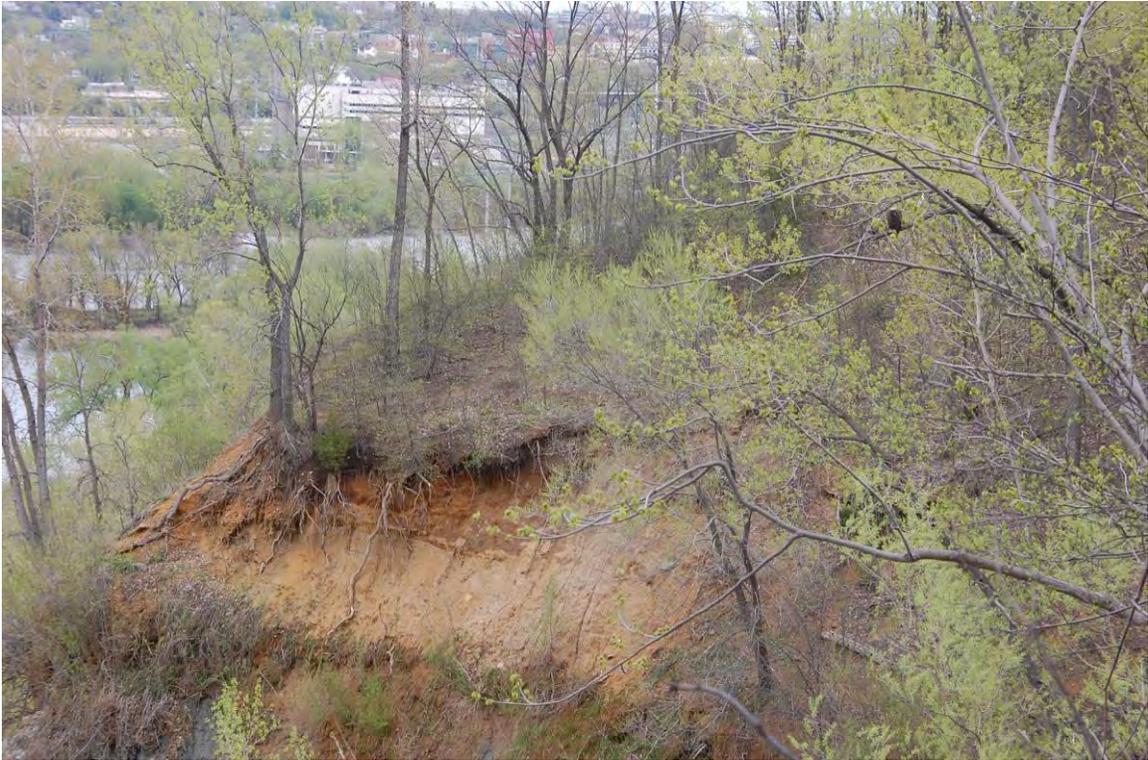
There is diverse vegetation on the upper soil slopes of the study area and trees of various sizes—from saplings to mature 40-foot trees. There is also grass/weed vegetation that has formed carpet-like mats on many of the park's slopes (see photos 12, 13, and 24 in Attachment D).

**Photo 13 Close-up of overhanging soil and root zone (West Clay Pit) (May 2014 site visit)**

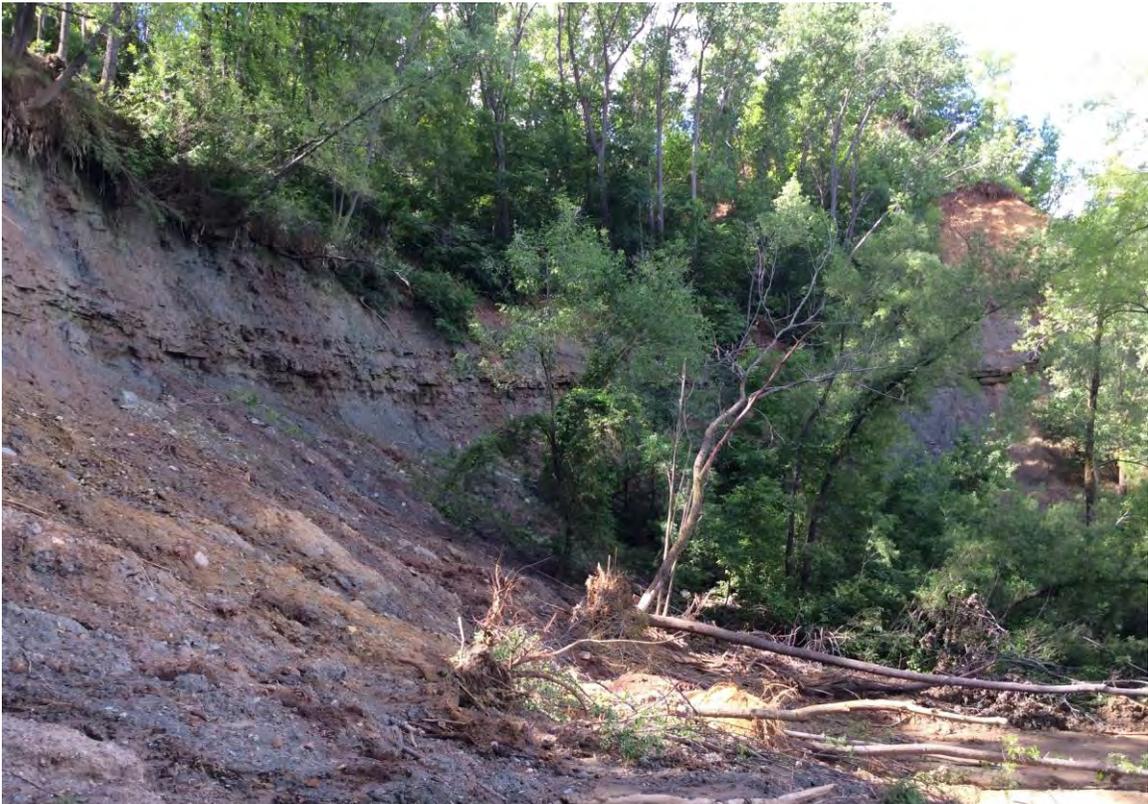
**Photo 14 Middle Clay Pit wall (note fresh soil scarp in upper right corner) (July 2014 site visit)**

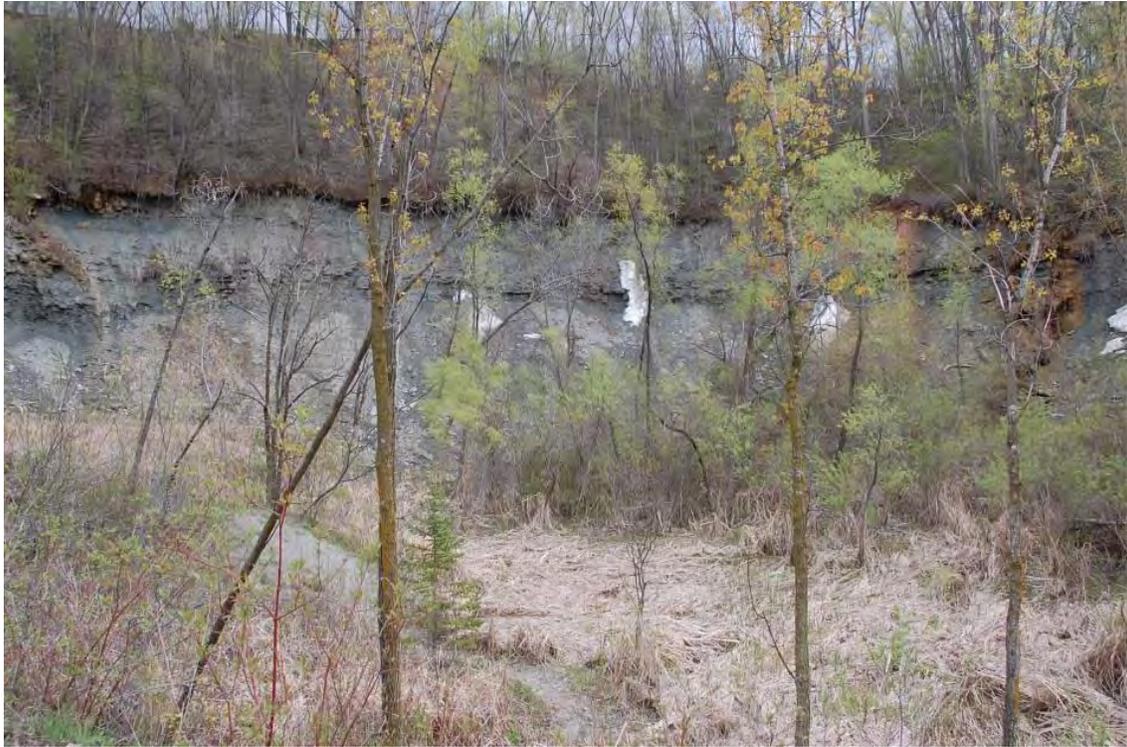
**Photo 15 Middle Clay Pit with snow/ice (from seepage) on face of shale (May 2014 site visit)**

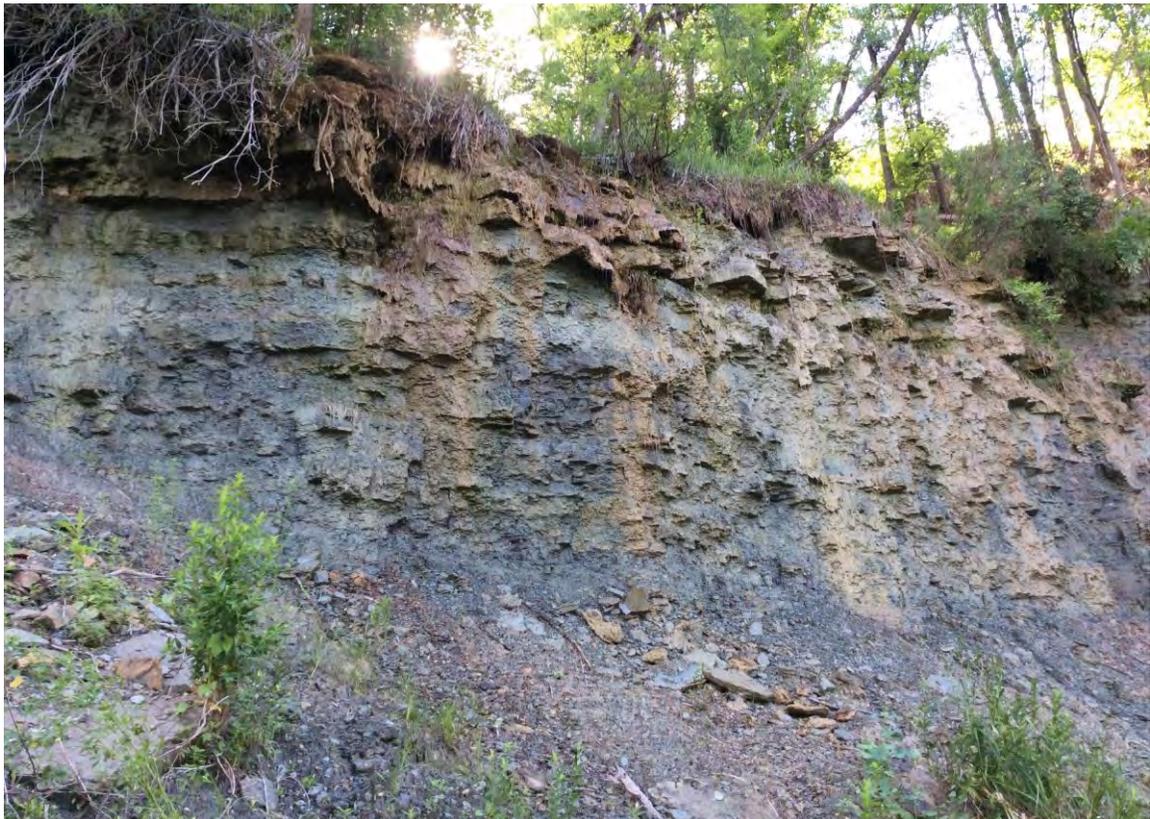
**Photo 16 Weeping rock outcrop in Middle Clay Pit (July 2014 site visit)**

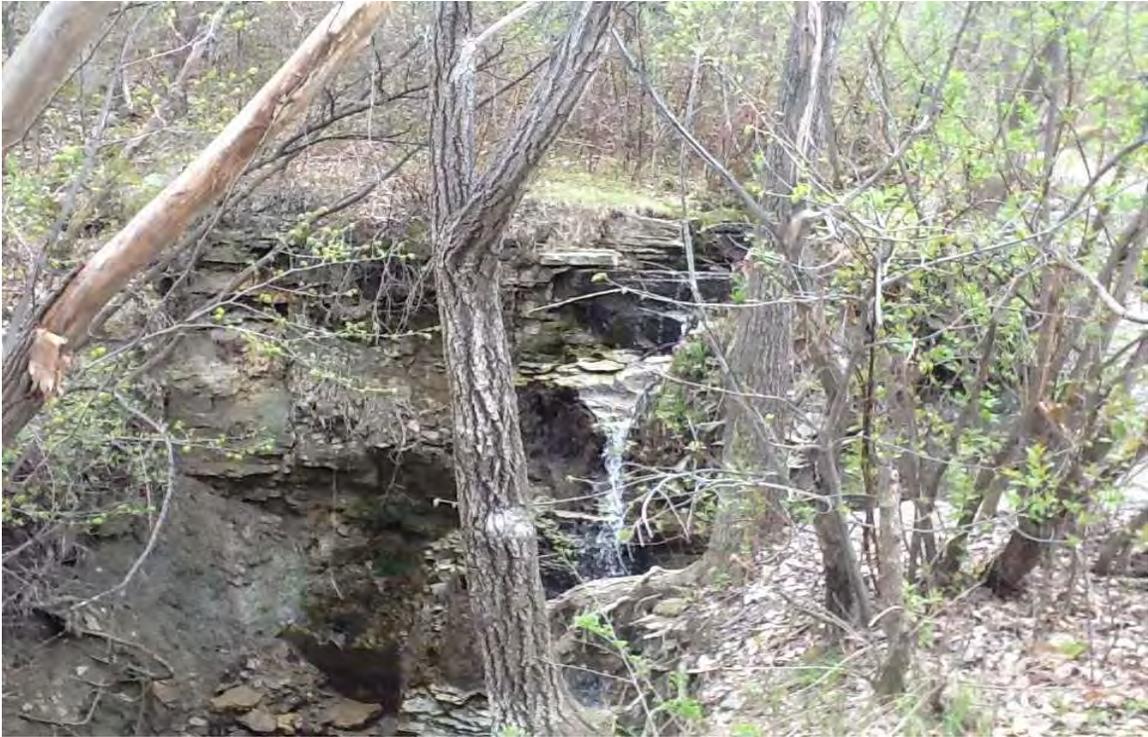
**Photo 21 Lower falls along Brickyard Trail (May 2014 site visit)**

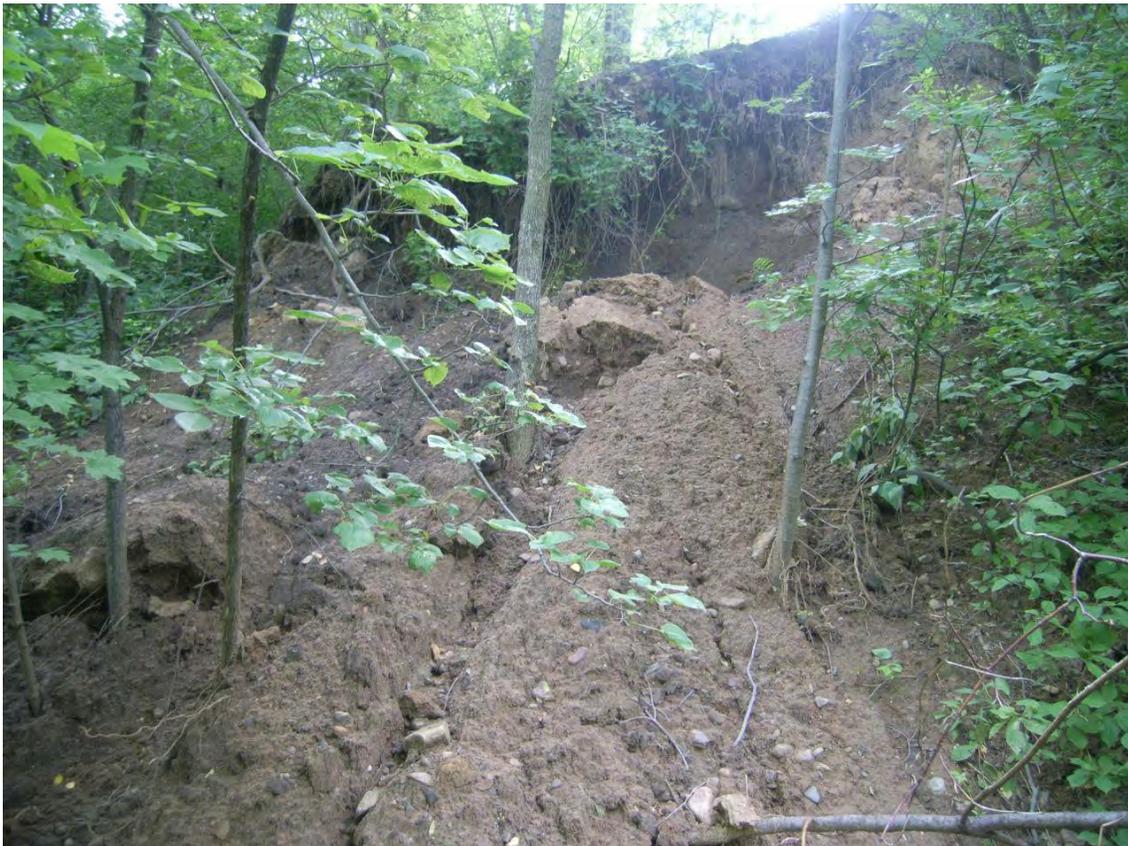
**Photo 22 Slide below the Bruce Vento Spur of the Brickyard Trail (July 2014 site visit)**

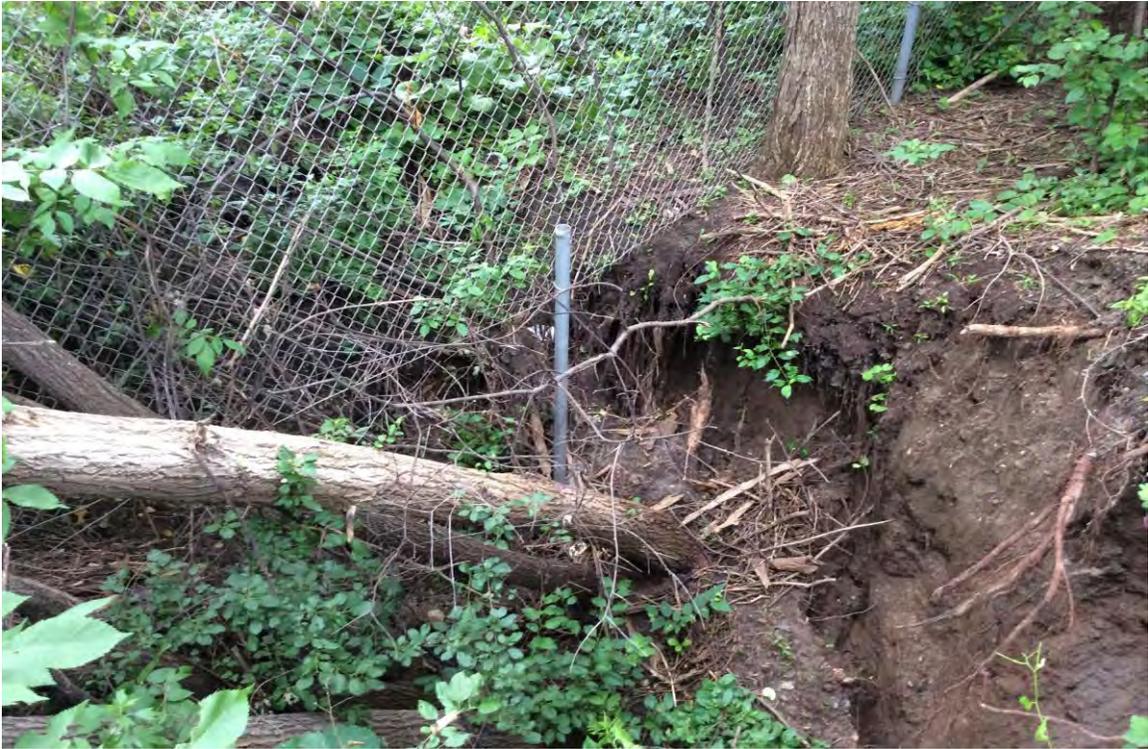
During the July 2014 site visit, Barr staff also observed an apparent sinkhole that had opened up along the Brickyard Access Trail–Bluff Section just north of the intersection of Cherokee Heights Boulevard/Highway 13 and Fremont Avenue (location shown on Large Figure 1-2). The sinkhole, which was about 10 feet deep and 8 feet across, had engulfed the chain-link fence along the road (Photo 2-27).

**Photo 23 "Sinkhole" along Brickyard Trail – Bluff Section (note sunken fence post) (July 2014 site visit)**

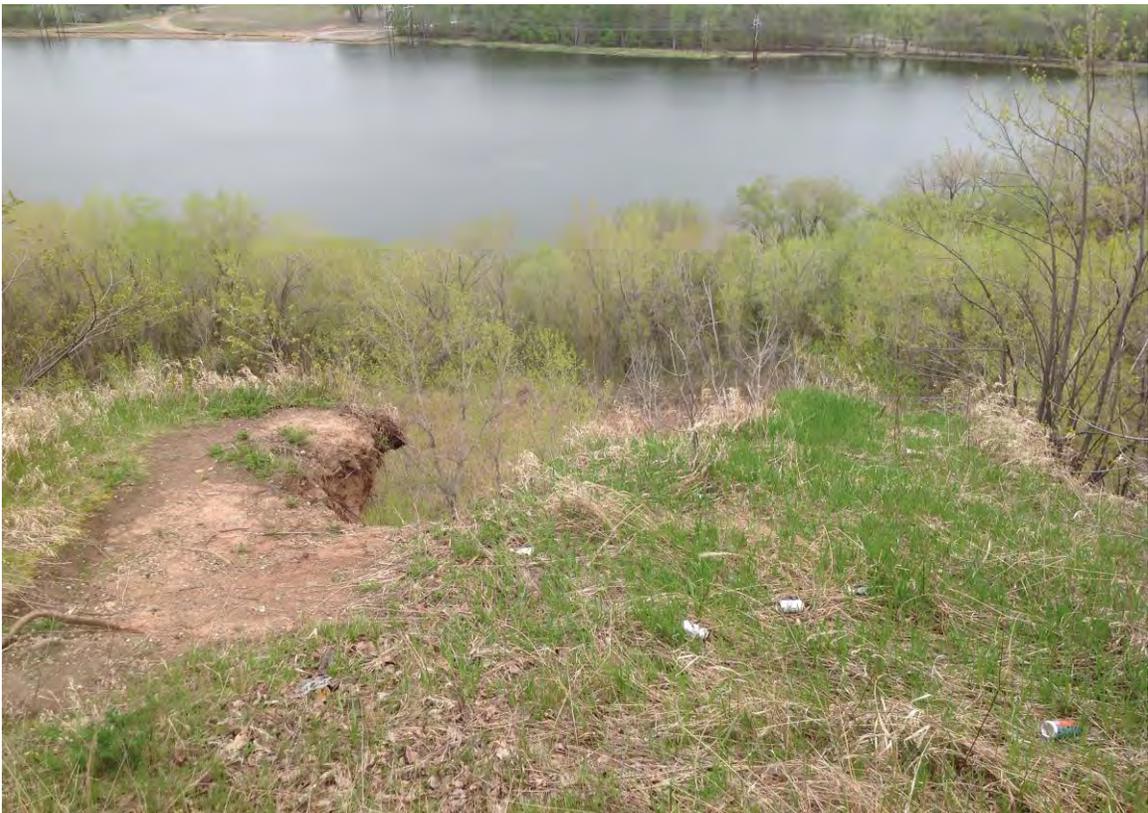
**Photo 24 Soil overhang at Bruce Vento Overlook (May 2014 site visit)**
