## **Brickyard Area of Lilydale Regional Park**

### ***Stormwater Management and Slope-Stability Analysis***

Prepared for  
City of St. Paul Department of Parks and Recreation

January 28, 2015

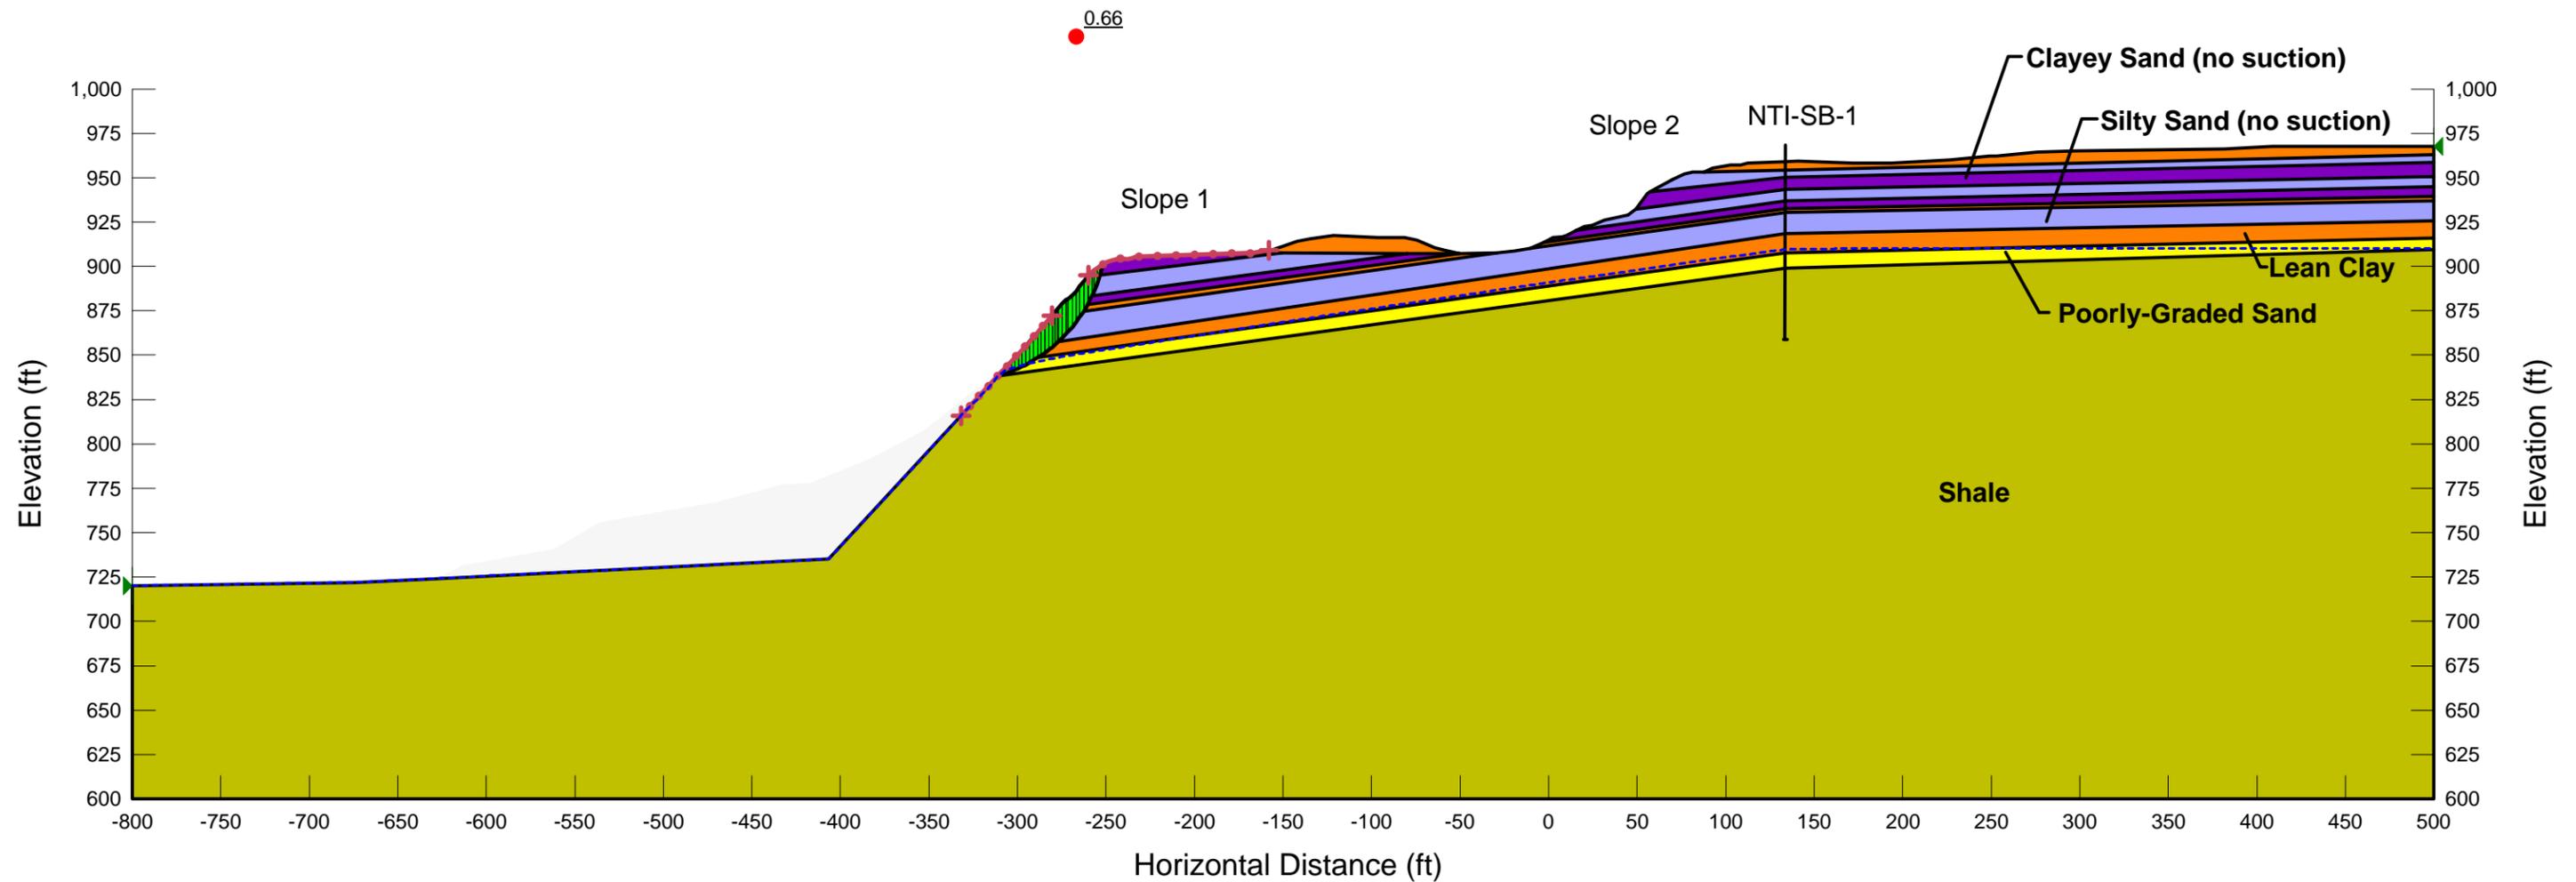
**FS = 0.66**

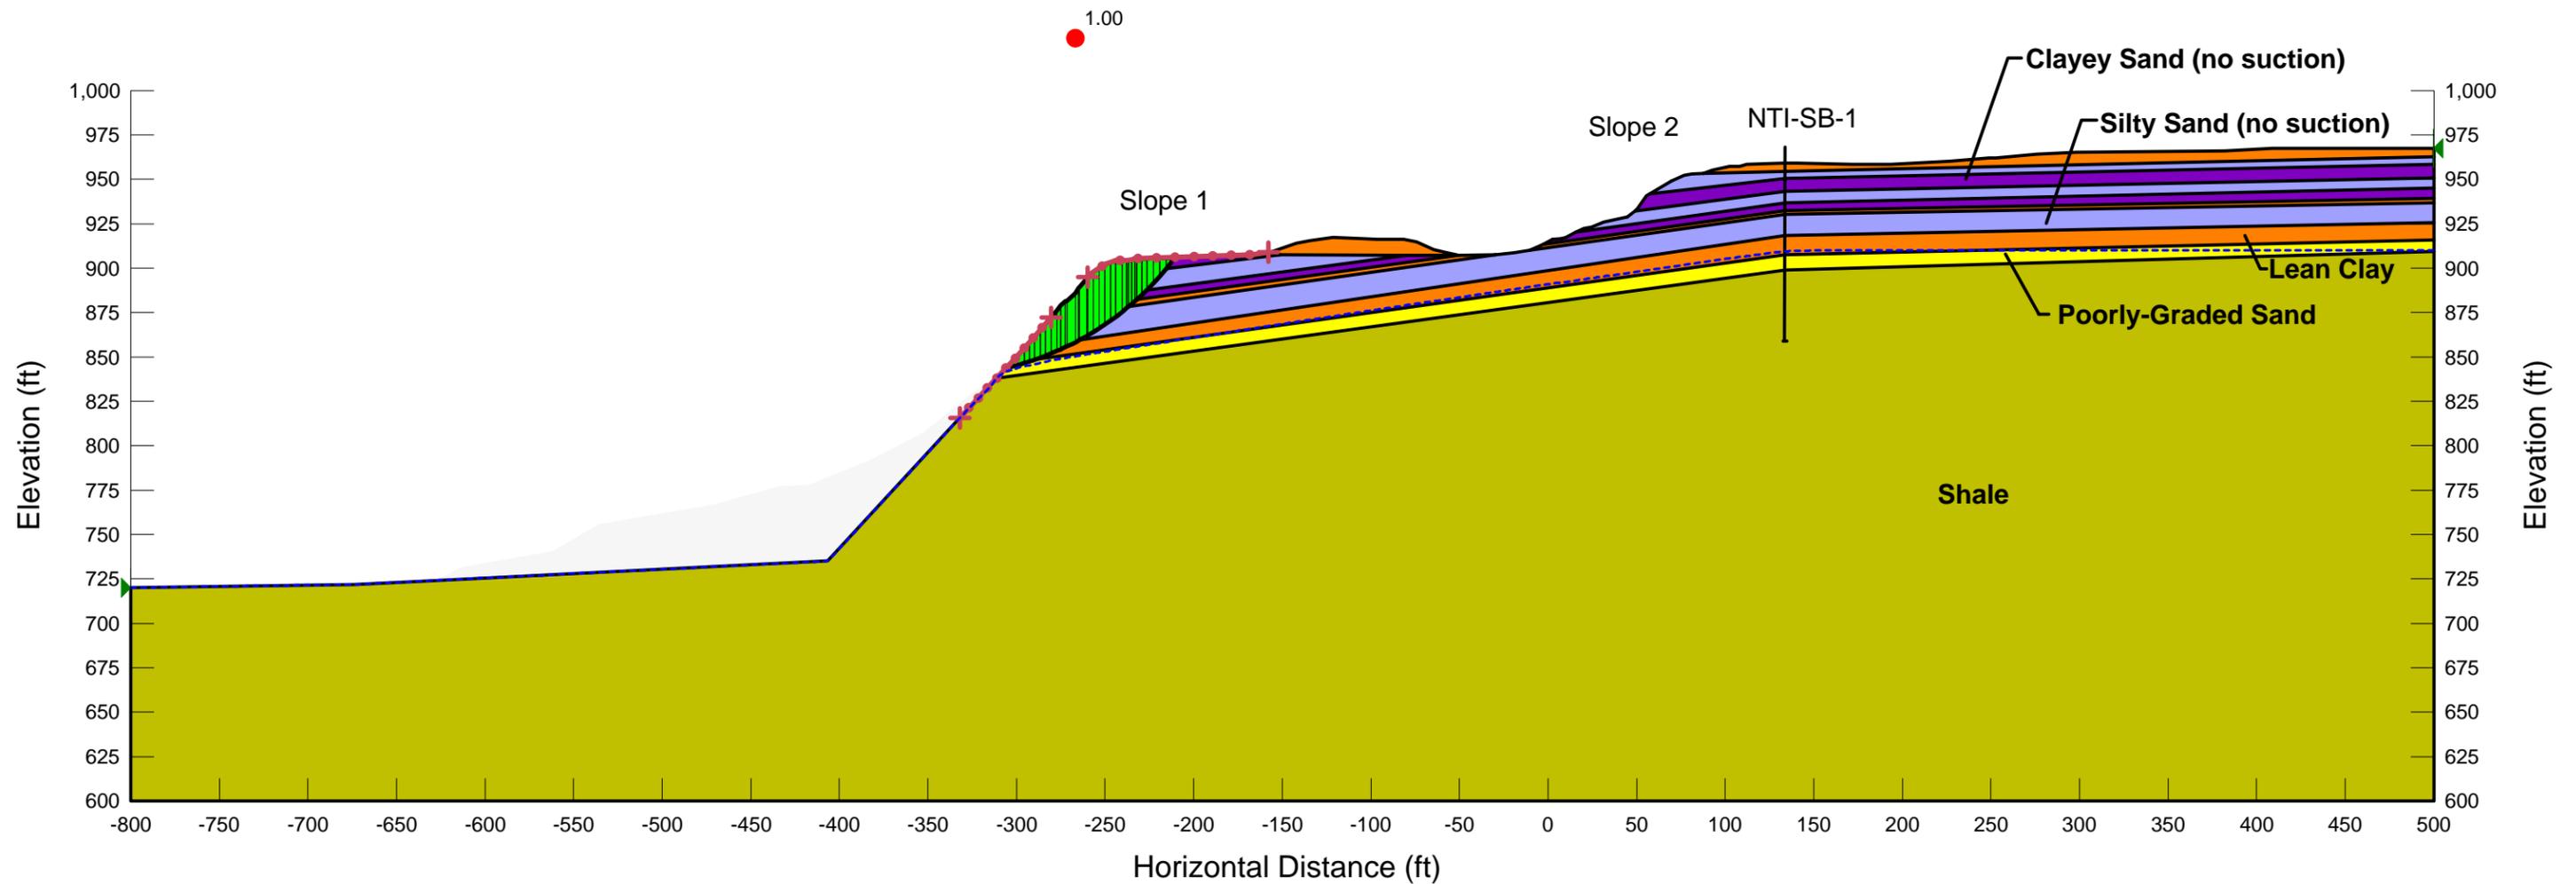
**Figure E-8 Waterfall Landslide Slope 1 Drained Friction Angle at Stability**  
**Lilydale Regional Park**  
**Seepage and Slope Stability Analysis**  
**1.0.1 Slope - Existing Conditions\_slope 1**  
**File Name: Lilydale\_waterfall landslide.gsz**  
**Date Saved: 1/18/2015**

**FS = 1.00**

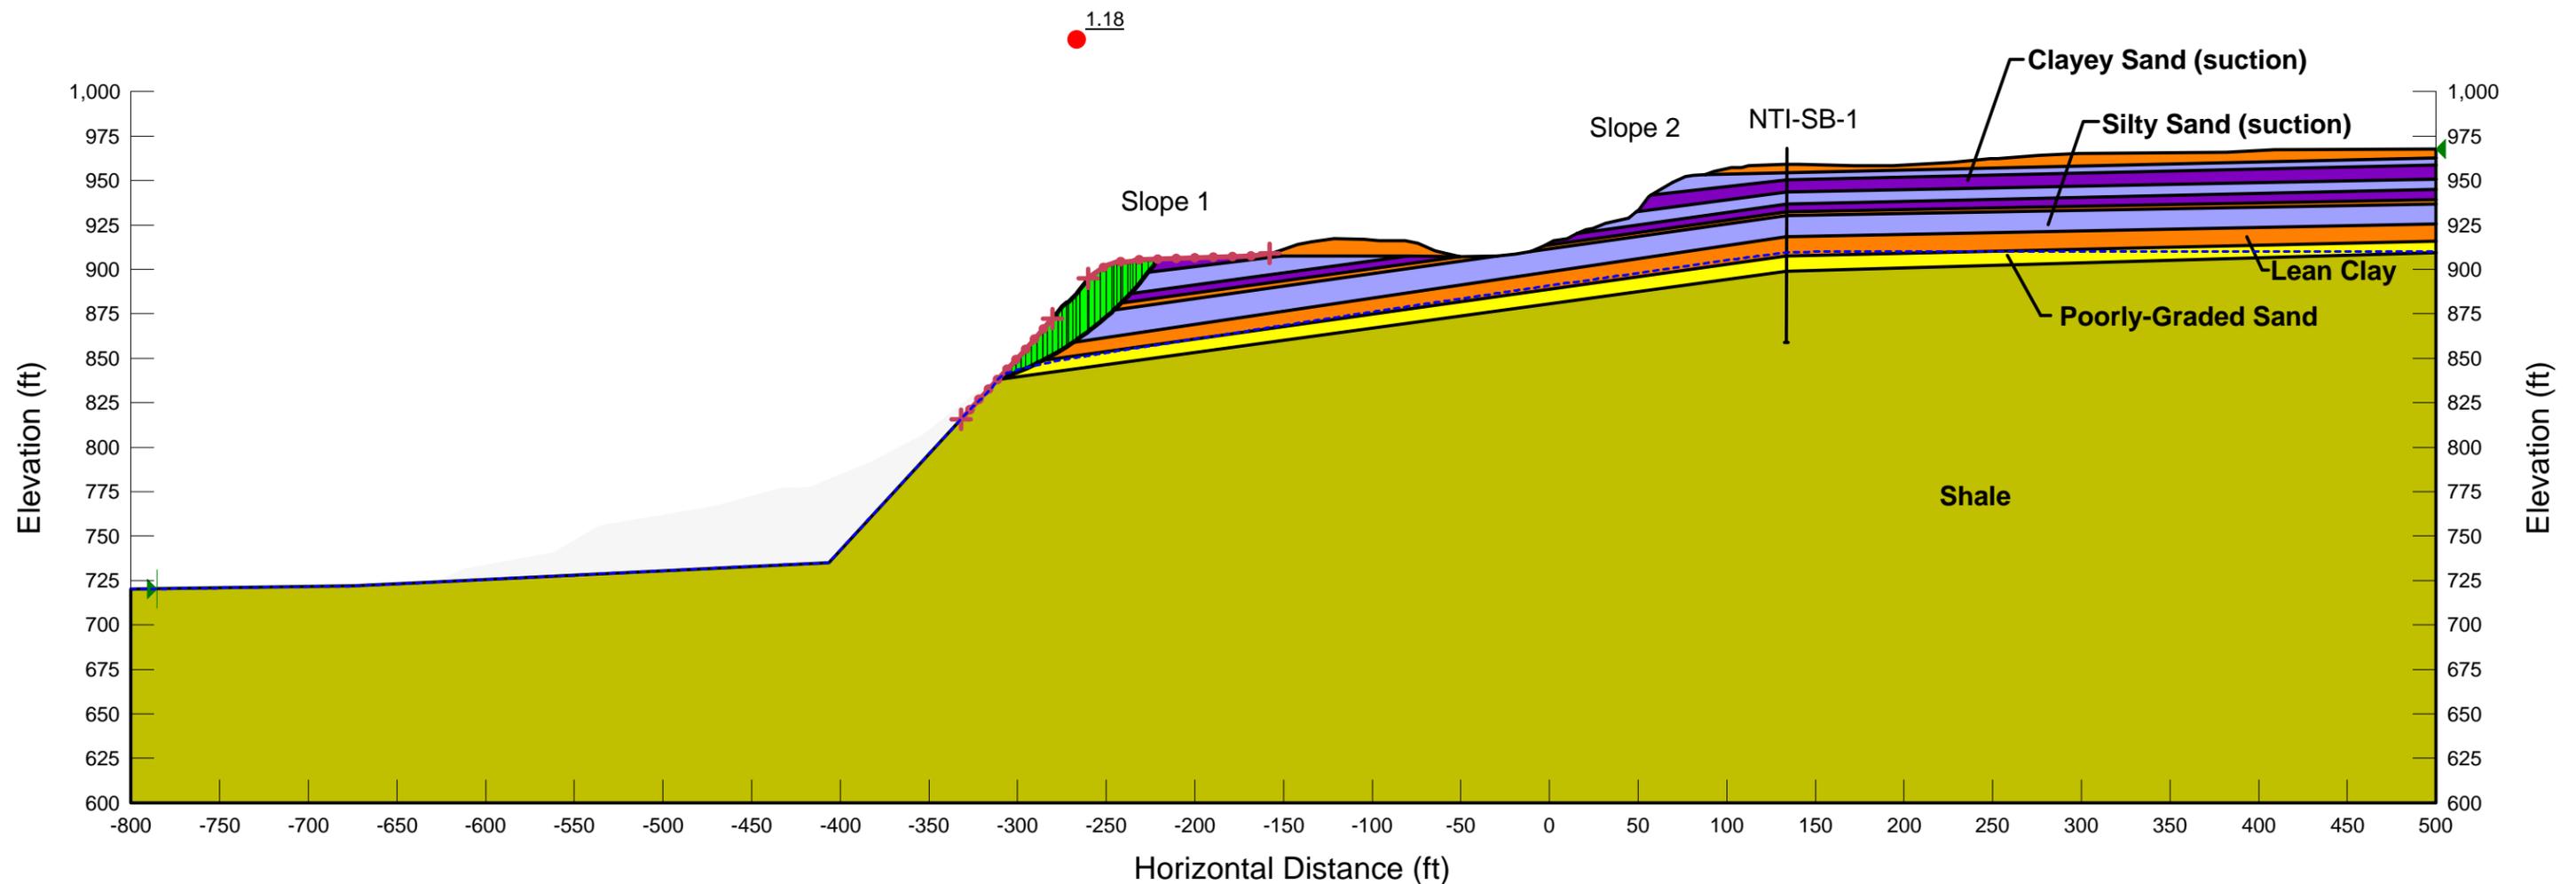
# Figure E-9 Waterfall Landslide Slope 1 Drained Friction Angle with Suction

**FS = 1.18**

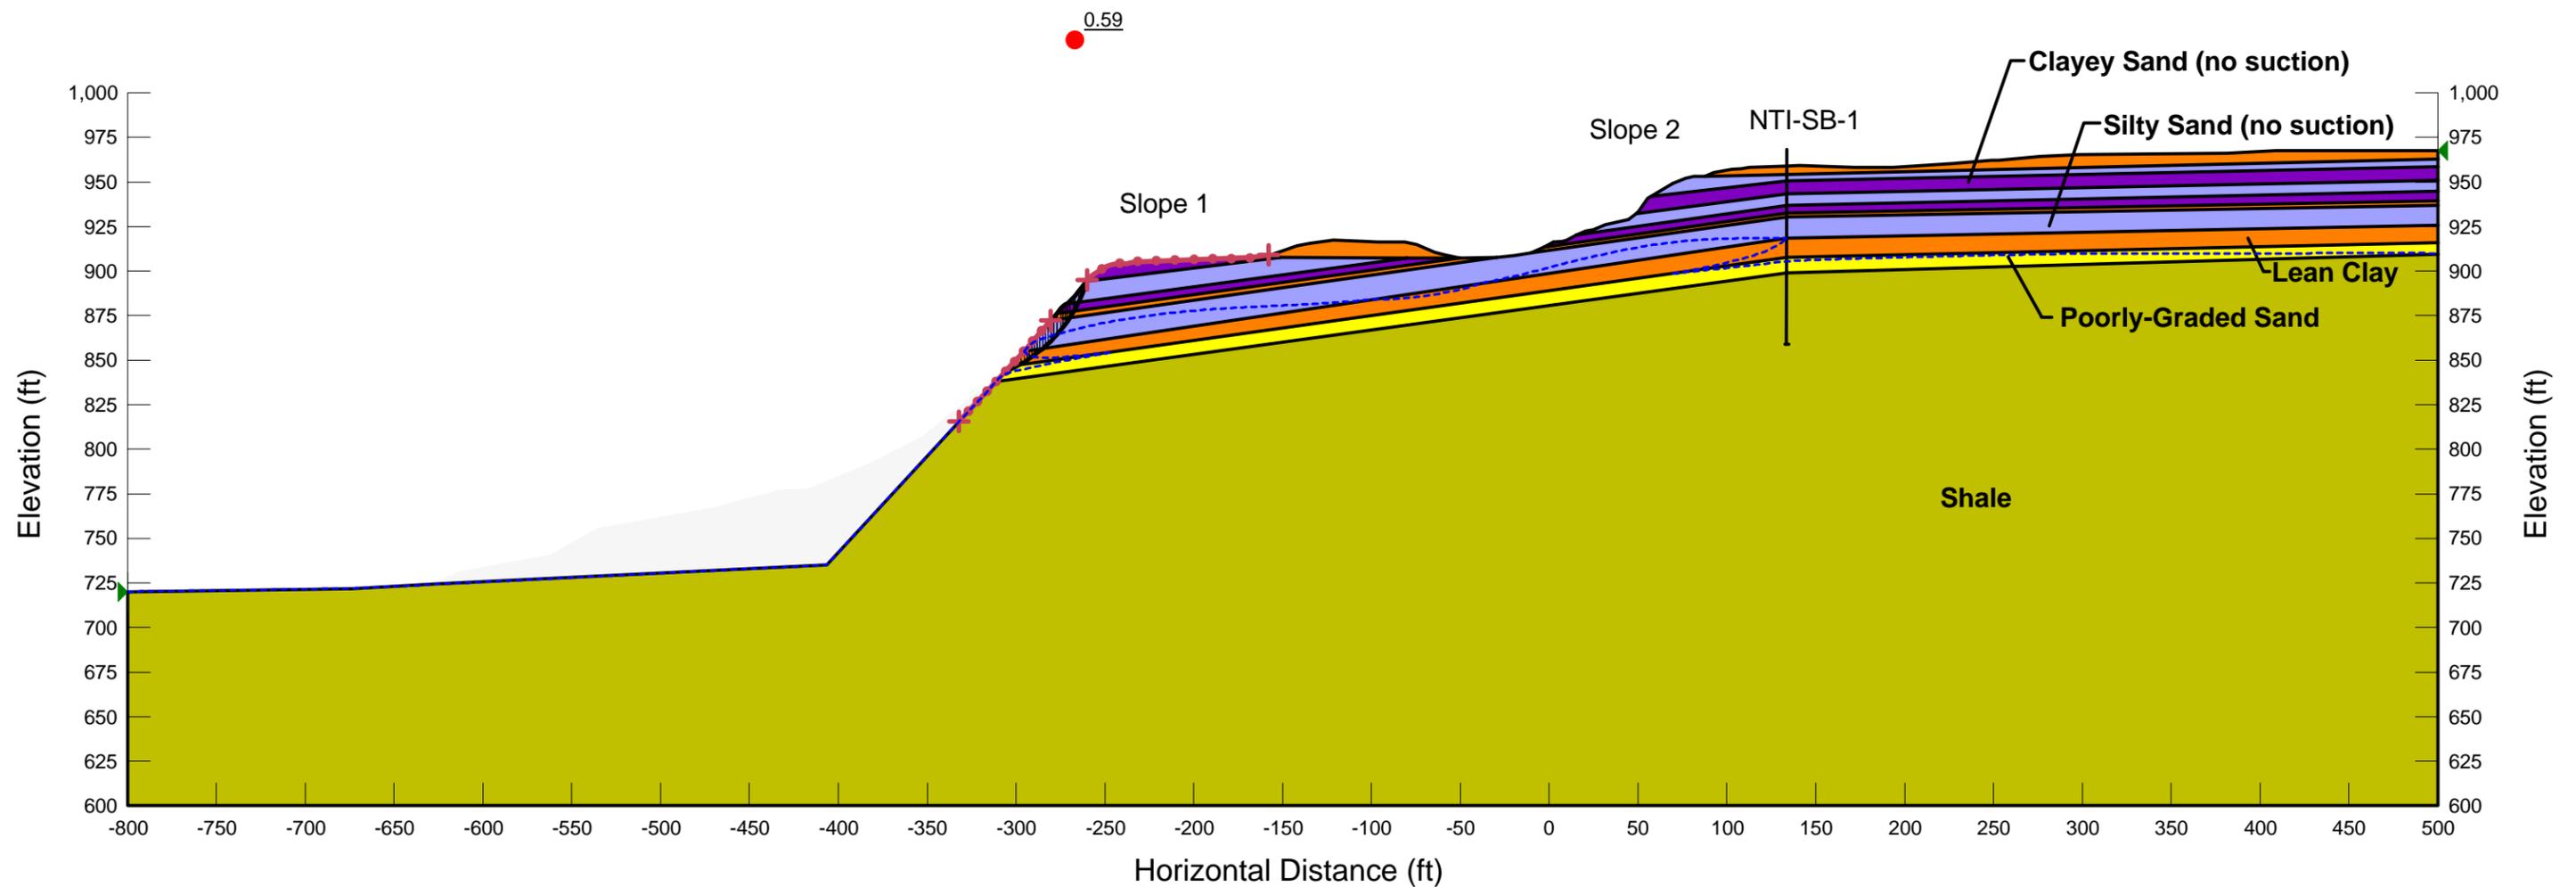
# Figure E-10. Waterfall Landslide Slope 1 Drained Friction Angle with Rainfall

**FS = 0.59**

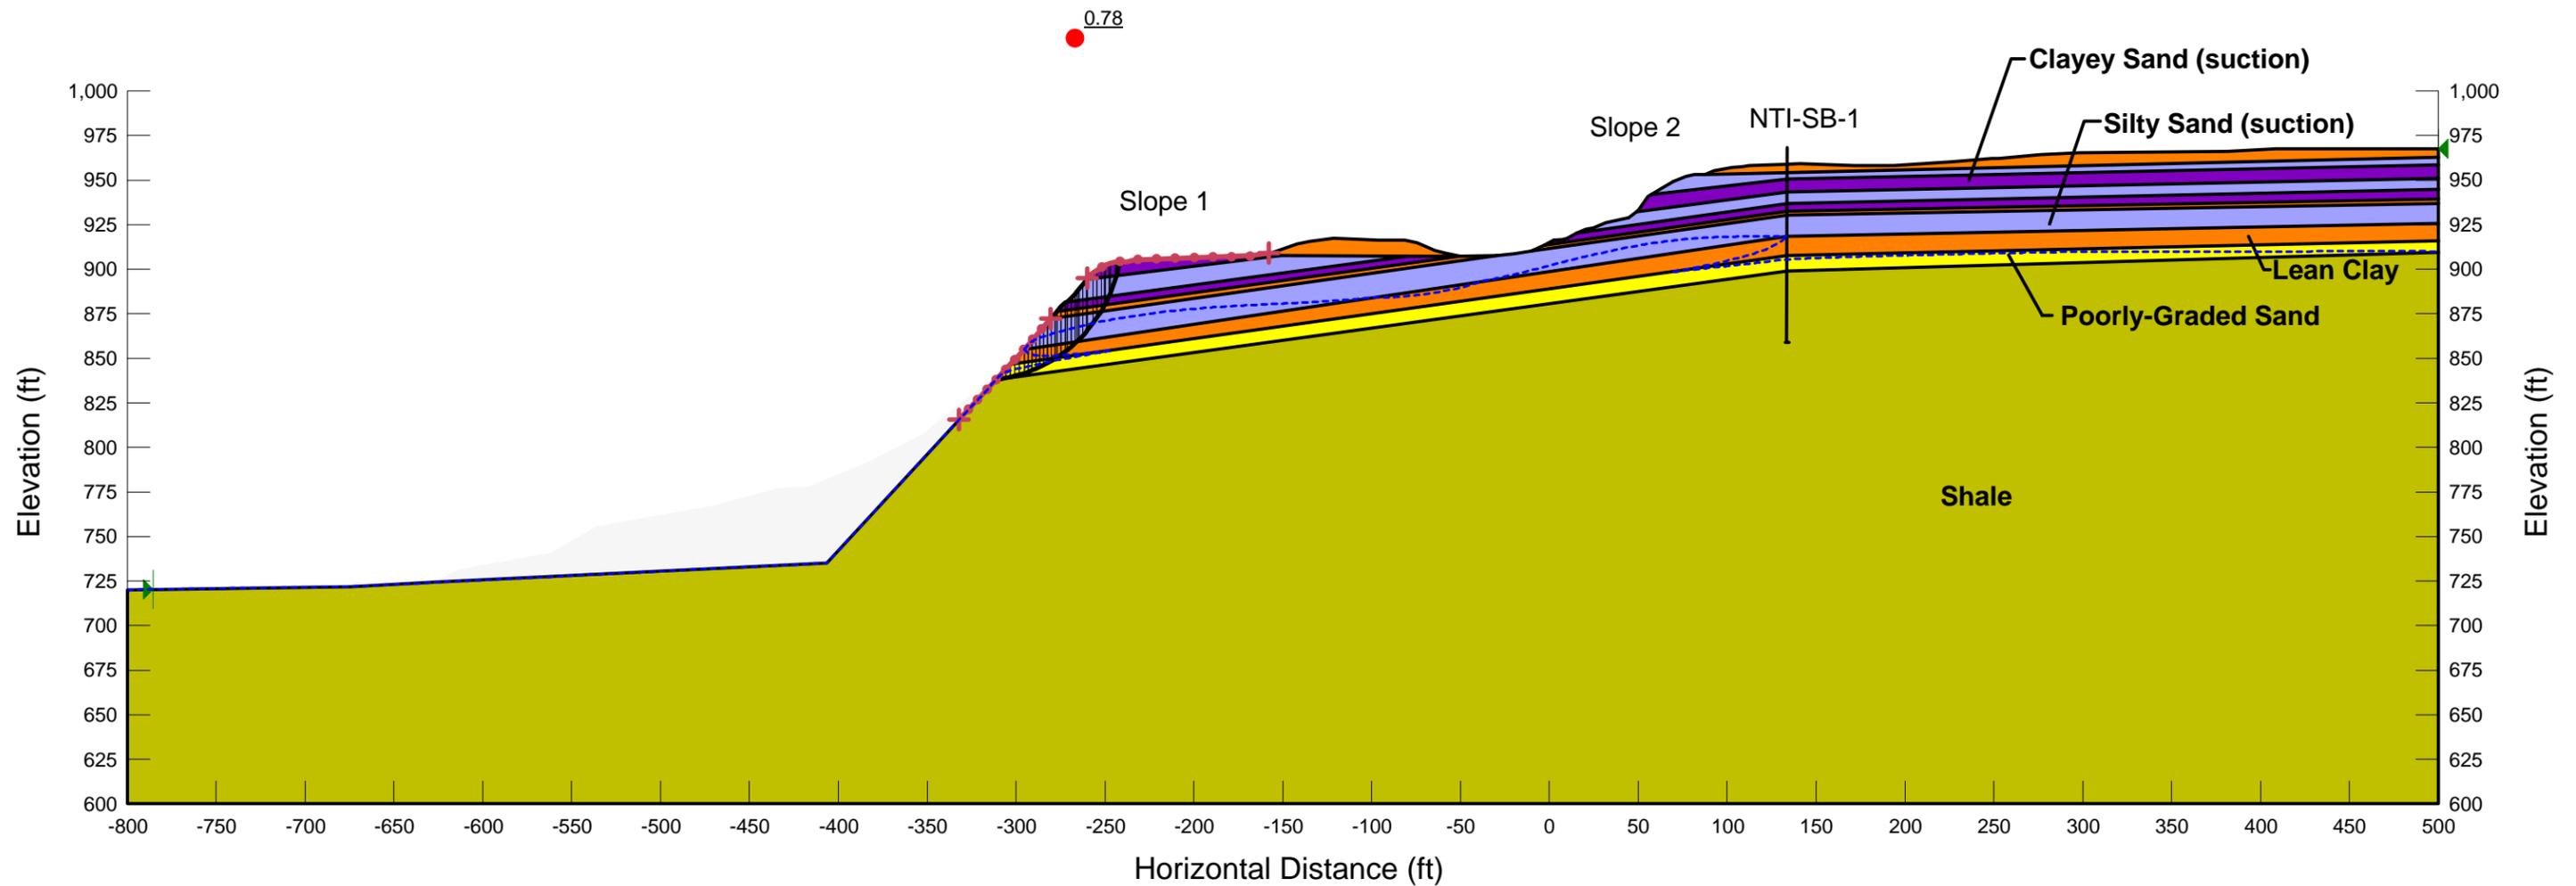
# Figure E-11. Waterfall Landslide Slope 1 Drained Friction Angle with Suction with Rainfall

**FS = 0.78**

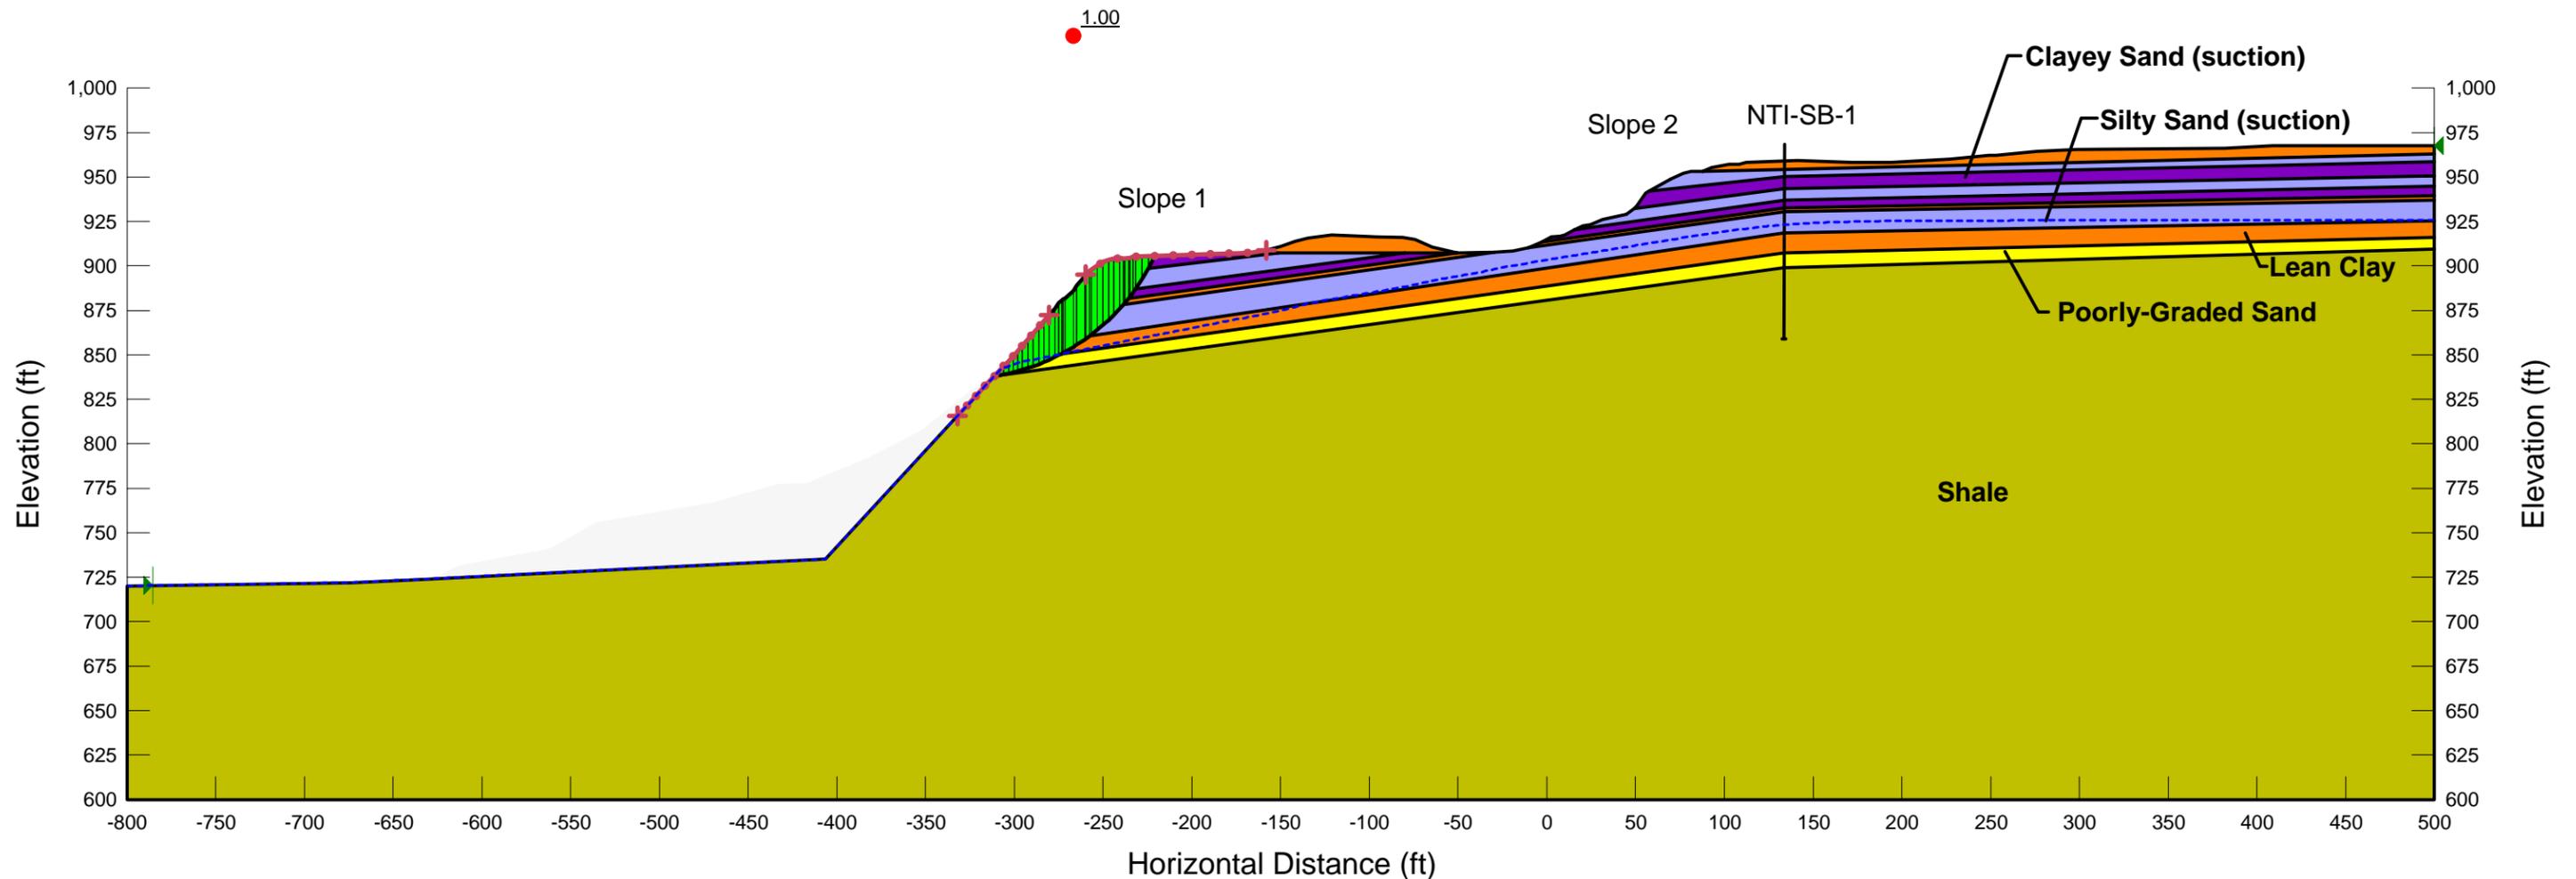
# Figure E-12 Waterfall Landslide Slope 1 Drained Friction Angle with Suction with High Groundwater Lilydale Regional Park

**FS = 1.00**

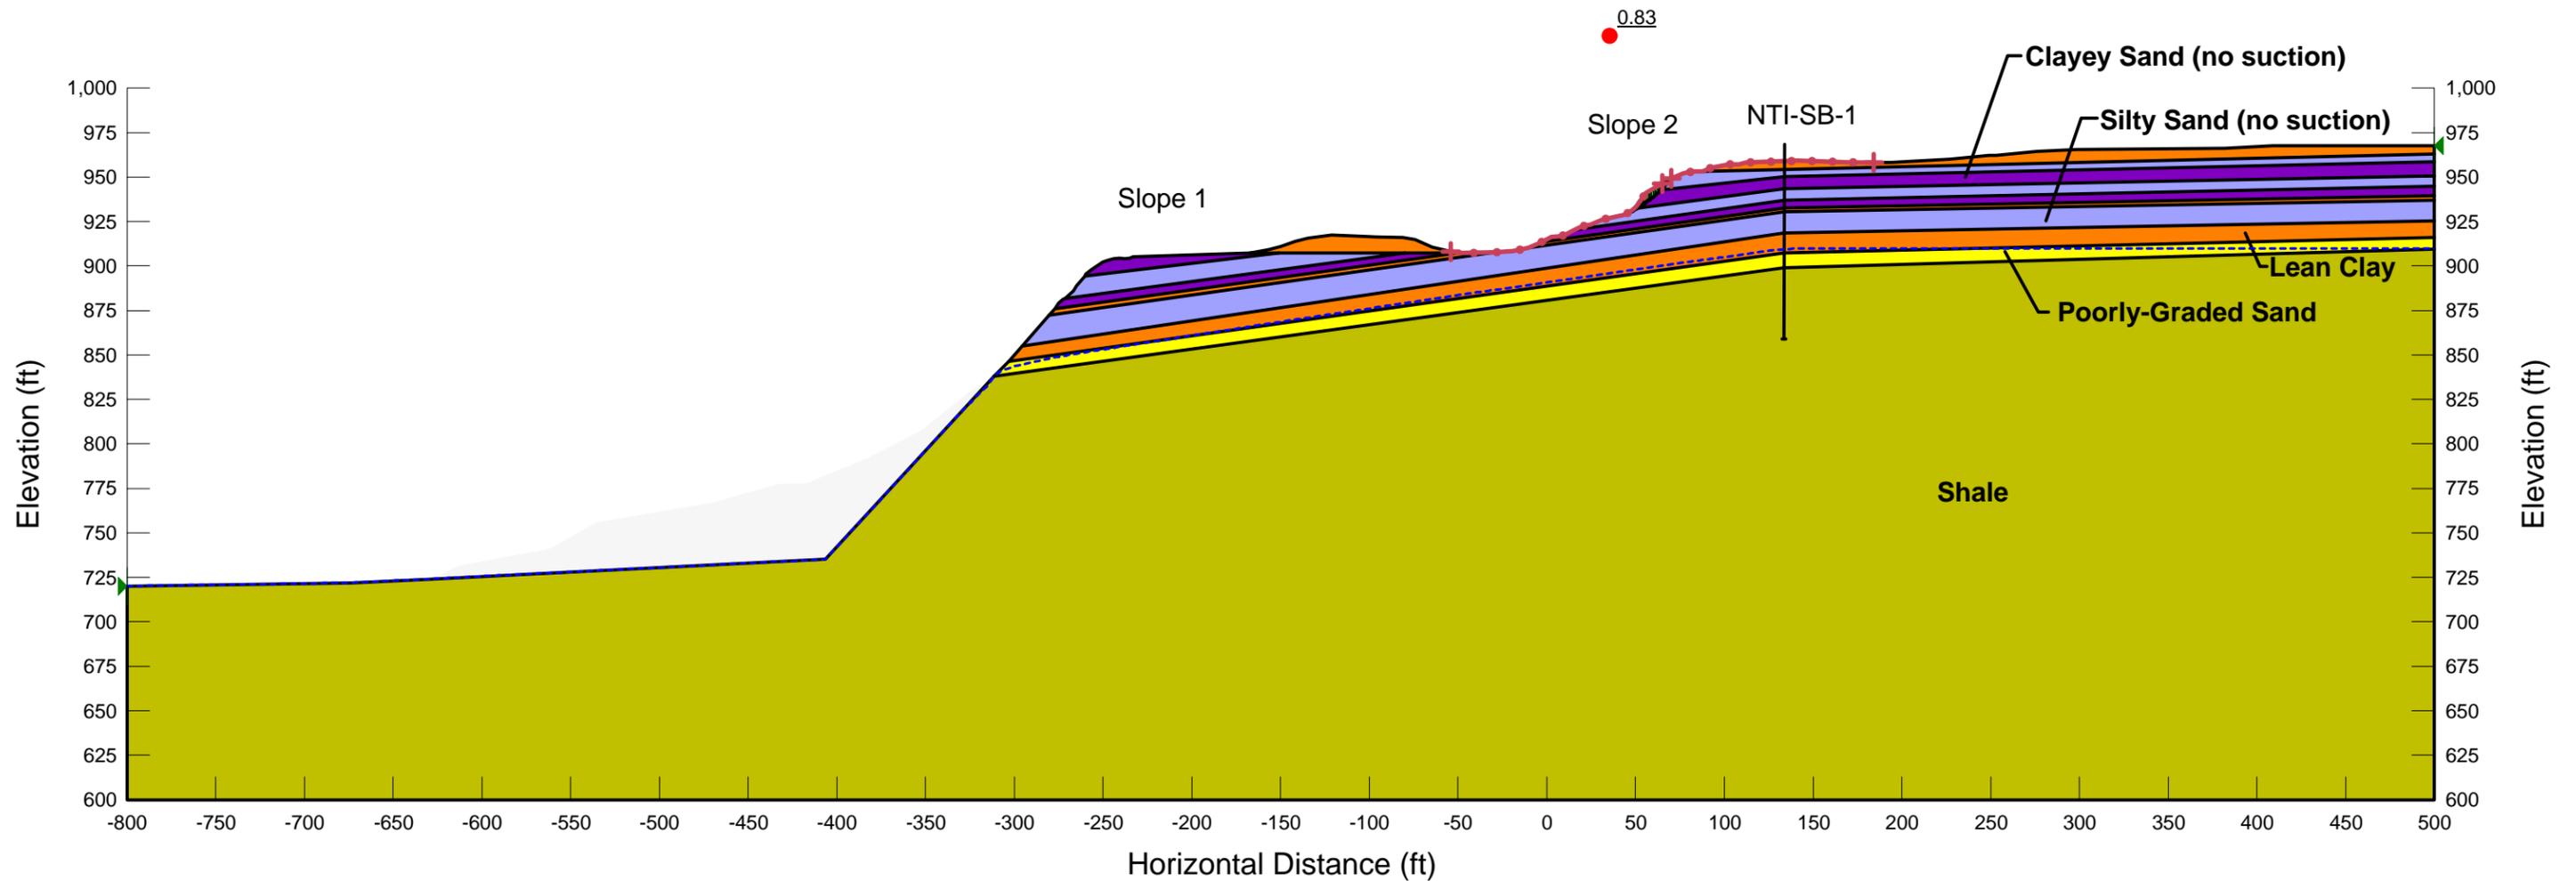
**Figure E-13 Waterfall Landslide Slope 2 Drained Friction Angle**  
**Lilydale Regional Park**  
**Seepage and Slope Stability Analysis**  
**1.0.3 Slope - Existing Conditions\_slope 2**  
**File Name: Lilydale\_waterfall landslide.gsz**  
**Date Saved: 1/18/2015**

**FS = 0.83**

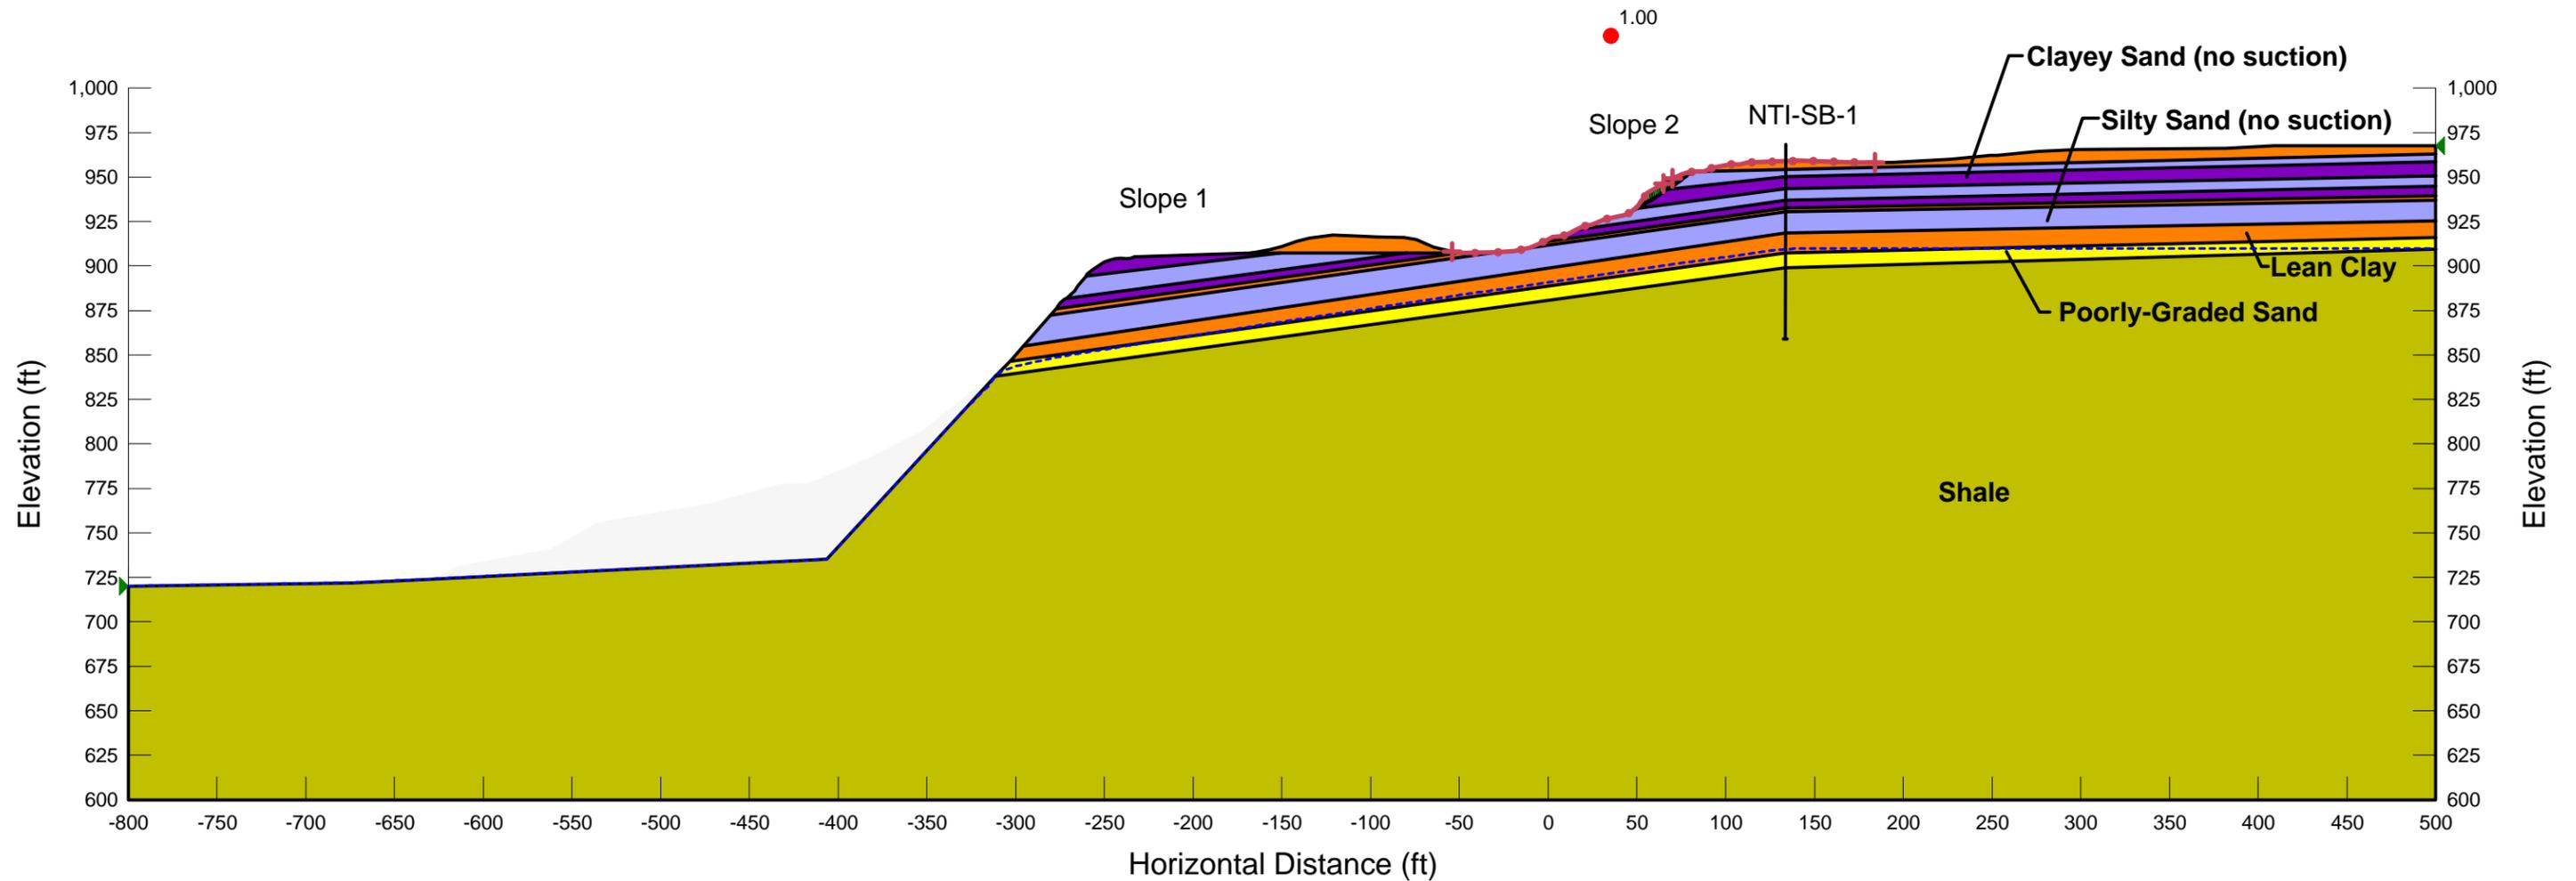
# Figure E-14 Waterfall Landslide Slope 2 Drained Friction Angle at Stability

**FS = 1.00**

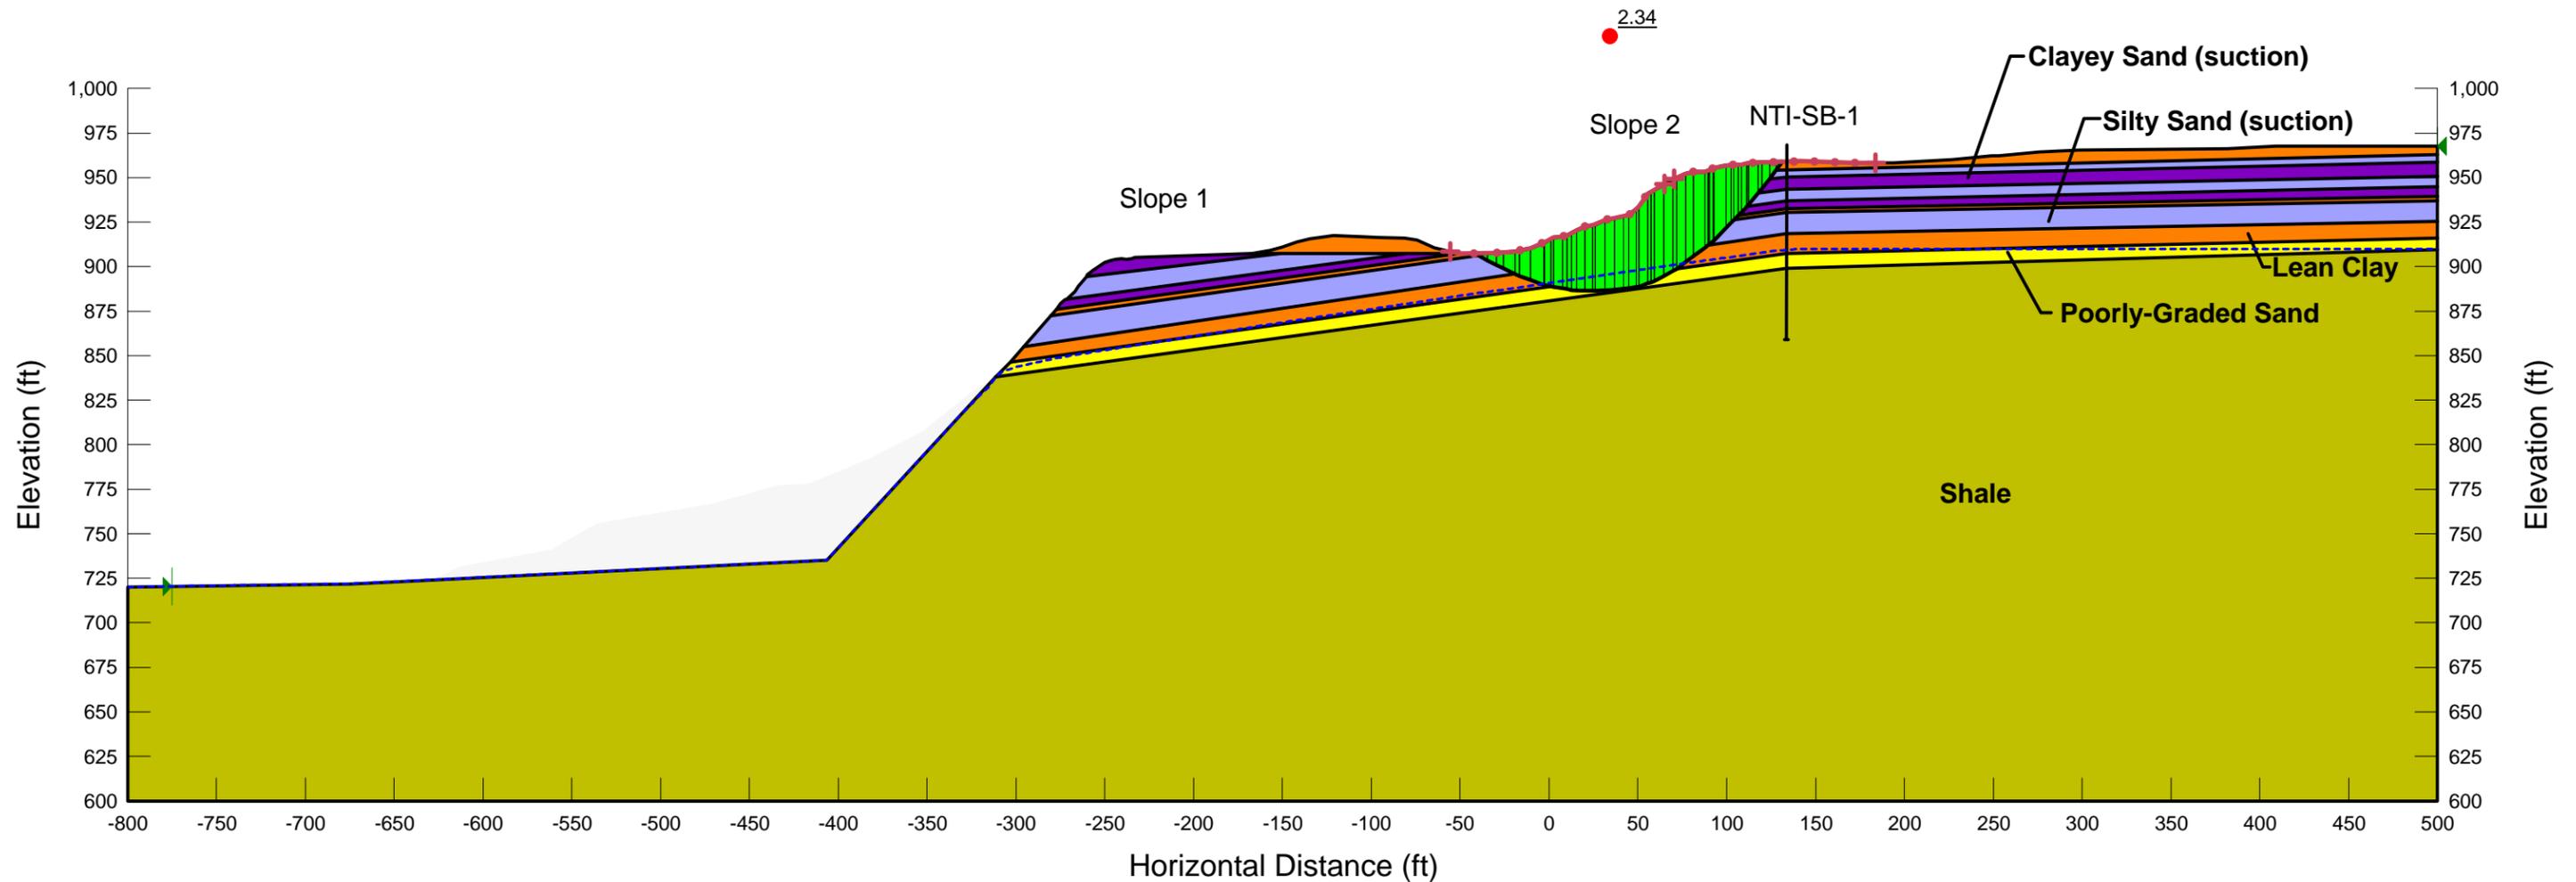
**Figure E-15 Waterfall Landslide Slope 2 Drained Friction Angle with Suction**  
**Lilydale Regional Park**  
**Seepage and Slope Stability Analysis**  
**1.0.4 Slope - Existing Conditions with Suction\_slope 2**  
**File Name: Lilydale\_waterfall landslide.gsz**  
**Date Saved: 1/18/2015**

**FS = 2.34**

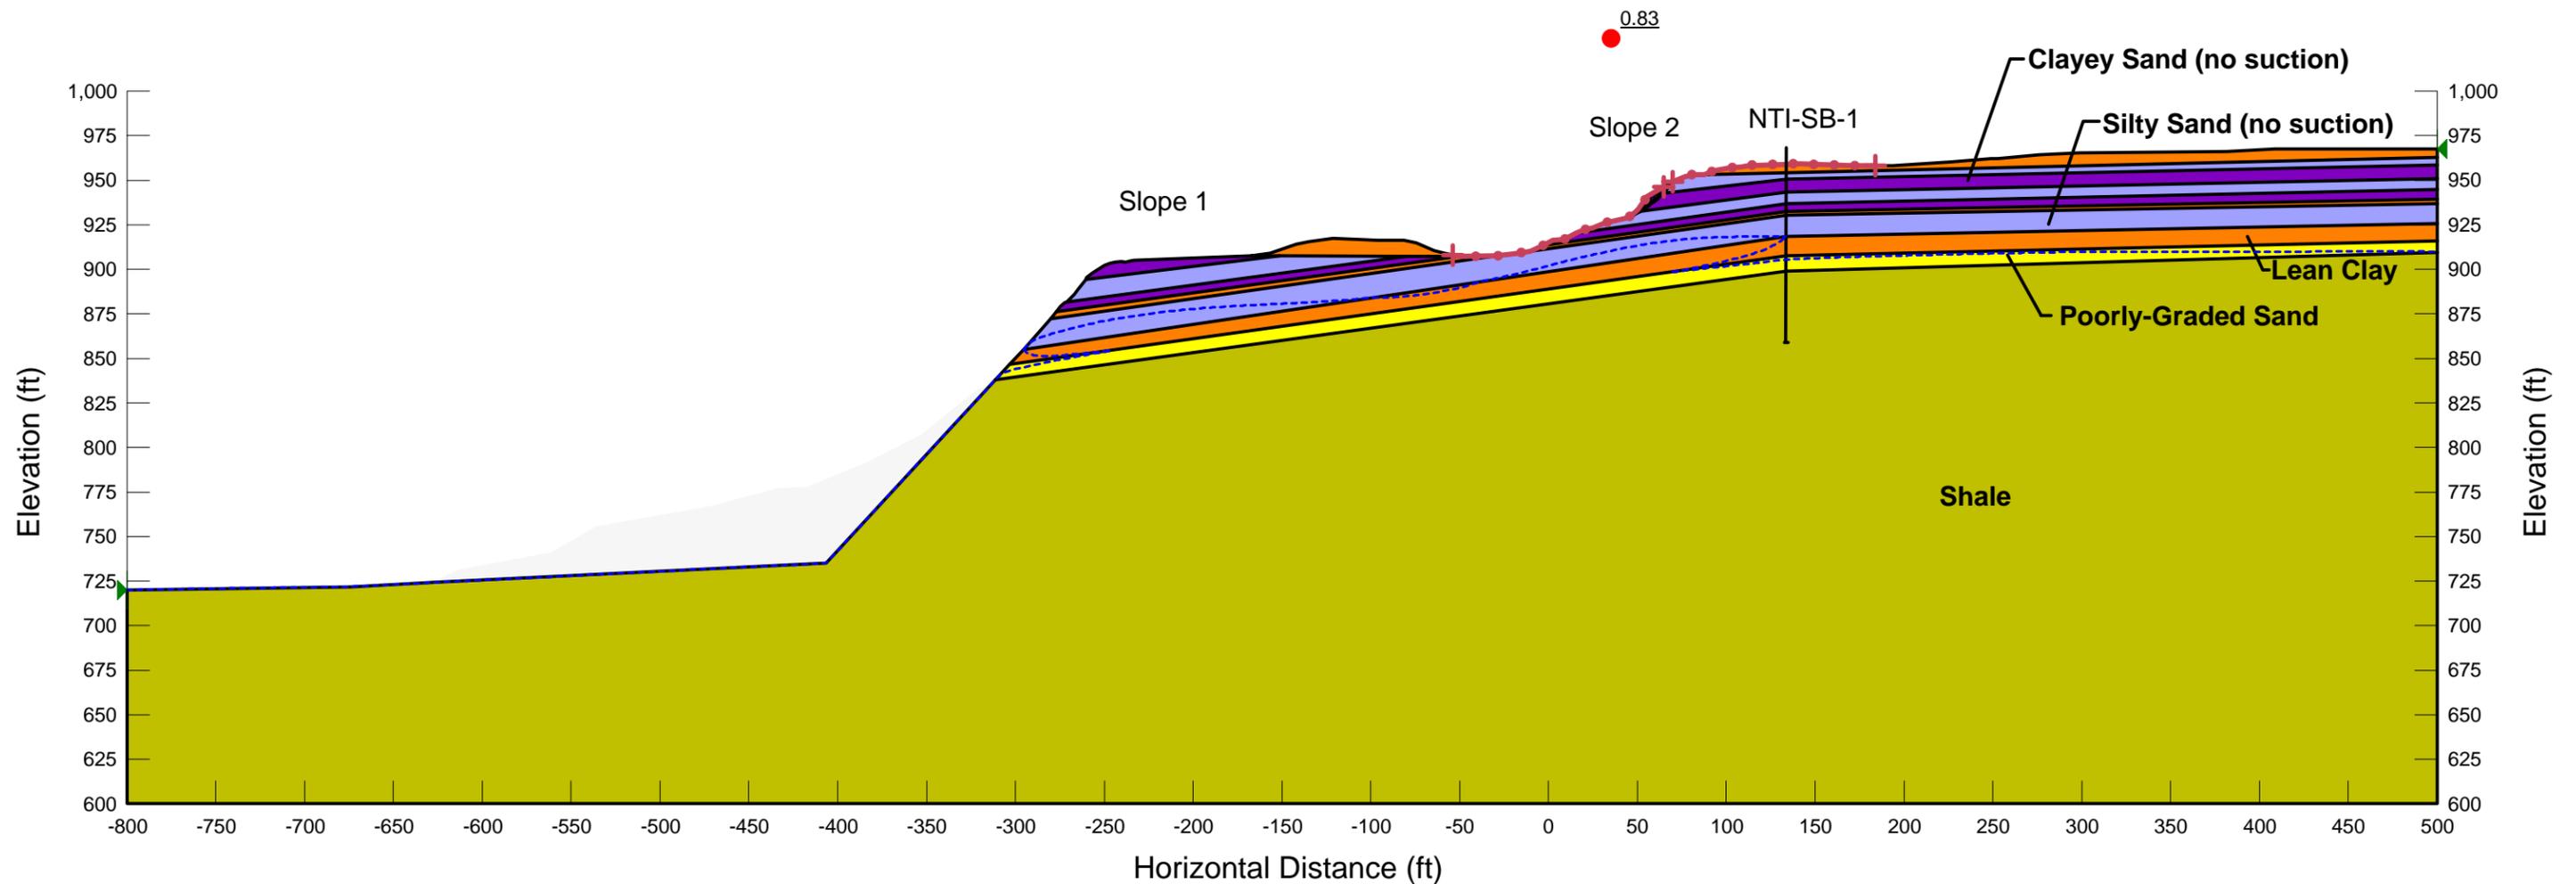
# Figure E-16 Waterfall Landslide Slope 2 Drained Friction Angle with Rainfall

**FS = 0.83**
