## **Brickyard Area of Lilydale Regional Park**

### ***Stormwater Management and Slope-Stability Analysis***

Prepared for  
City of St. Paul Department of Parks and Recreation

January 28, 2015

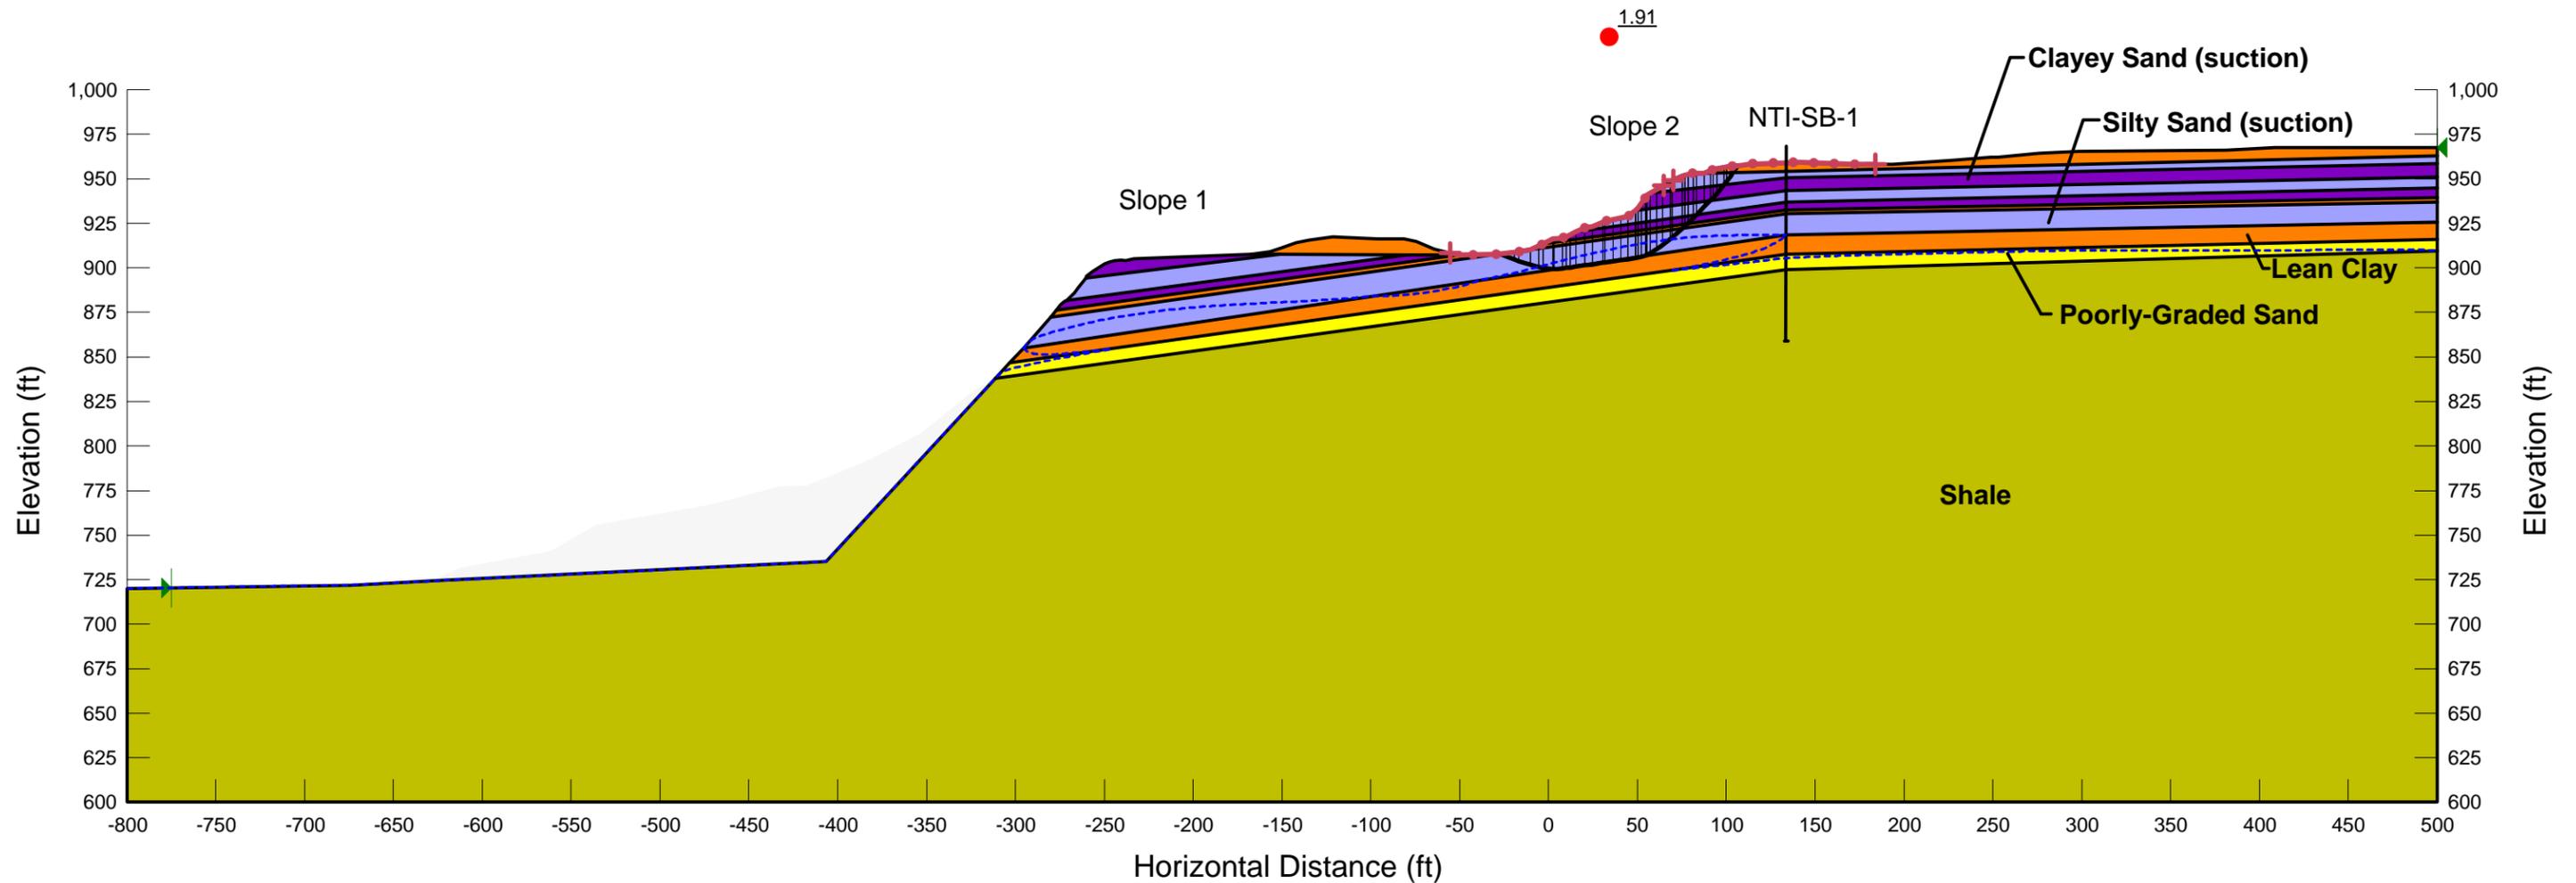
# Figure E-17 Waterfall Landslide Slope 2 Drained Friction Angle with Suction with Rainfall

**FS = 1.91**

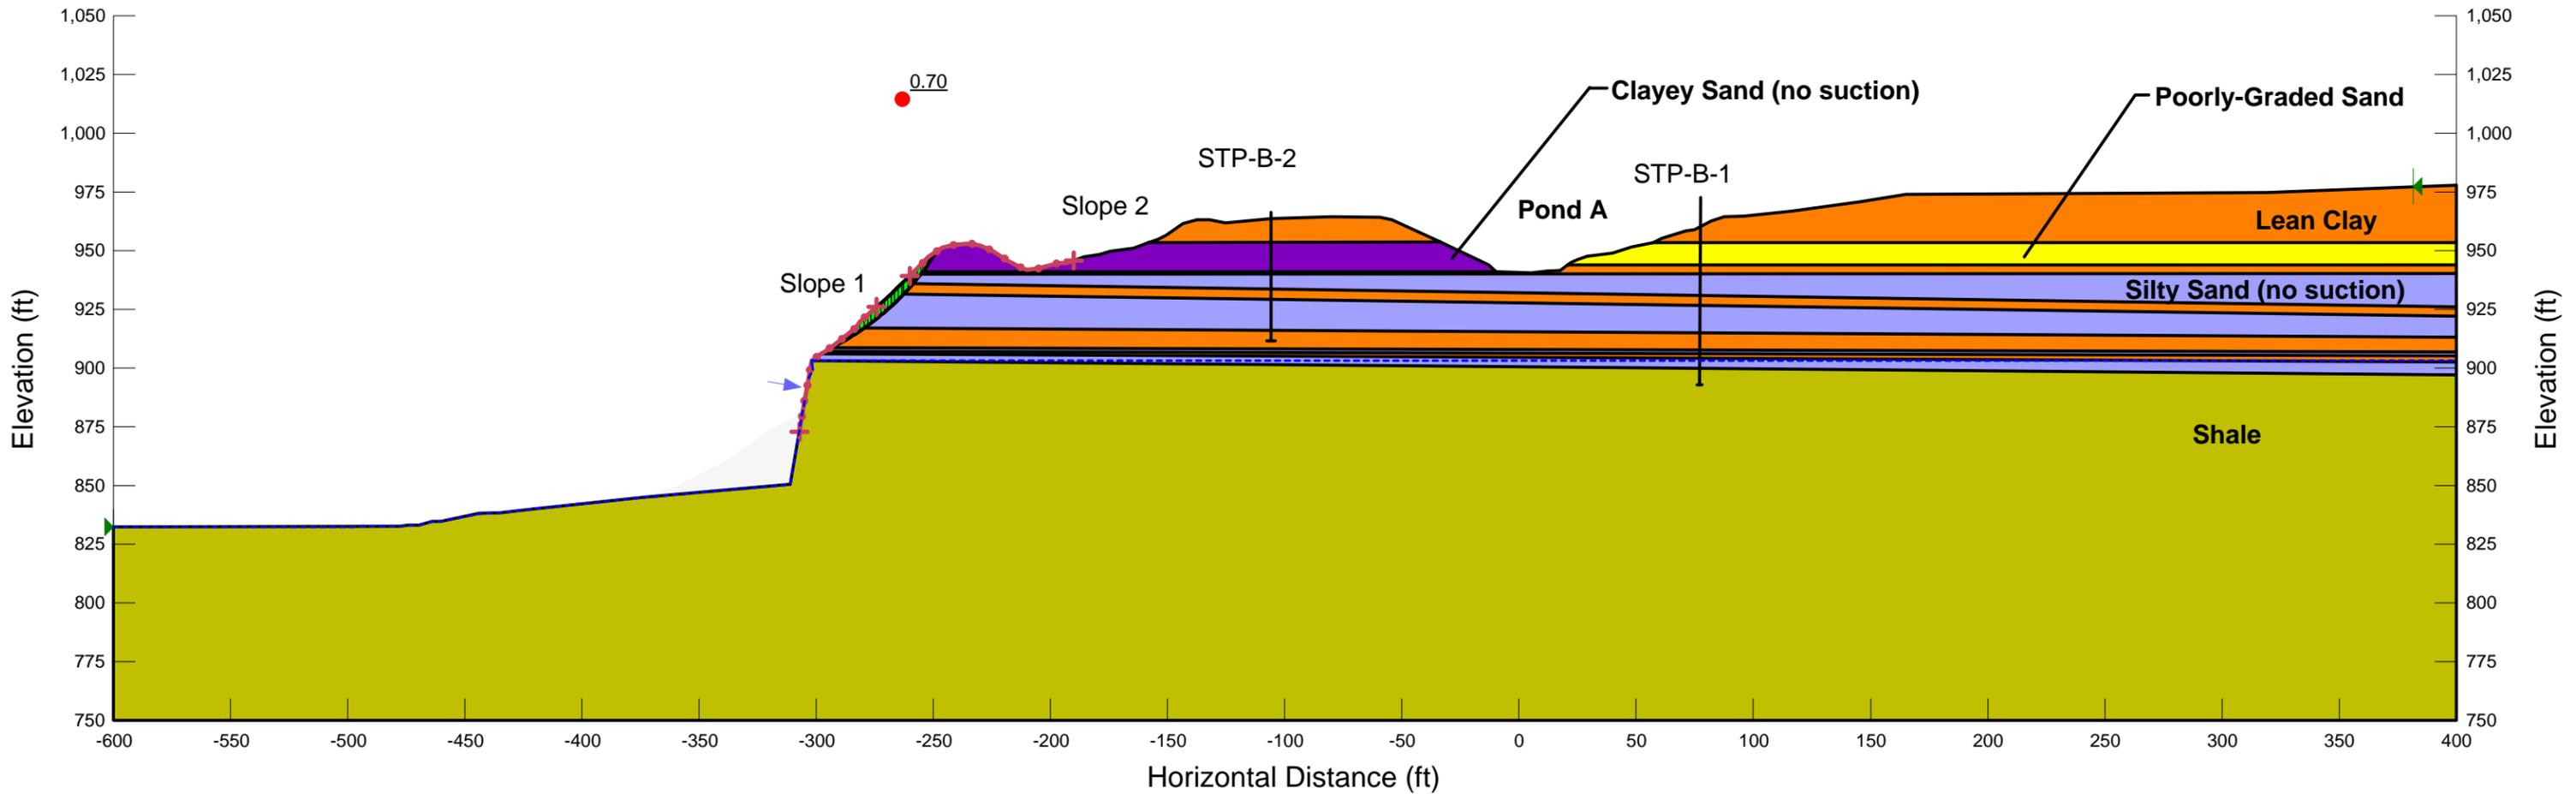
**Figure E-18 Cherokee Heights Slope 1 Drained Friction Angle**  
**Cherokee Heights**  
**Seepage and Slope Stability Analysis**  
**1.0.1 Slope - Existing Conditions Slope 1**  
**File Name: Lilydale\_cherokee heights culvert.gsz**  
**Date Saved: 12/21/2014**

**FS = 0.70**

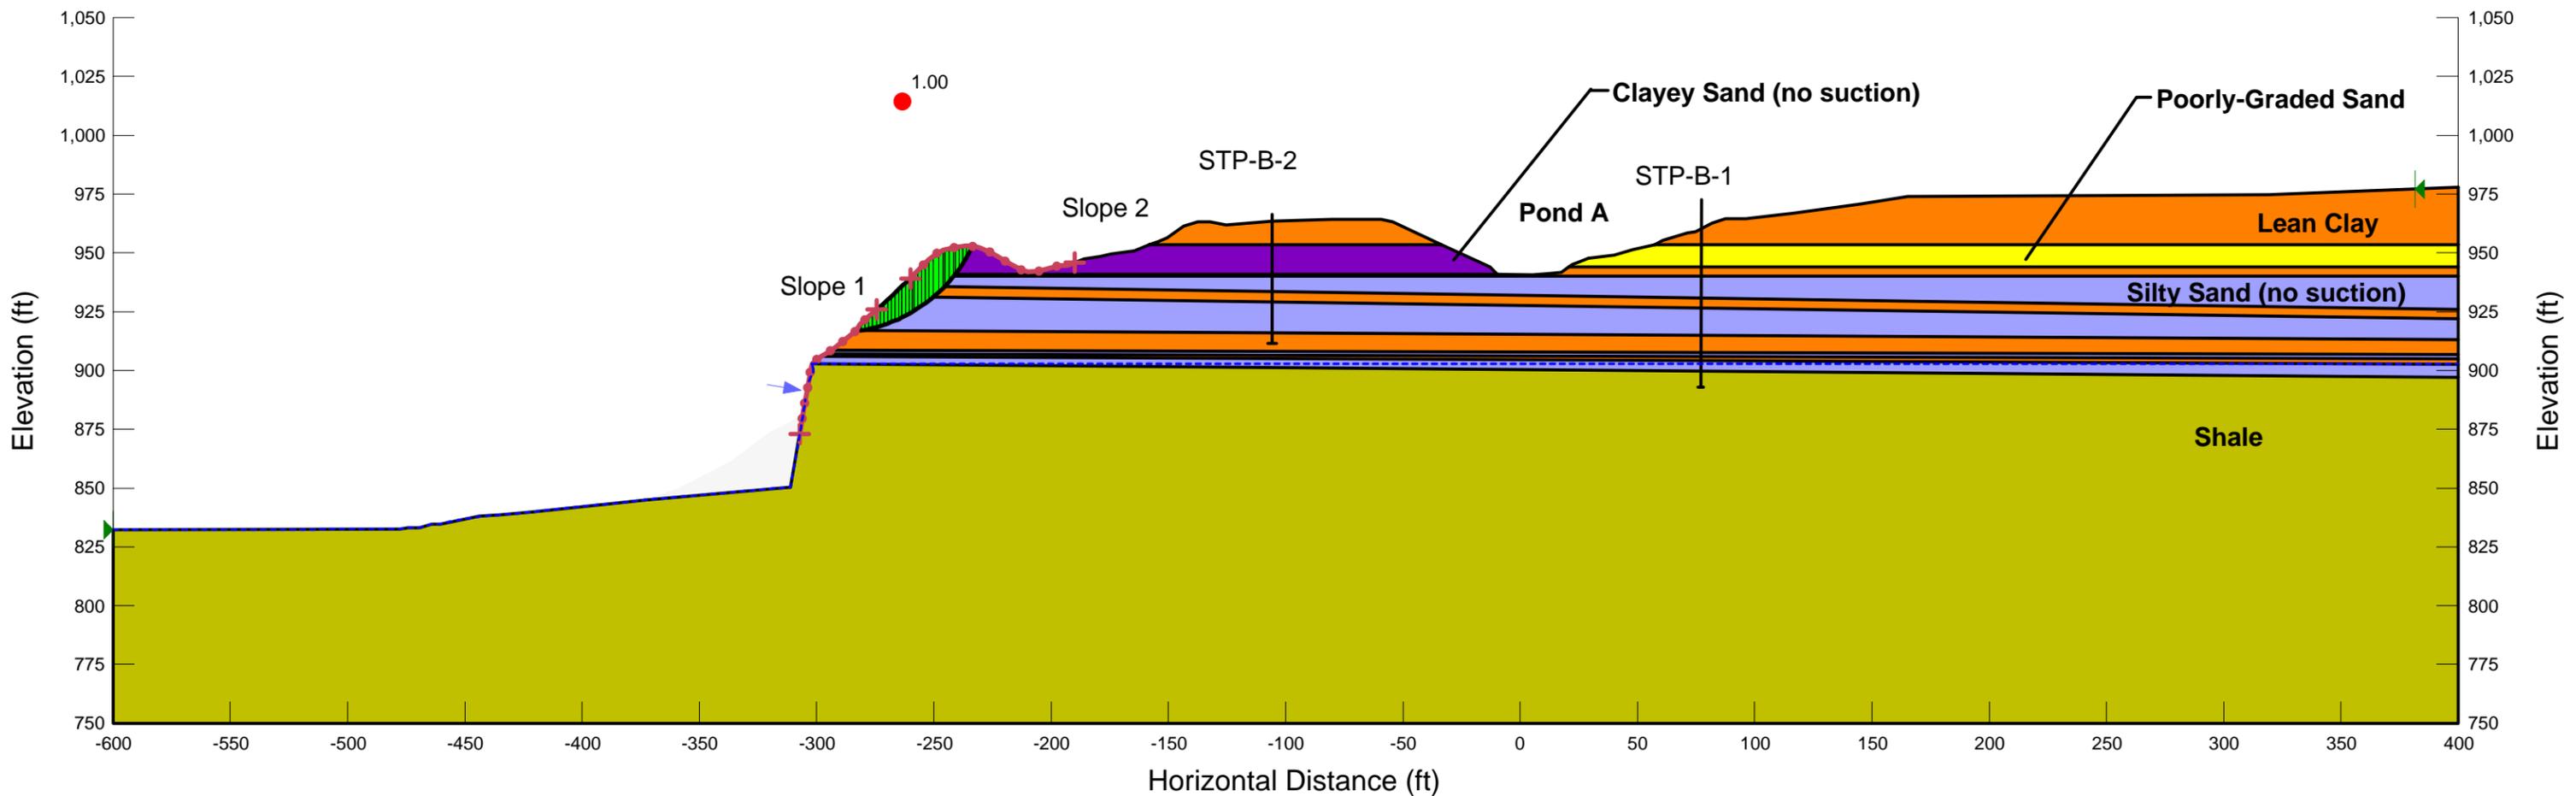
**Figure E-19 Cherokee Heights Slope 1 Drained Friction Angle at Stability  
Cherokee Heights**

**FS = 1.00**

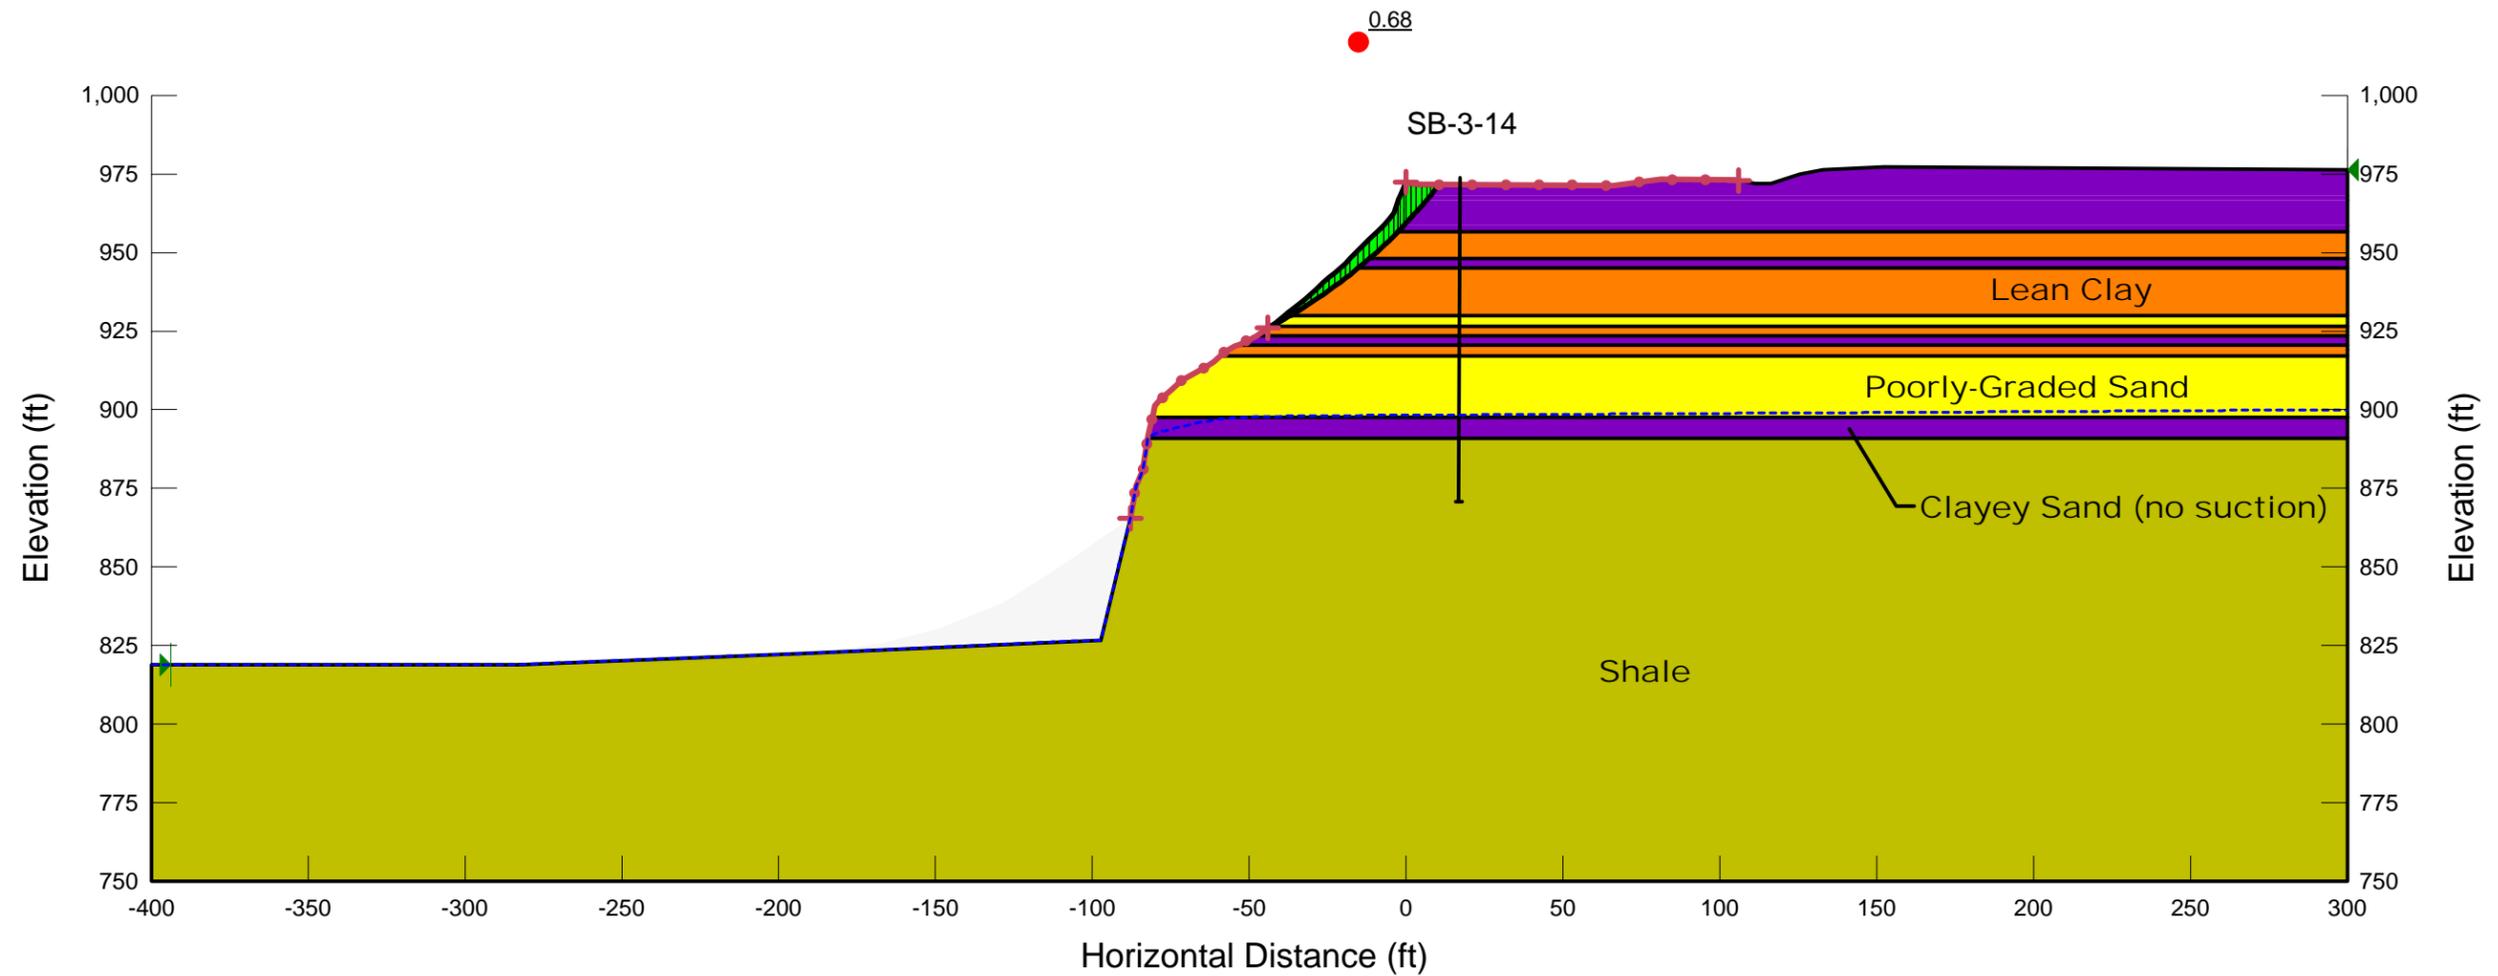
**Figure E-37 Middle Clay Pit Drained Friction Angle**  
**Lilydale Regional Park**  
**Seepage and Slope Stability Analysis**  
**1.1.1 Slope - Existing Conditions**  
**File Name: middle clay pit\_trans\_rain.gsz**  
**Date Saved: 12/21/2014**

**FS = 0.68**

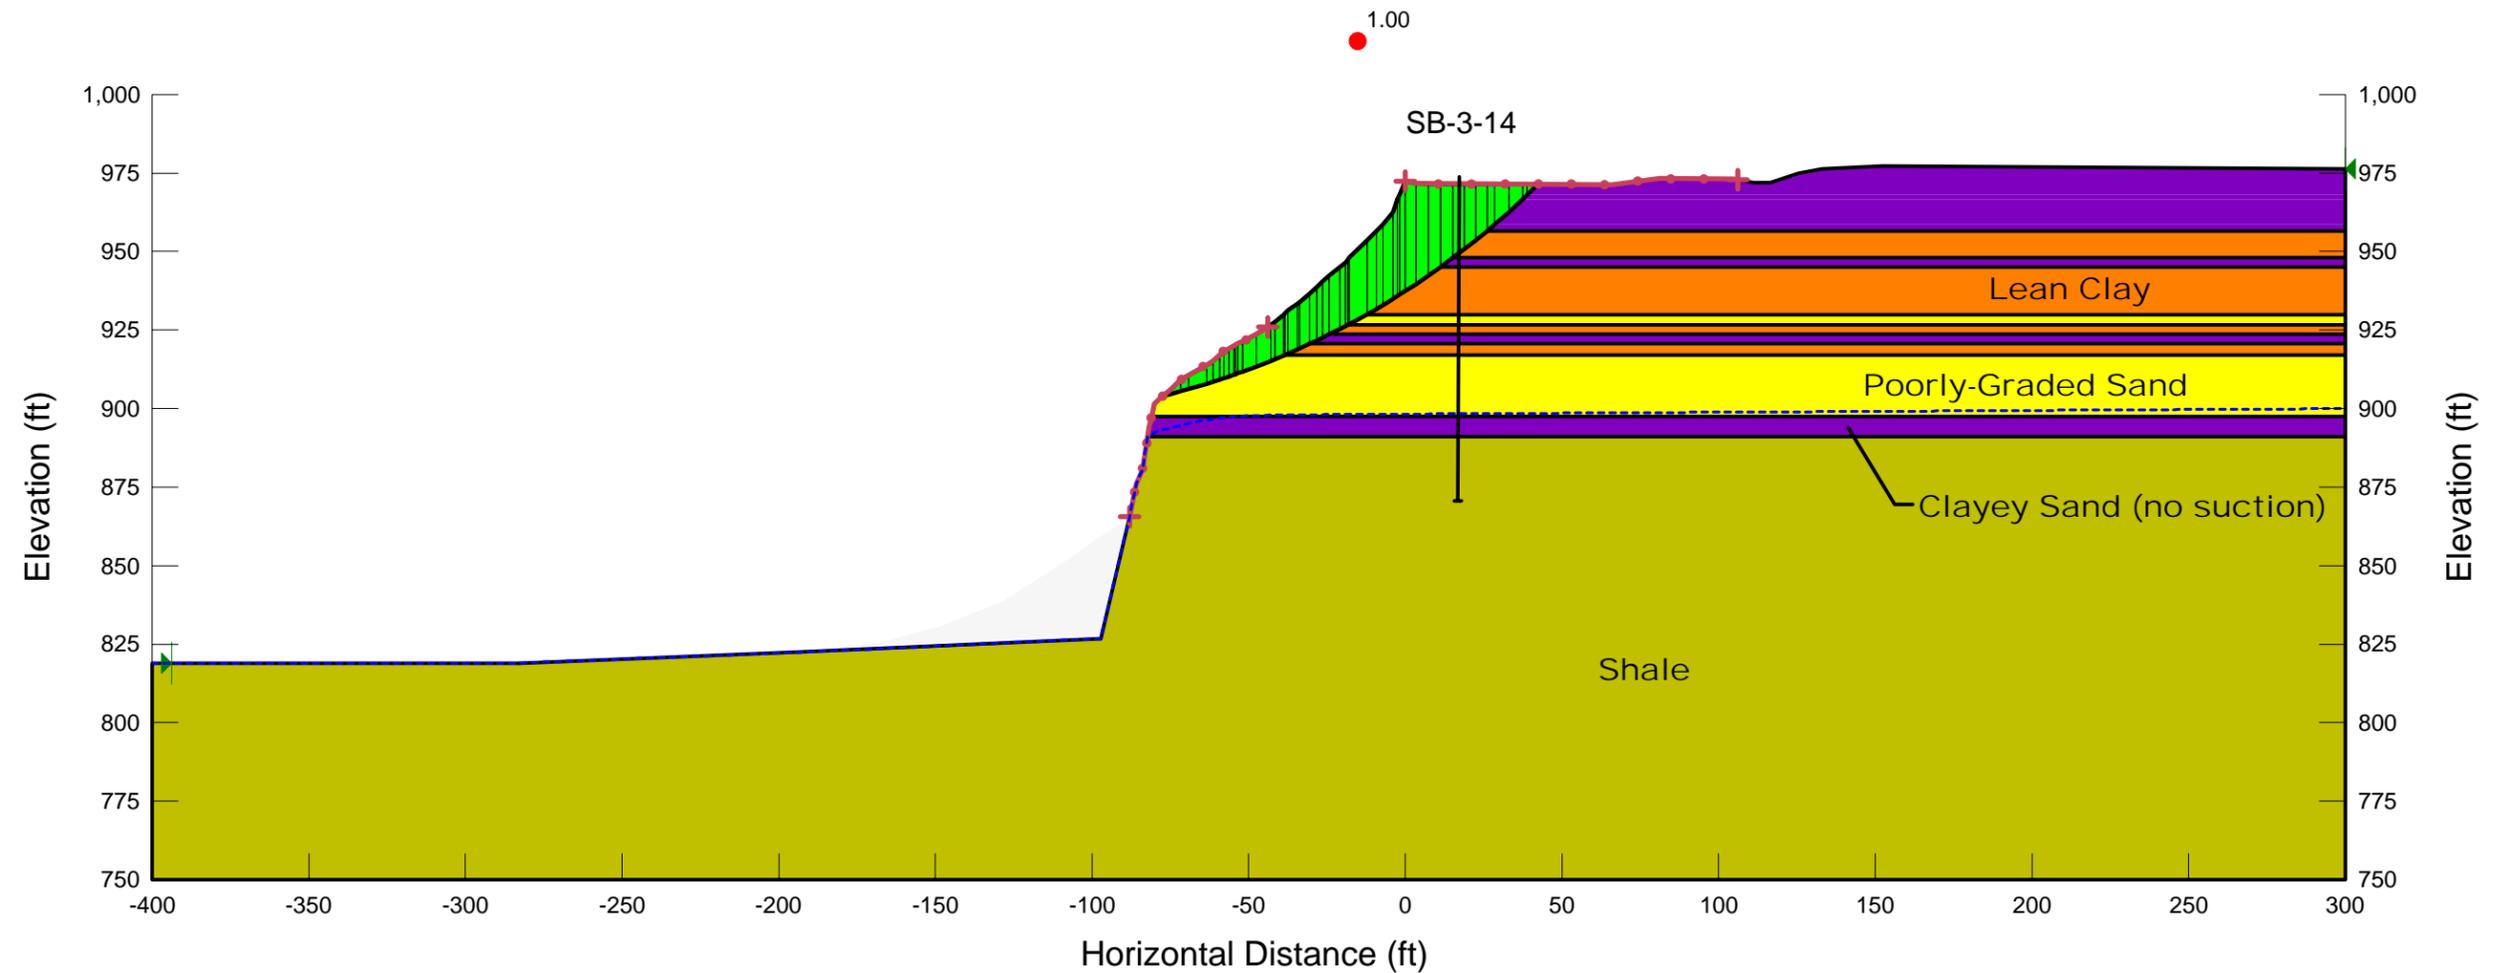
**Figure E-38 Middle Clay Pit Drained Friction Angle at Stability**  
**Lilydale Regional Park**  
**Seepage and Slope Stability Analysis**  
**1.1.1 Slope - Existing Conditions**  
**File Name: middle clay pit\_trans\_rain.gsz**  
**Date Saved: 12/21/2014**

**FS = 1.00**

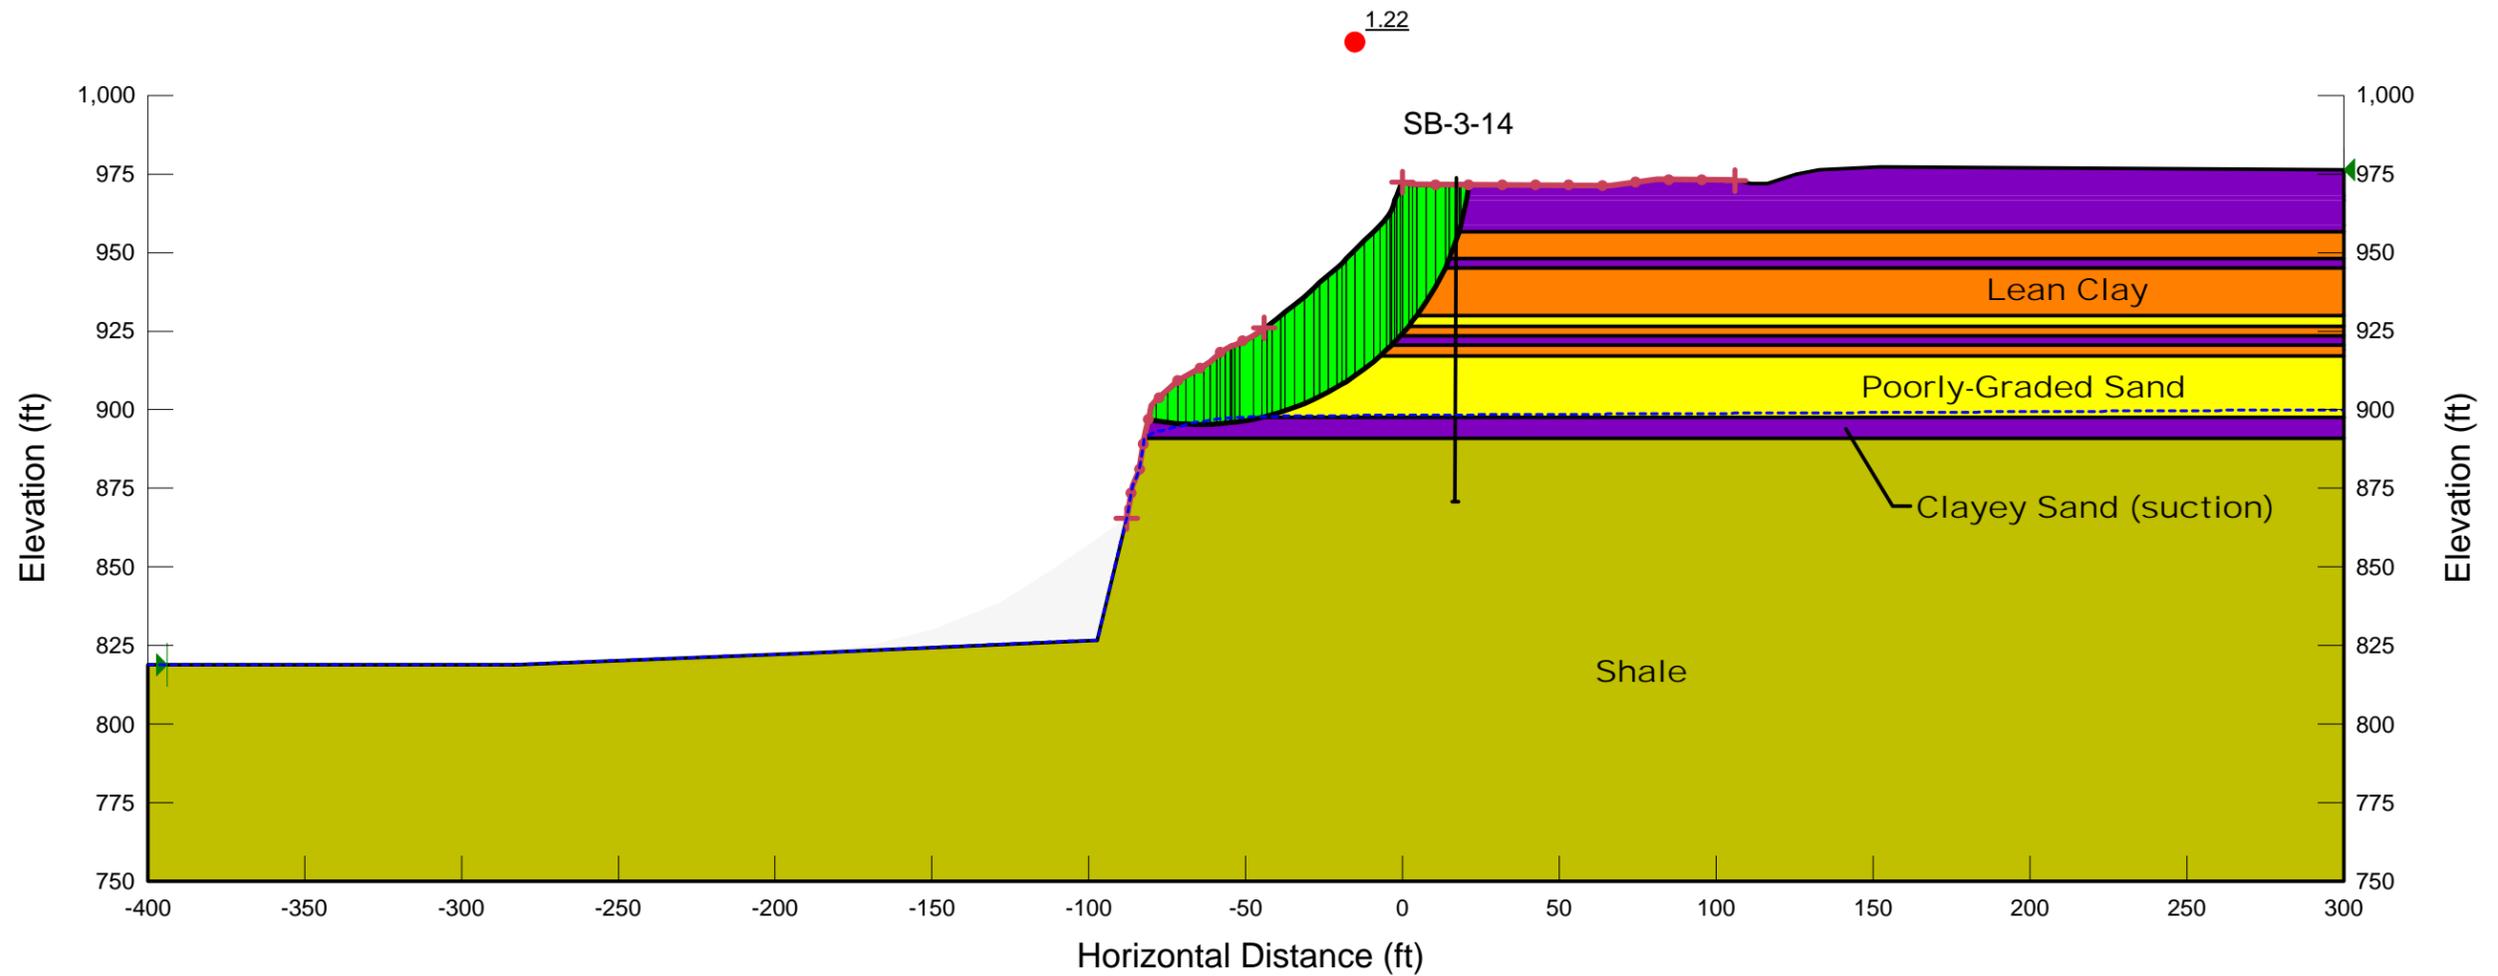
**Figure E-39 Middle Clay Pit Drained Friction Angle with Suction**  
**Lilydale Regional Park**  
**Seepage and Slope Stability Analysis**  
**1.1.2 Slope - Existing Conditions with Suction**  
**File Name: middle clay pit\_trans\_rain.gsz**  
**Date Saved: 11/25/2014**

**FS = 1.22**

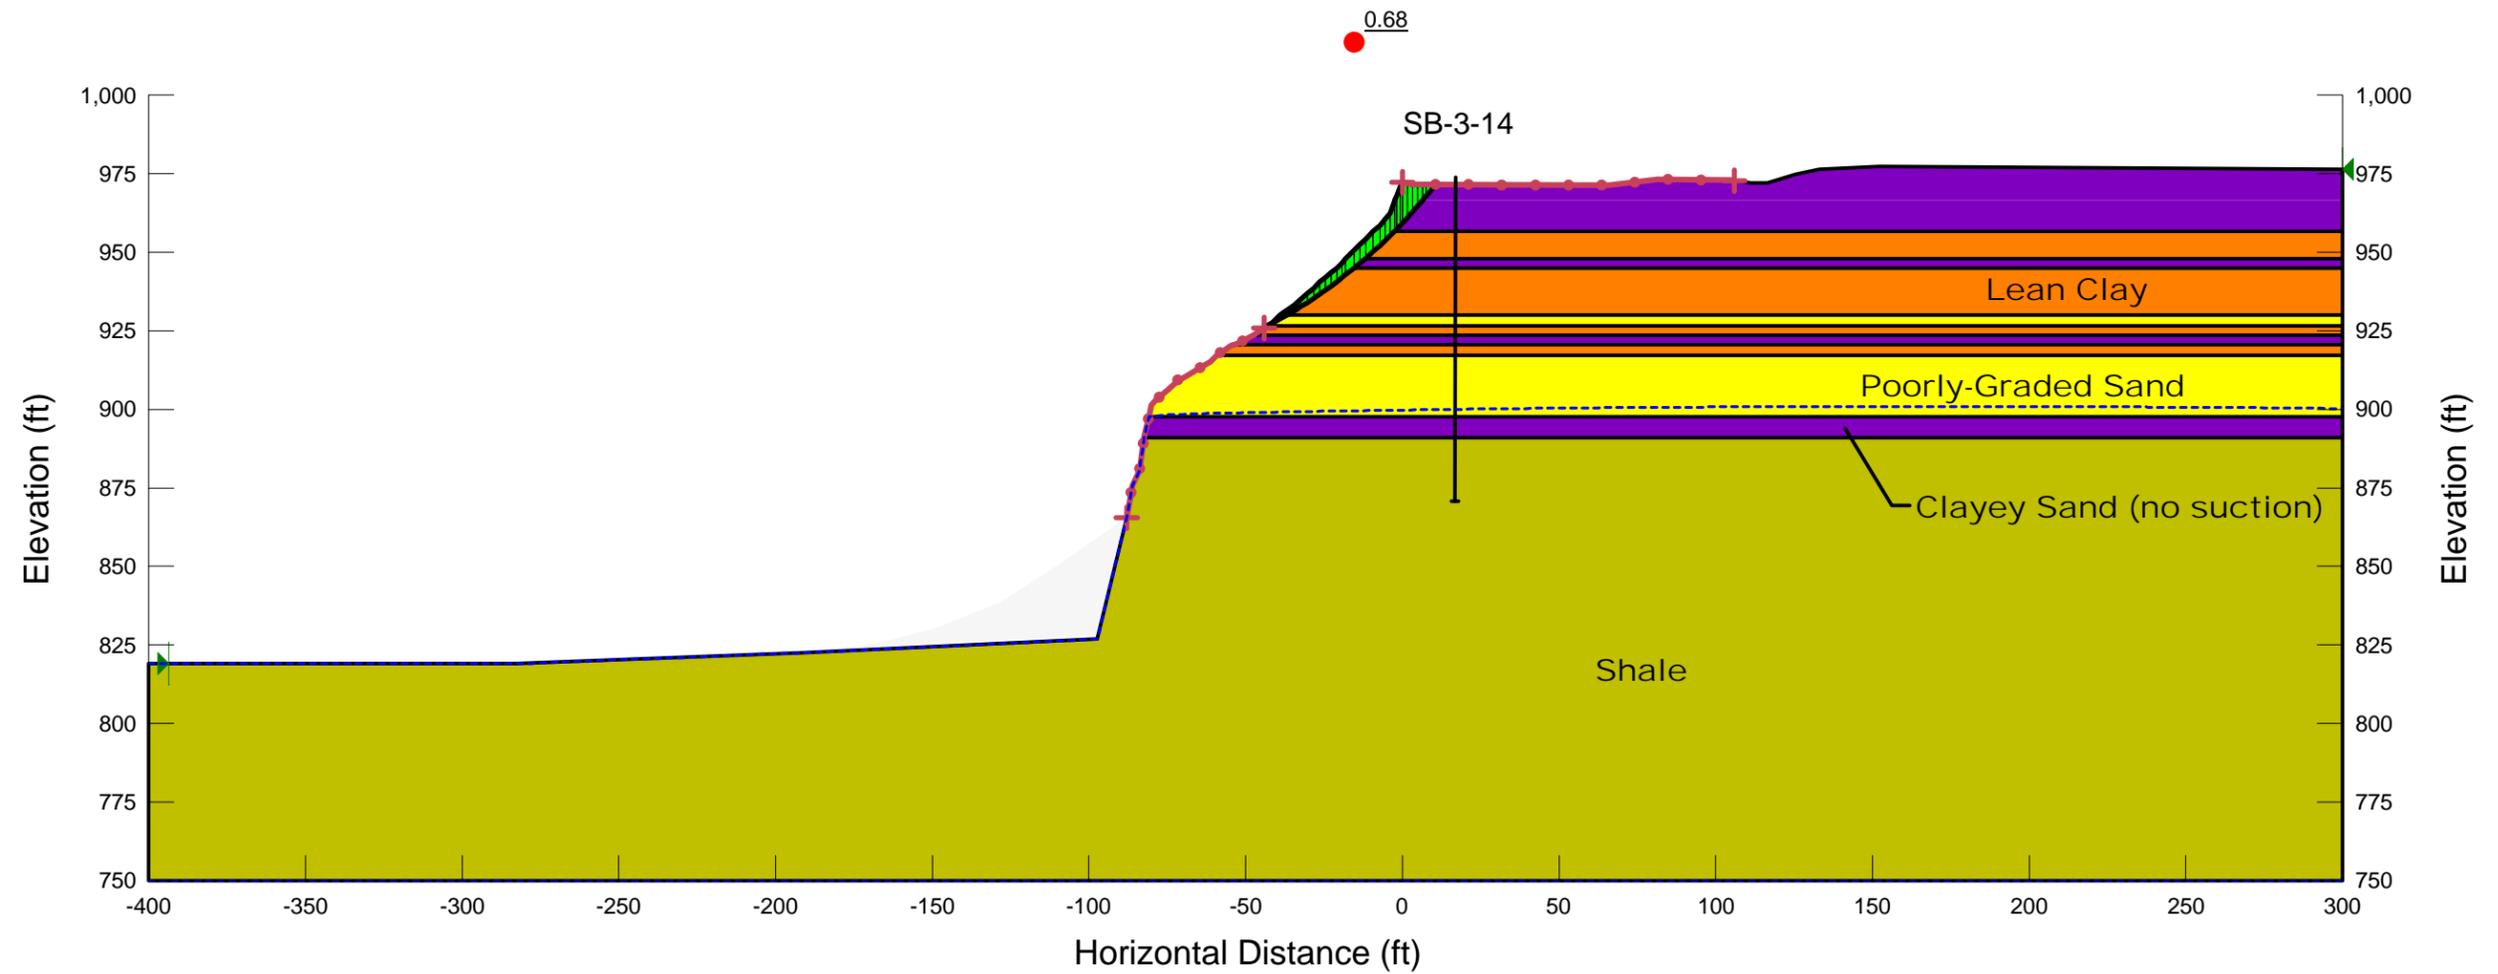
**Figure E-40 Middle Clay Pit Drained Friction Angle with Rainfall**  
**Lilydale Regional Park**  
**Seepage and Slope Stability Analysis**  
**1.2.1b Slope - Rain Event (SAT)**  
**File Name: middle clay pit\_trans\_rain.gsz**  
**Date Saved: 1/19/2015**

**FS = 0.68**

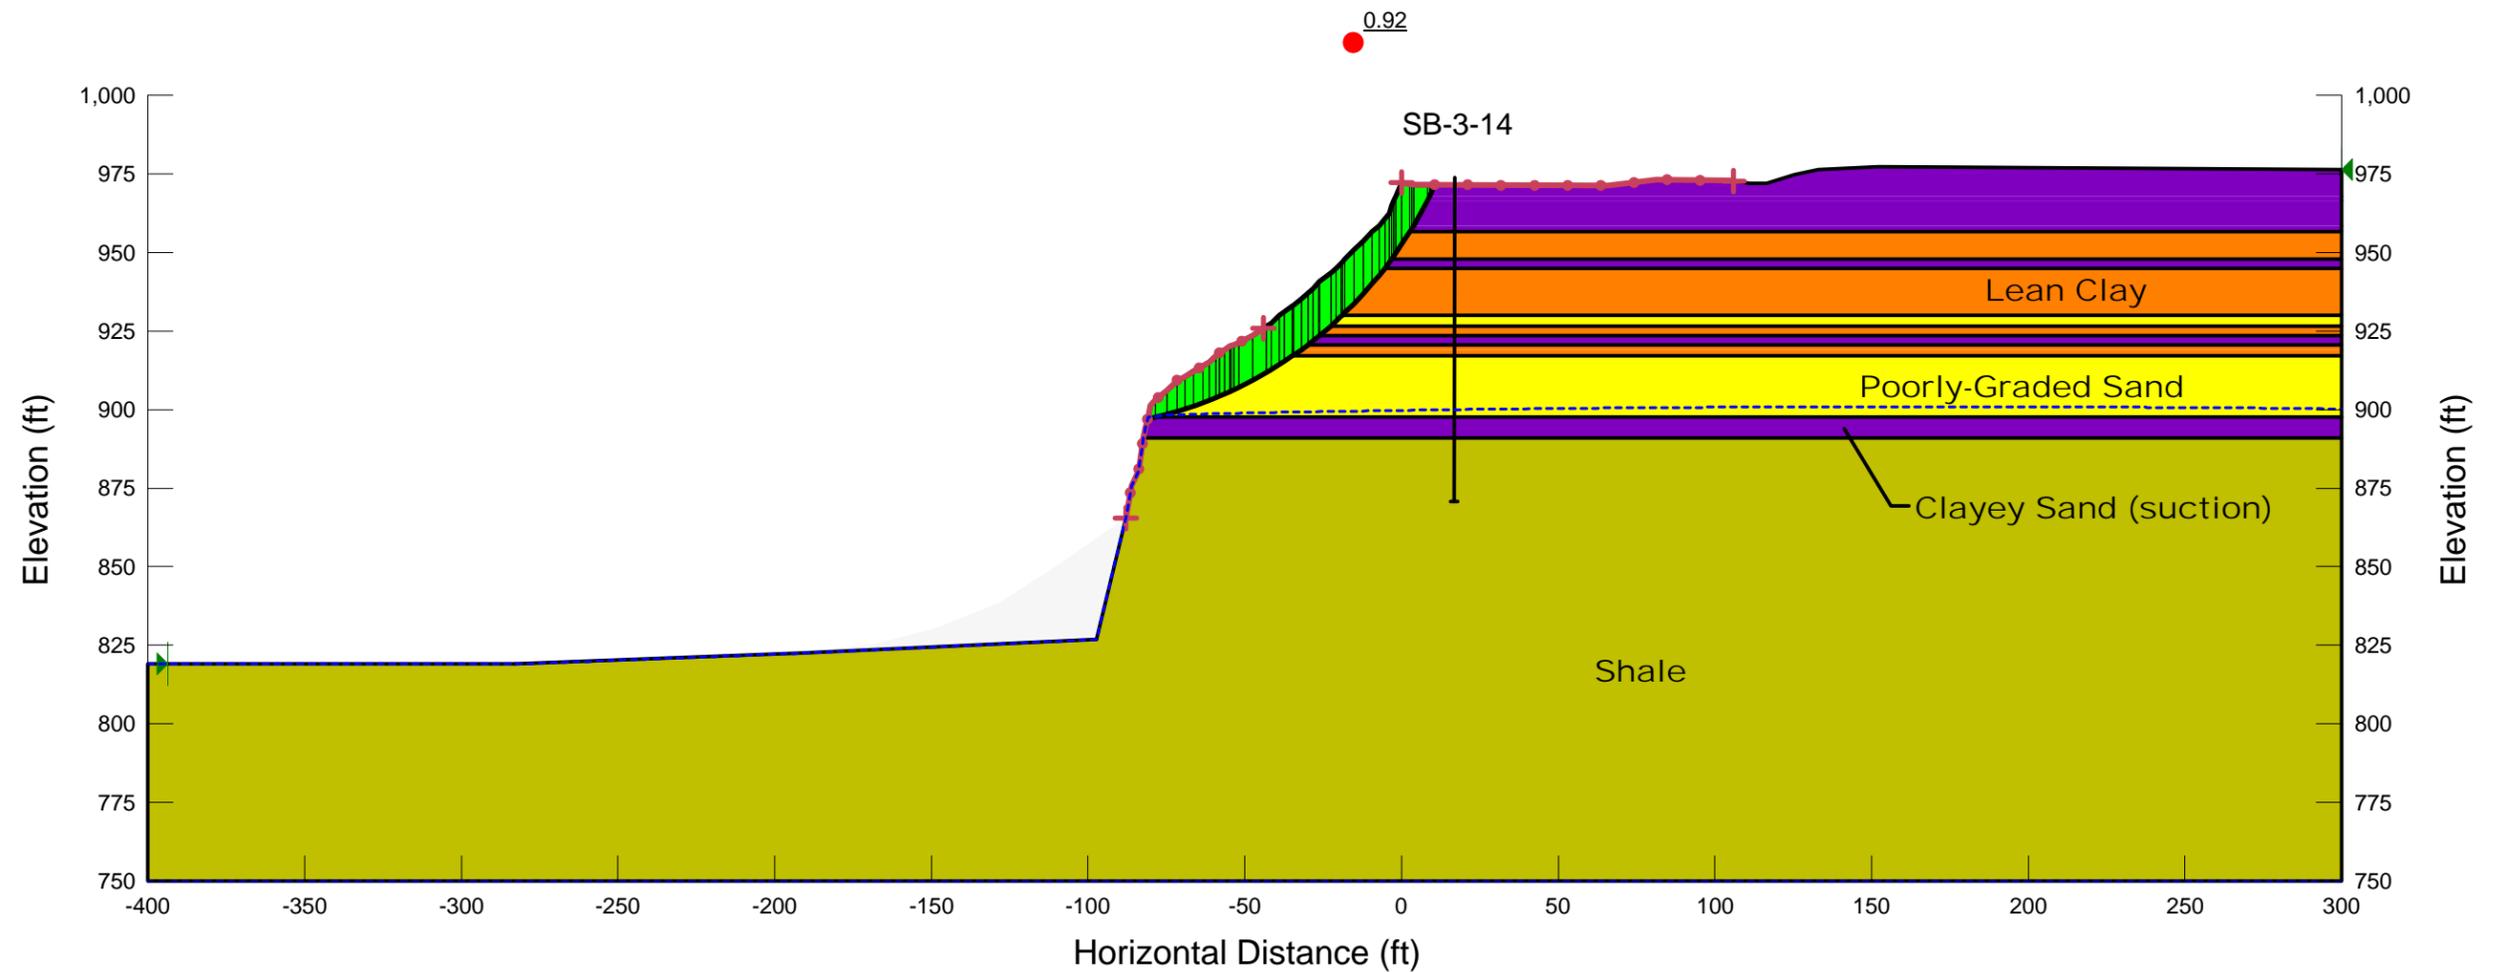
**Figure E-41 Middle Clay Pit Drained Friction Angle with Suction with Rainfall**  
**Lilydale Regional Park**  
**Seepage and Slope Stability Analysis**  
**1.2.2b Slope - Rain Event with Suction (SAT)**  
**File Name: middle clay pit\_trans\_rain.gsz**  
**Date Saved: 1/19/2015**

**FS = 0.92**

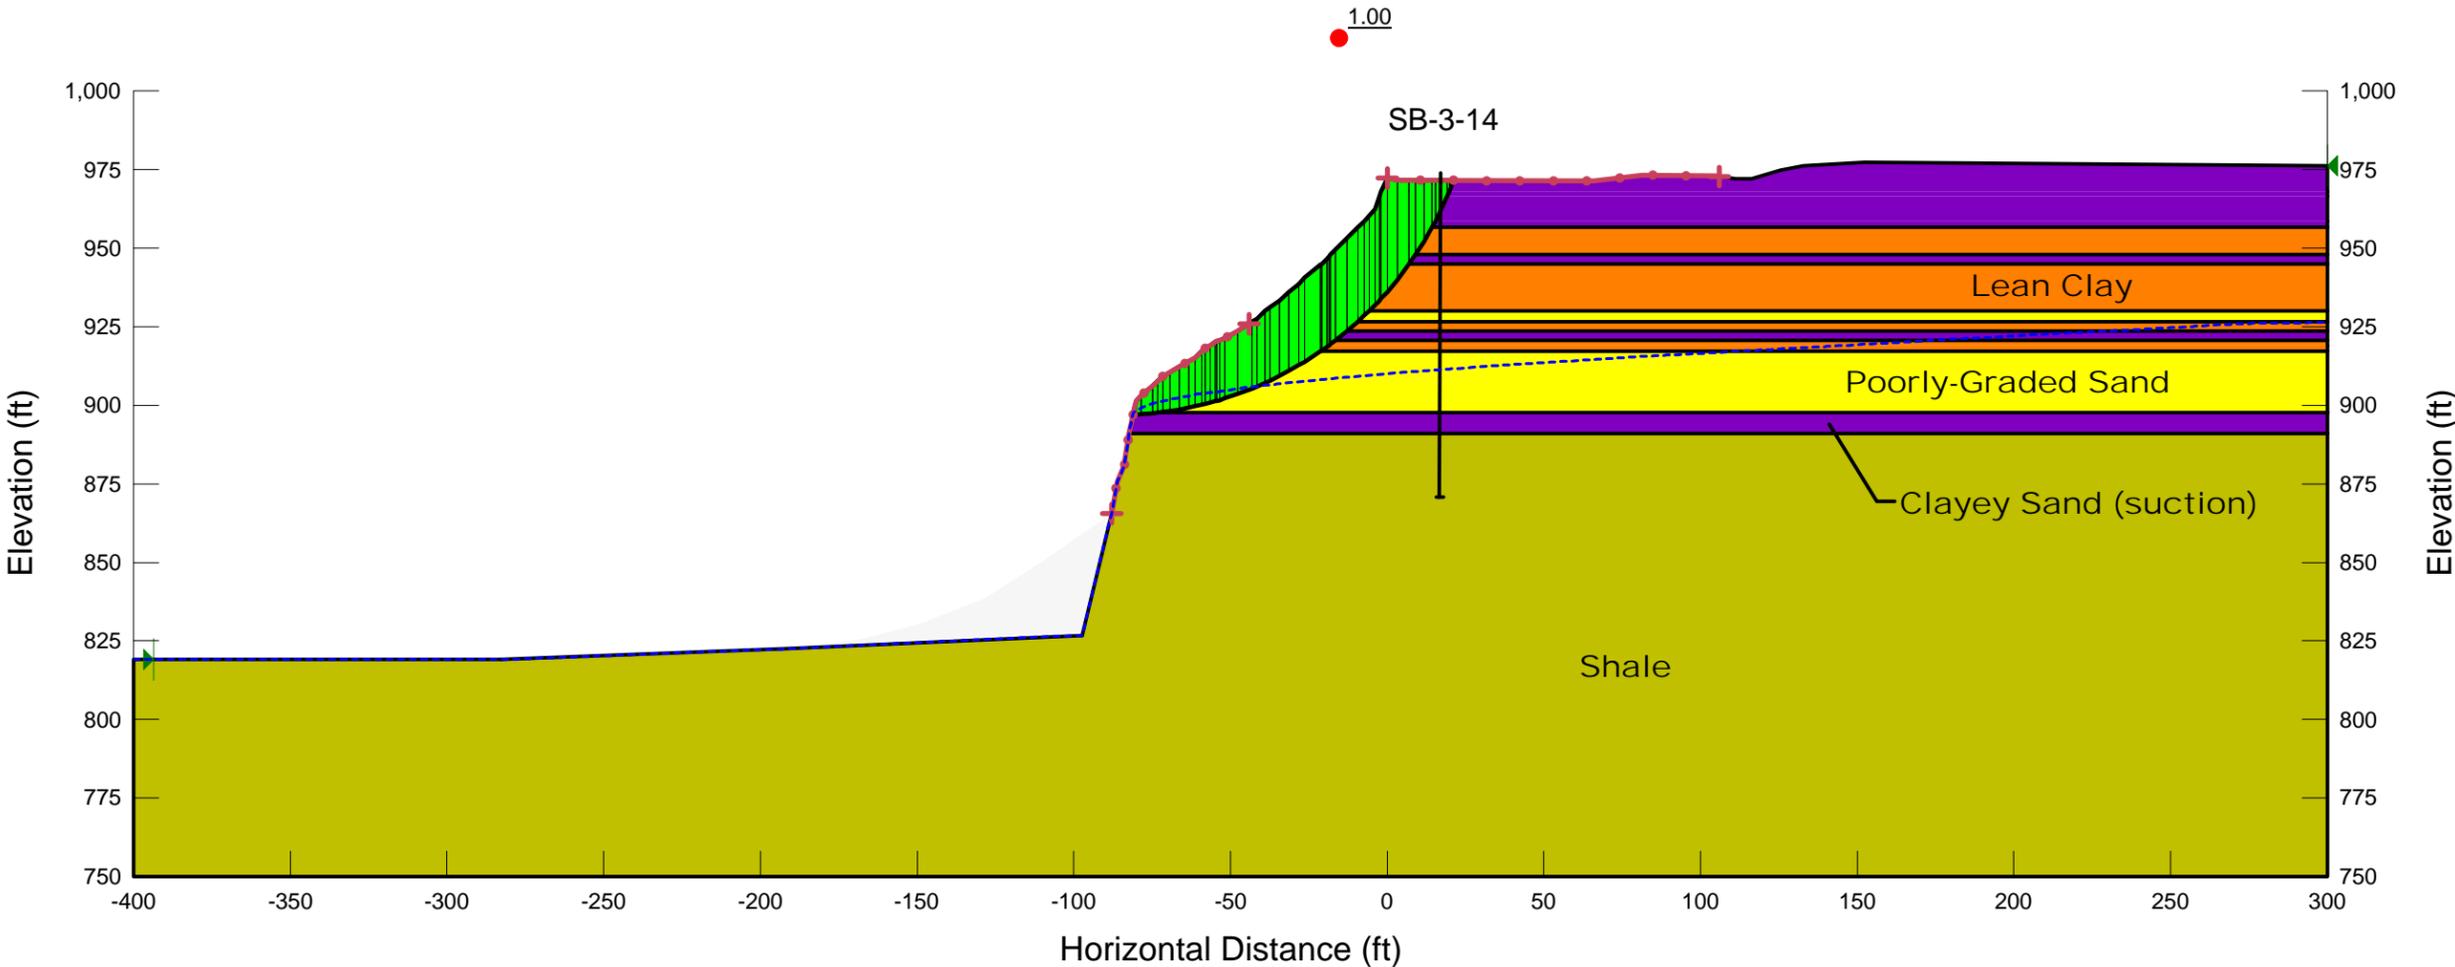
**Figure E-42 Middle Clay Pit Drained Friction Angle with Suction with High Groundwater**  
**Lilydale Regional Park**  
**Seepage and Slope Stability Analysis**  
**2.1 Slope - High GW with Suction**  
**File Name: middle clay pit\_trans\_rain.gsz**  
**Date Saved: 12/27/2014**

**FS = 1.00**
