## **Brickyard Area of Lilydale Regional Park**

### ***Stormwater Management and Slope-Stability Analysis***

Prepared for  
City of St. Paul Department of Parks and Recreation

January 28, 2015

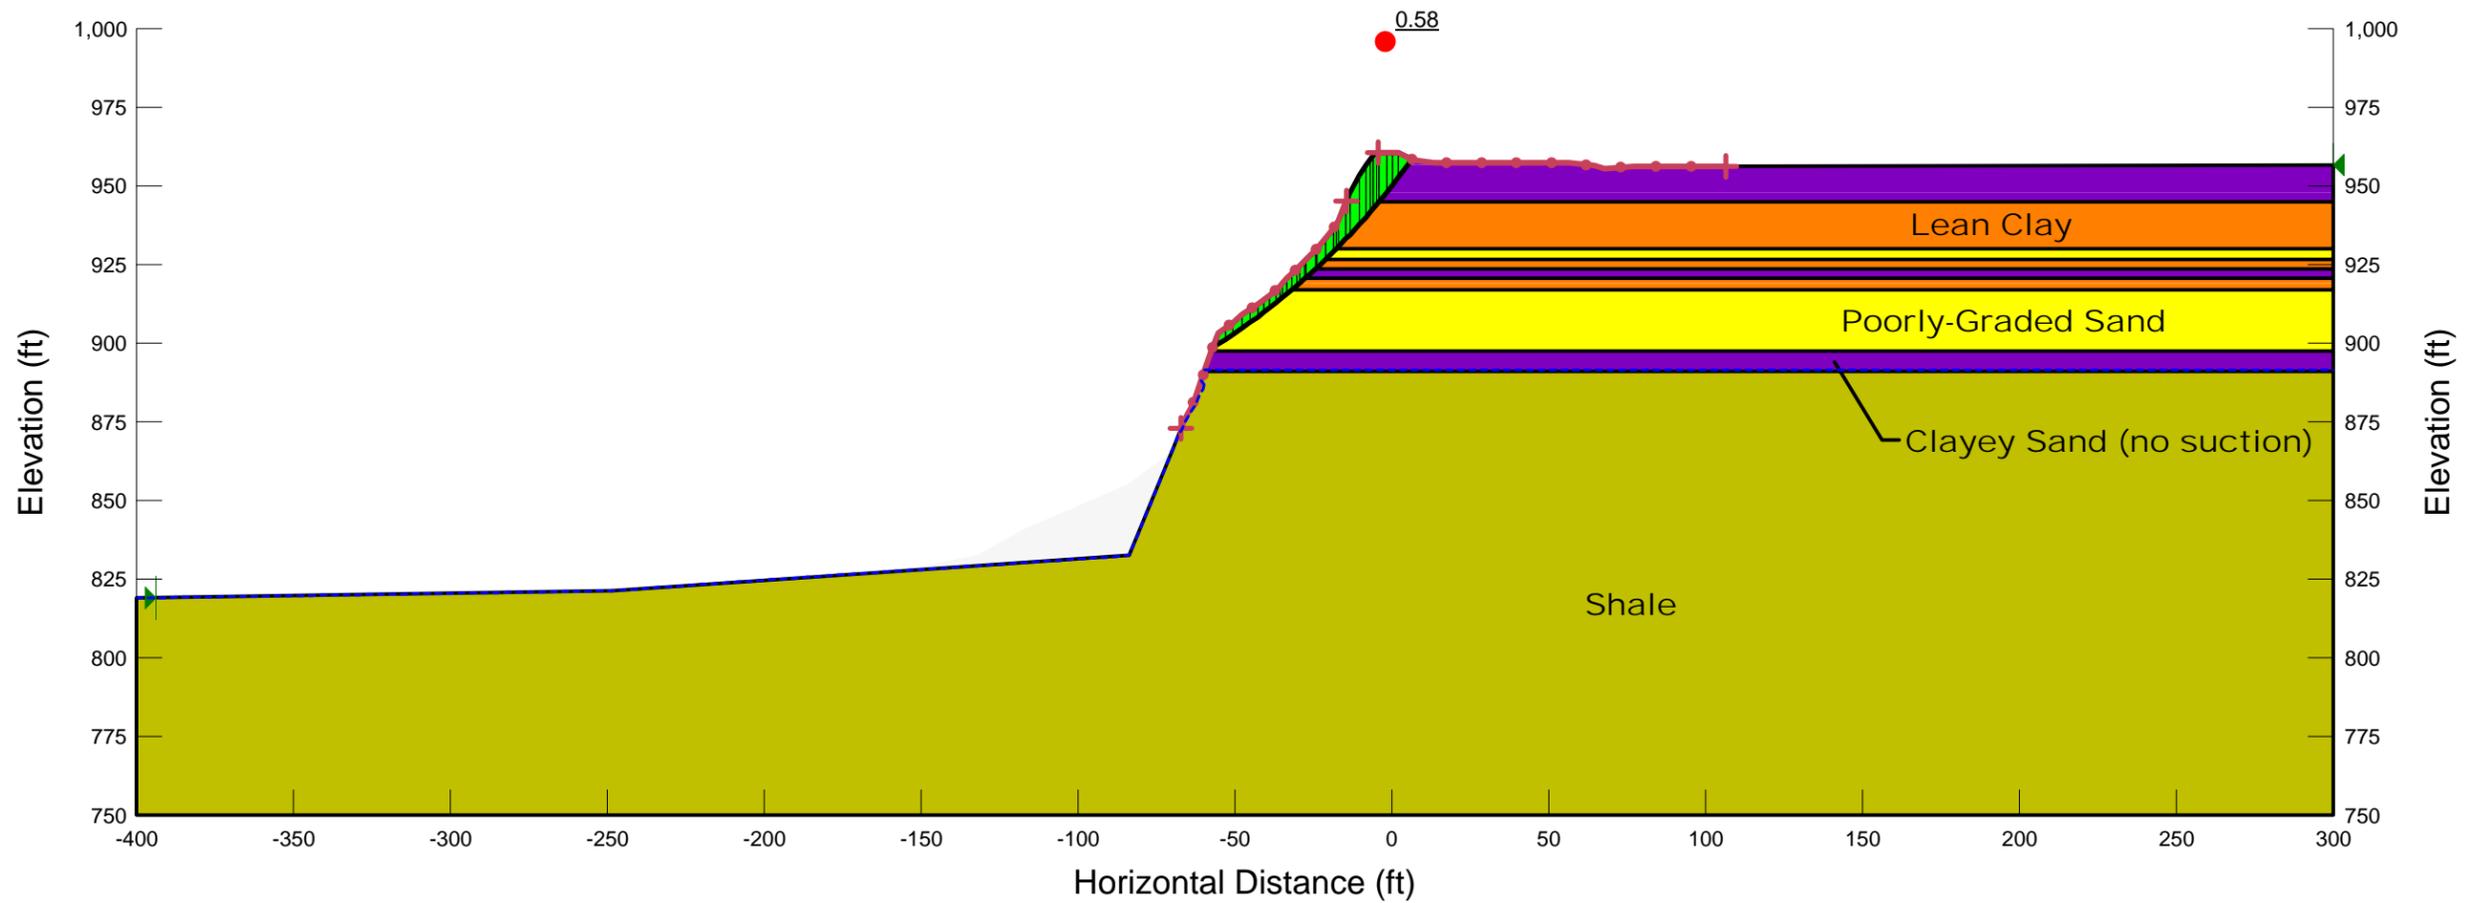
**Figure E-43 West Clay Pit Drained Friction Angle**  
**Lilydale Regional Park**  
**Seepage and Slope Stability Analysis**  
**1.0.1 Slope - Existing Conditions**  
**File Name: Lilydale\_west clay pit\_SC.gsz**  
**Date Saved: 12/21/2014**

**FS = 0.58**

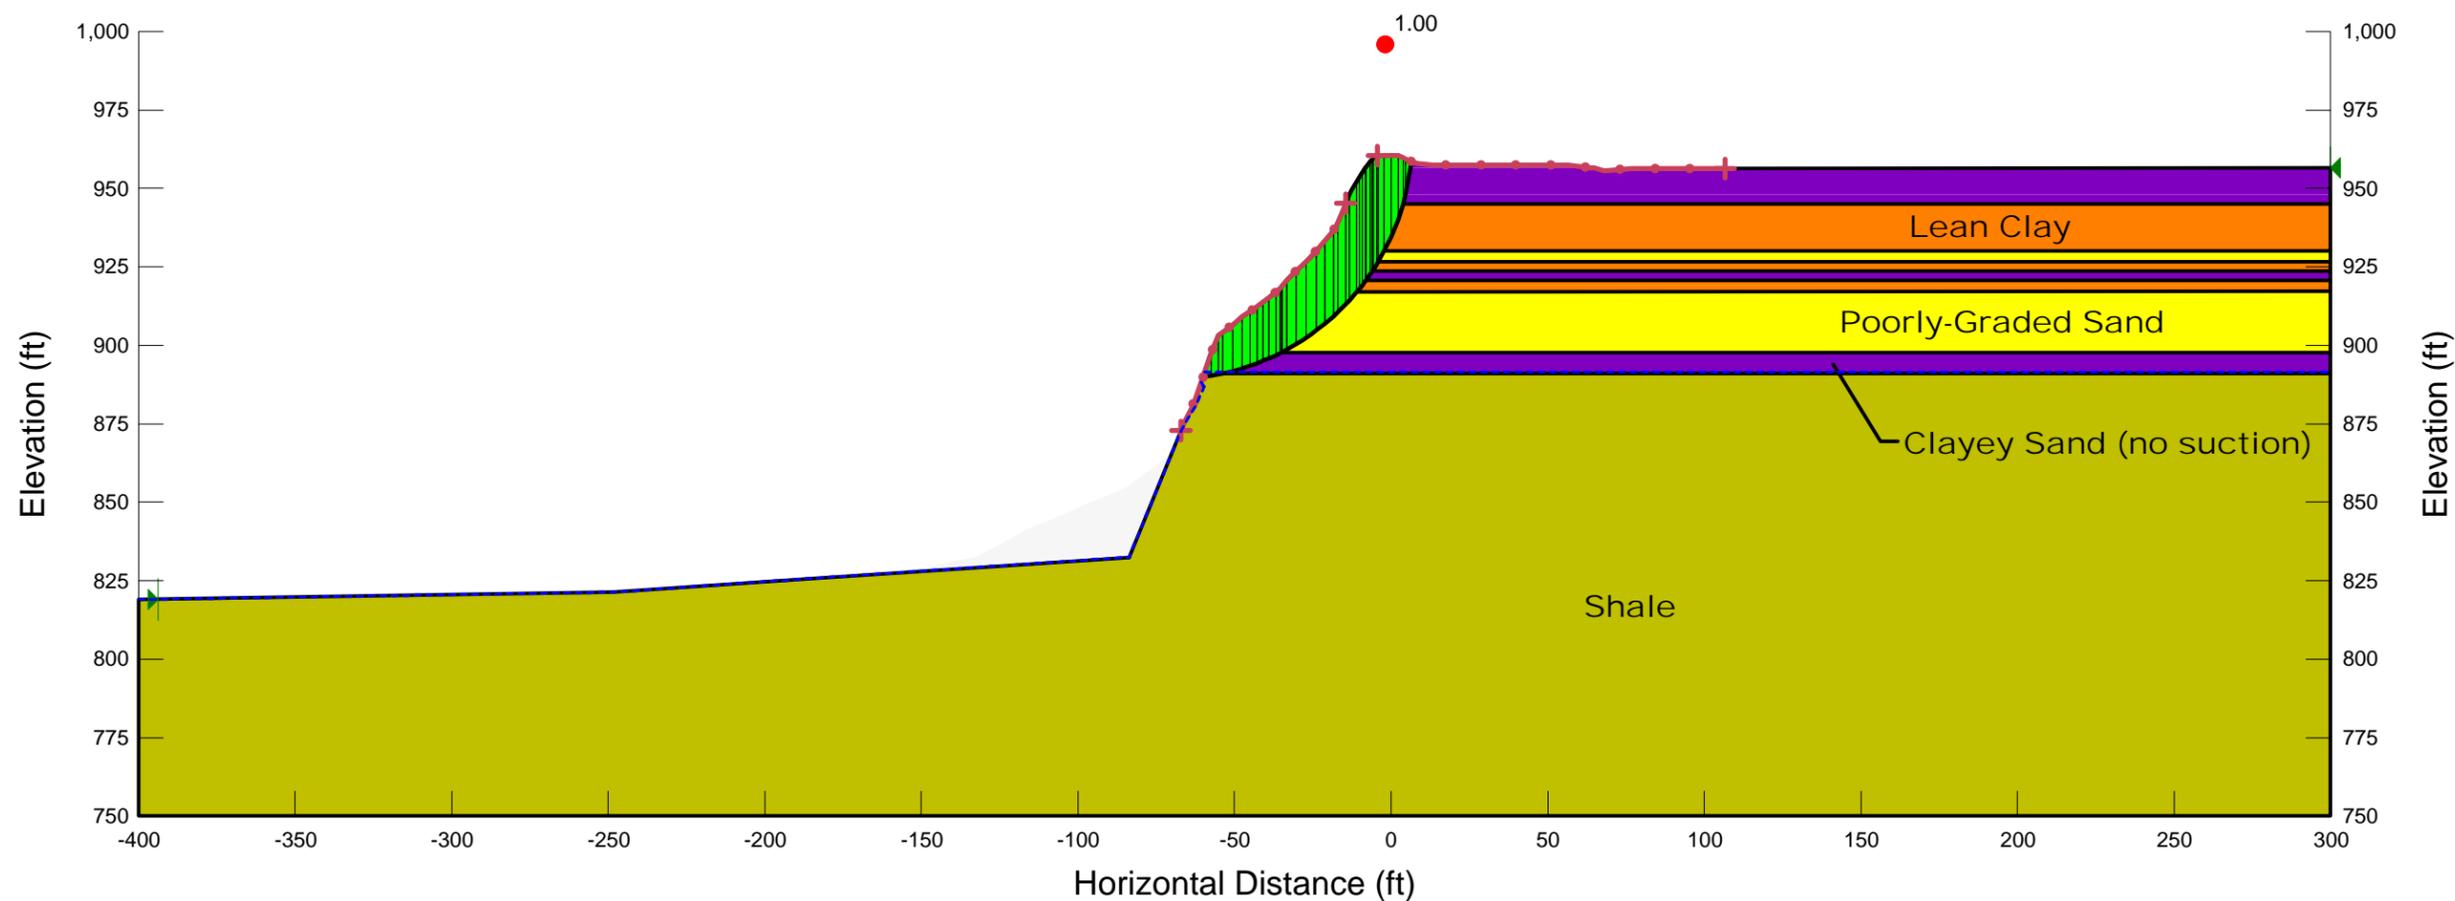
**Figure E-44 West Clay Pit Drained Friction Angle at Stability**  
**Lilydale Regional Park**  
**Seepage and Slope Stability Analysis 1.0.1 Slope - Existing**  
**Conditions**  
**File Name: Lilydale\_west clay pit\_SC.gsz Date Saved:**  
**12/21/2014**

**FS = 1.00**

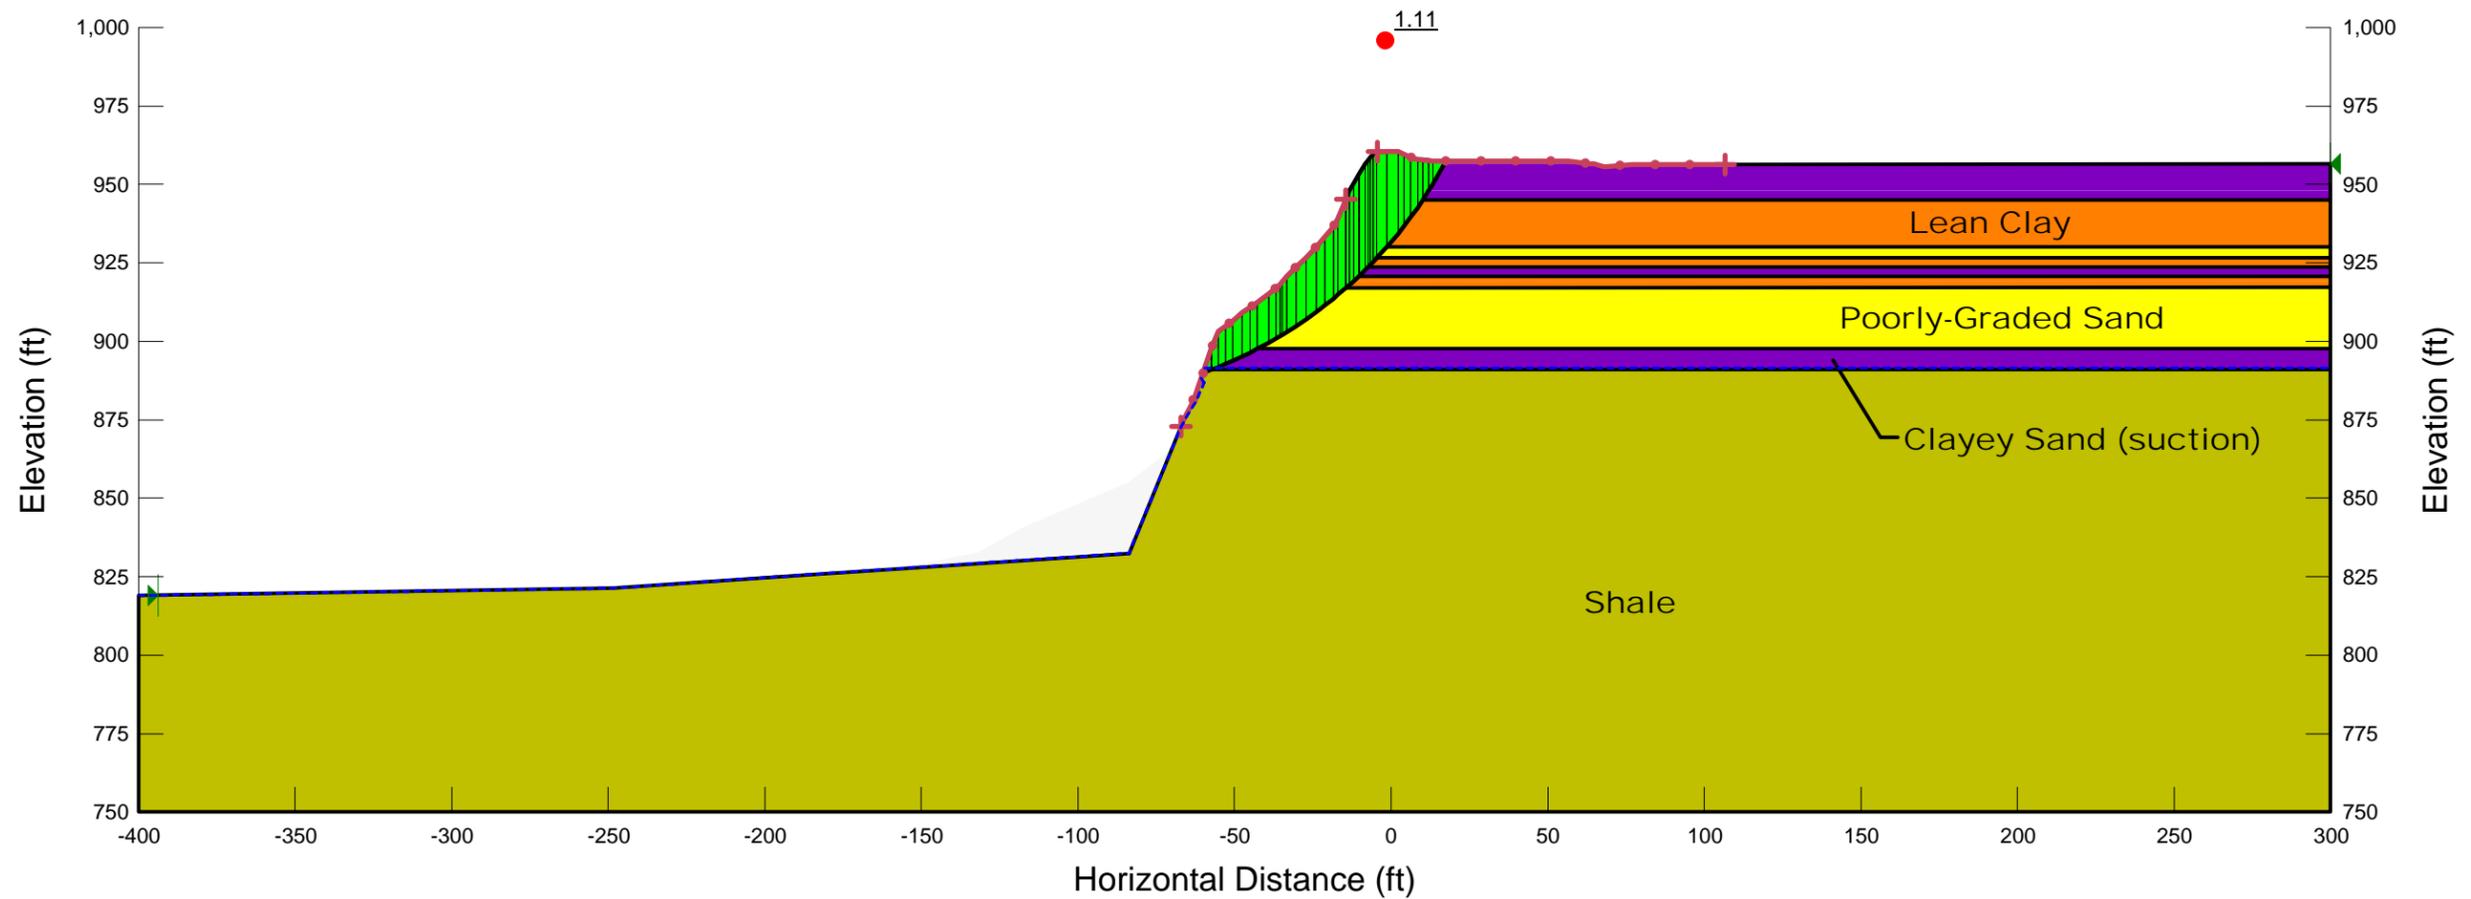
**Figure E-45 West Clay Pit Drained Friction Angle with Suction**  
**Lilydale Regional Park**  
**Seepage and Slope Stability Analysis**  
**1.0.2 Slope - Existing Conditions with Suction**  
**File Name: Lilydale\_west clay pit\_SC.gsz**  
**Date Saved: 12/21/2014**

**FS = 1.11**

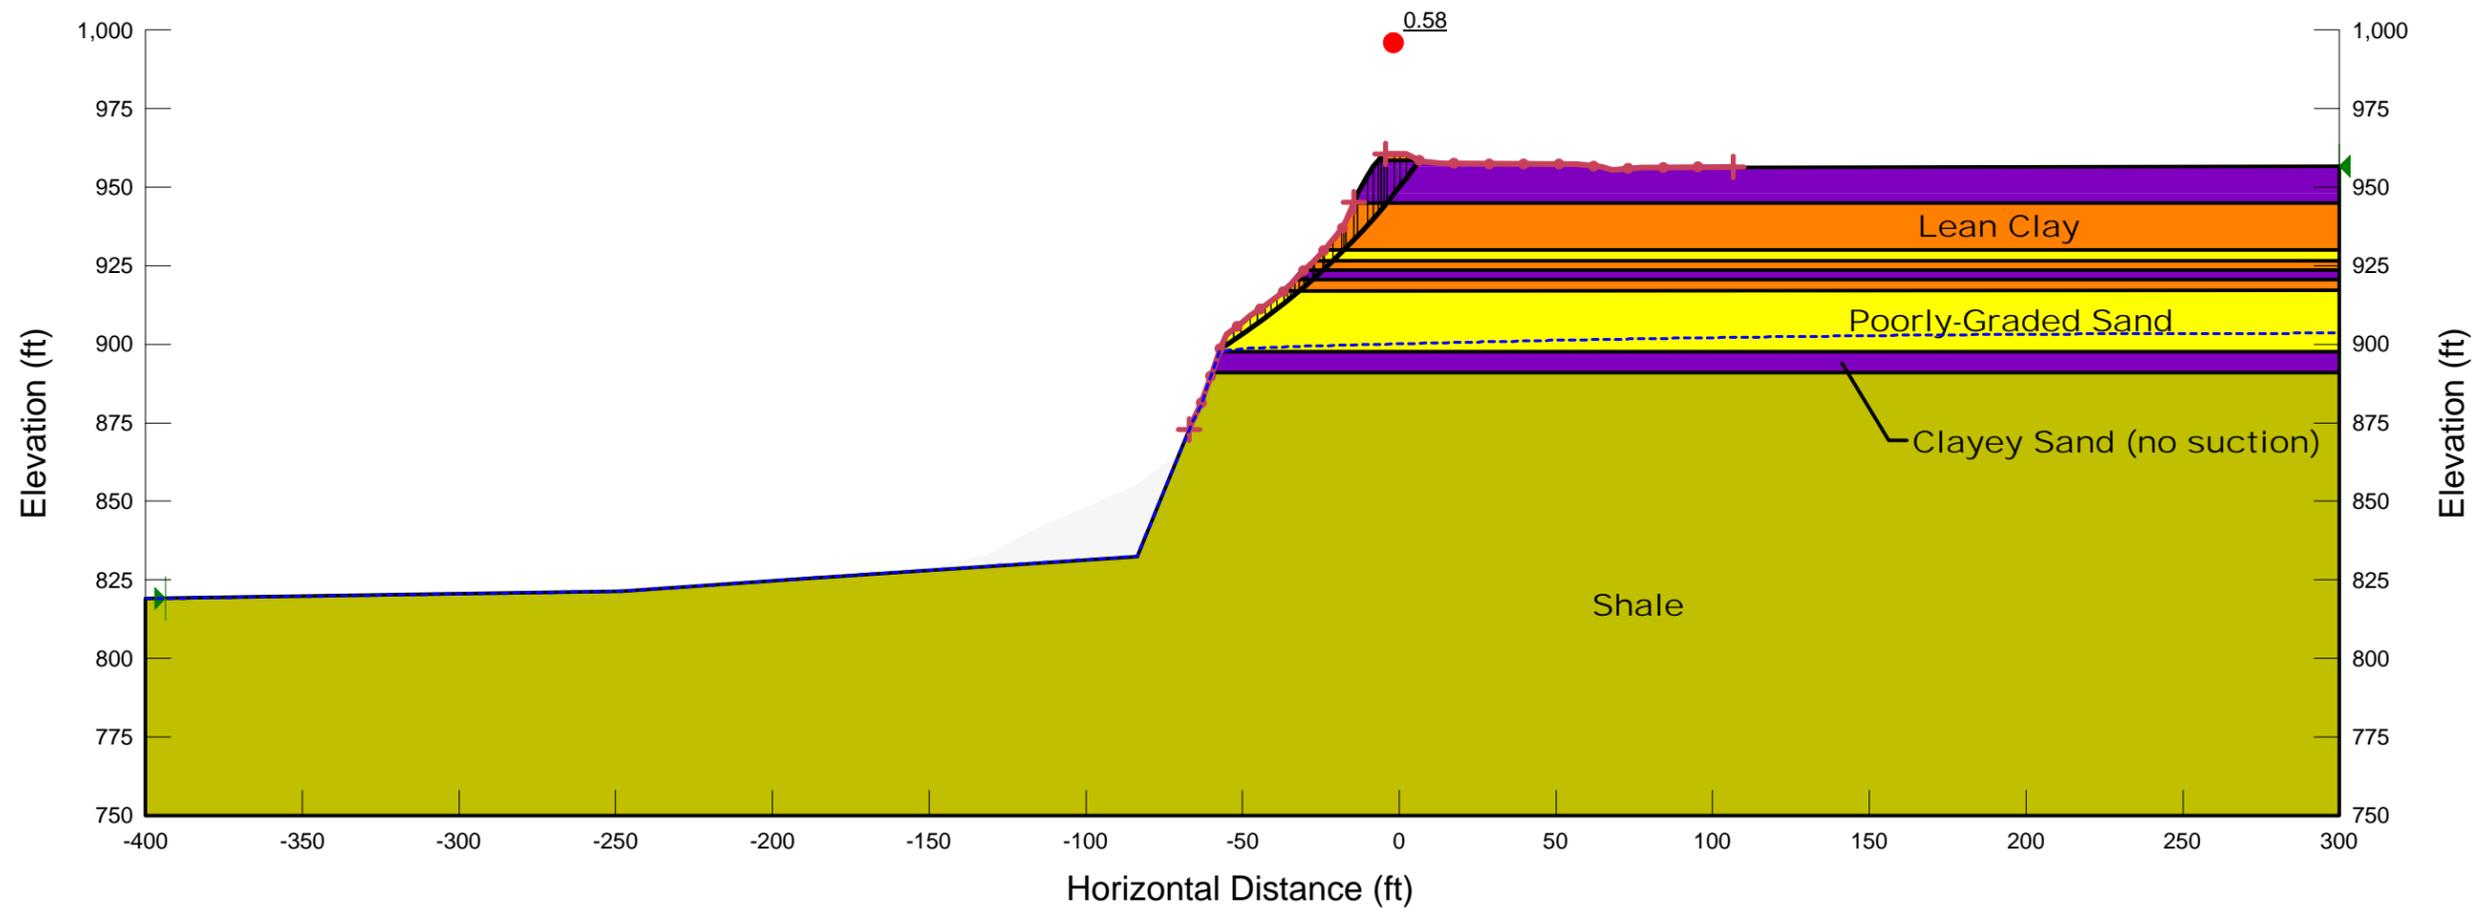
**Figure E-46 West Clay Pit Drained Friction Angle with Rainfall**  
**Lilydale Regional Park**  
**Seepage and Slope Stability Analysis**  
**1.2b.1 Slope - Rain Event (SAT)**  
**File Name: Lilydale\_west clay pit\_SC.gsz**  
**Date Saved: 1/19/2015**

**FS = 0.58**

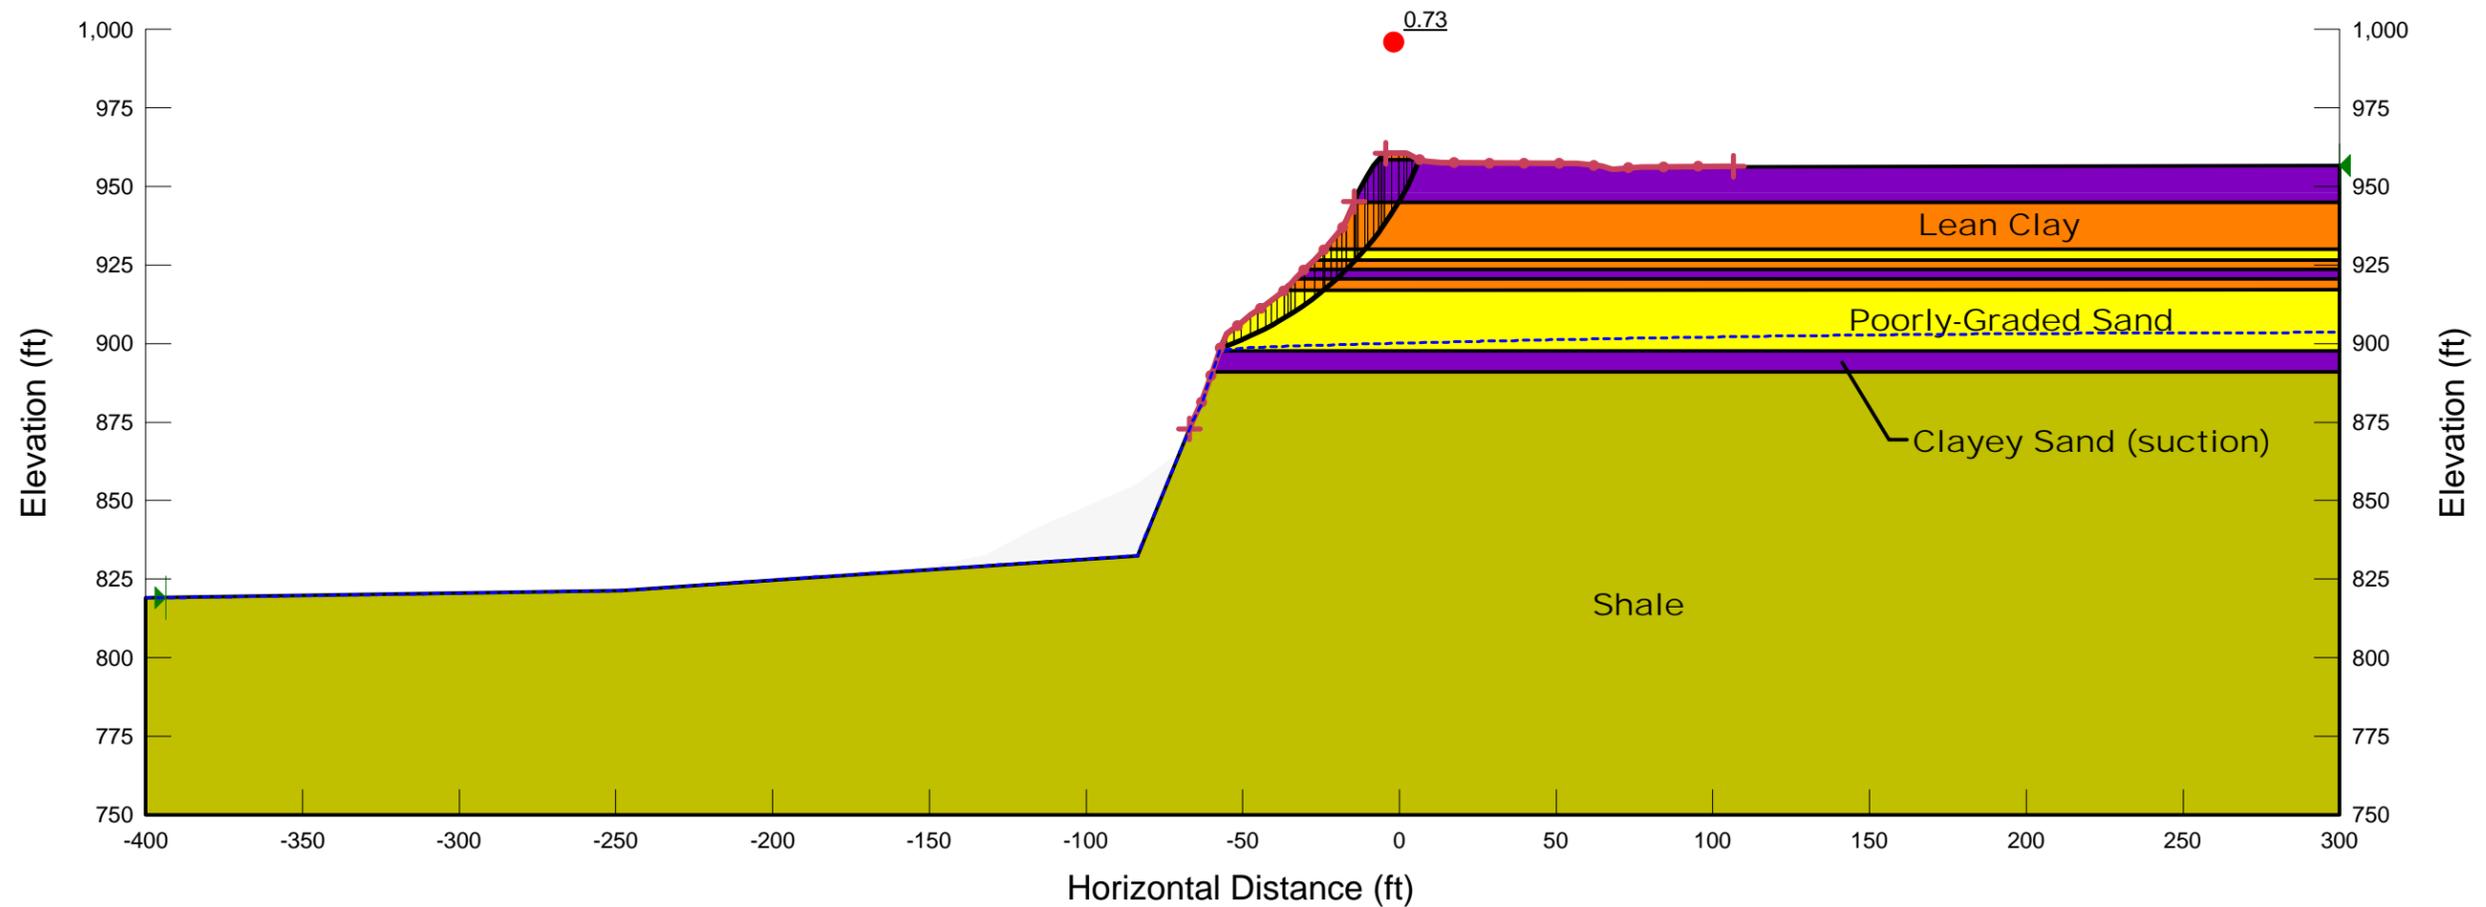
**Figure E-47 West Clay Pit Drained Friction Angle with Suction with Rainfall**  
**Lilydale Regional Park**  
**Seepage and Slope Stability Analysis**  
**1.2b.2 Slope - Rain Event with Suction (SAT)**  
**File Name: Lilydale\_west clay pit\_SC.gsz**  
**Date Saved: 1/19/2015**

**FS = 0.73**

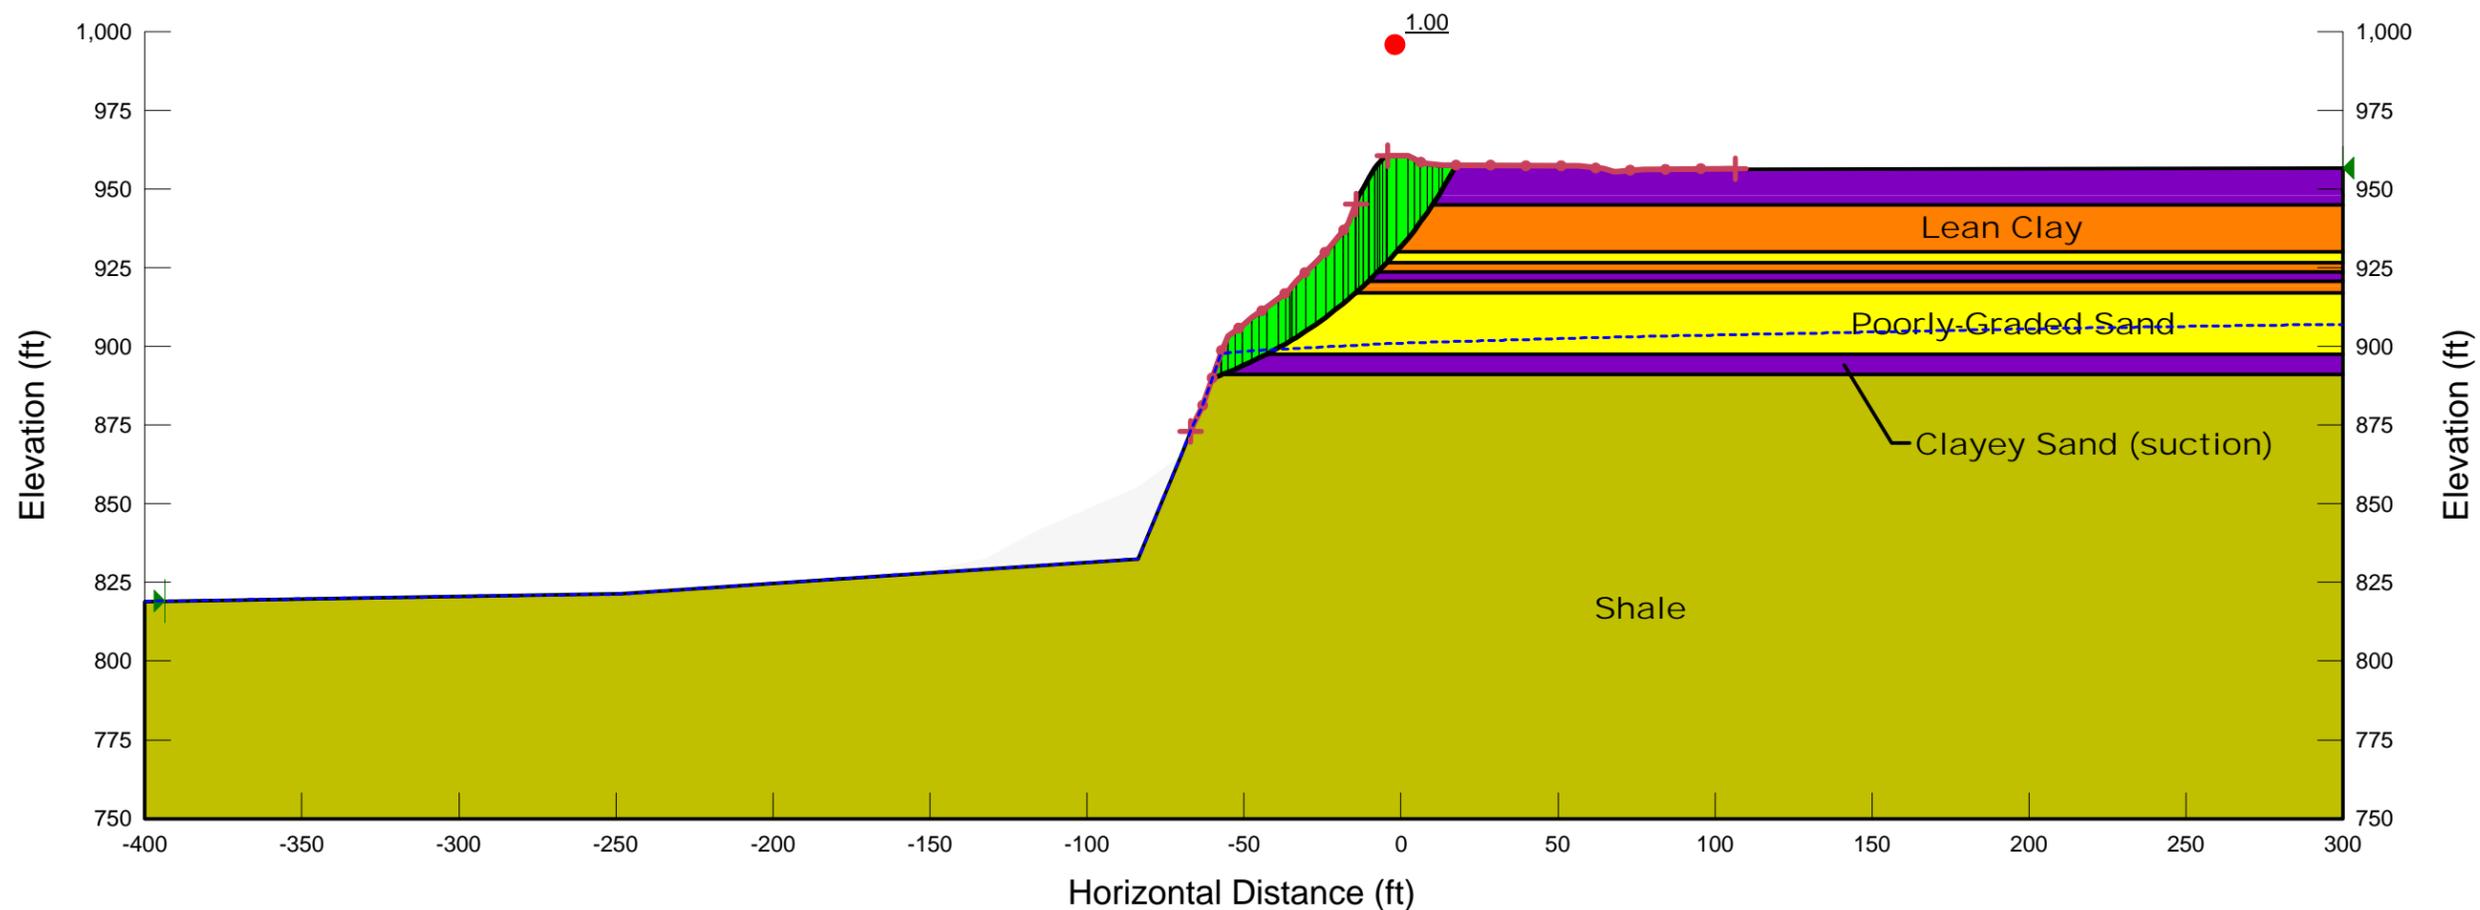
**Figure E-48 West Clay Pit Drained Friction Angle with Suction with High Groundwater**  
**Lilydale Regional Park**  
**Seepage and Slope Stability Analysis**  
**2.1 Slope - high GW with Suction**  
**File Name: Lilydale\_west clay pit\_SC.gsz**  
**Date Saved: 12/27/2014**

**FS = 1.00**
