CITY OF SAINT PAUL PUBLIC WORKS

Walnut Street Stairway

June 13, 2023

Walnut Street Stairway System

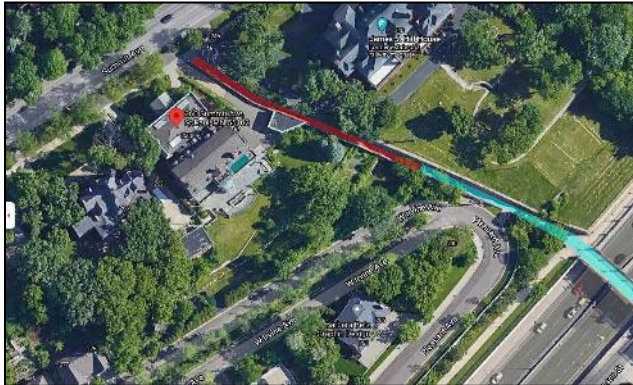
- The area in cyan was reconstructed by MnDOT and bears no resemblance to the original structure.
- The area in red retained the general design elements of the original stairway, with exception of other modifications or repairs. Typical lifespan of a structure is 50-75 years.

1986: MnDOT removes the lower portion of stairs during the construction of I-35E. The rebuilt concrete stairway bears no resemblance to the original structure.

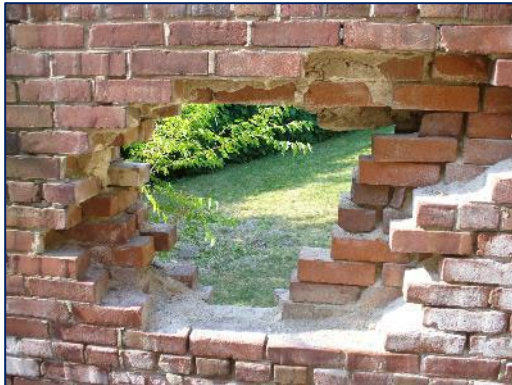
- In 2012, DSI issued an order to 260 Summit Ave to repair the south brick wall.
- City Attorney Office negotiated an agreement with the property owner in which the City accepted ownership of the stairway/wall structure.
- Public Works was then directed to repair major wall defects in 2013.

2013: City performs wall rehabilitation to repair brick voids and missing mortar.

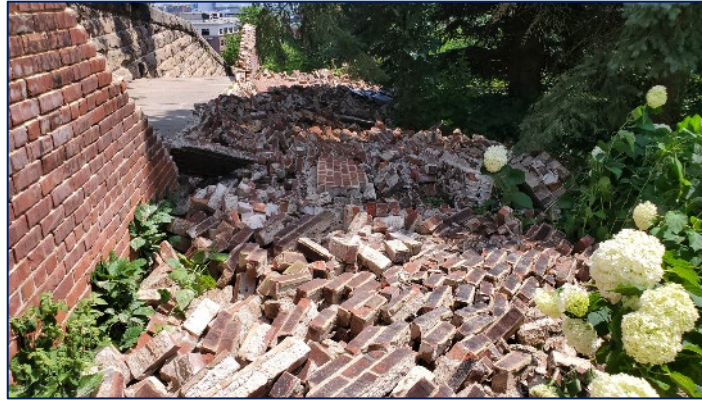
2020: A portion of the south brick wall collapses and the stairway is closed.

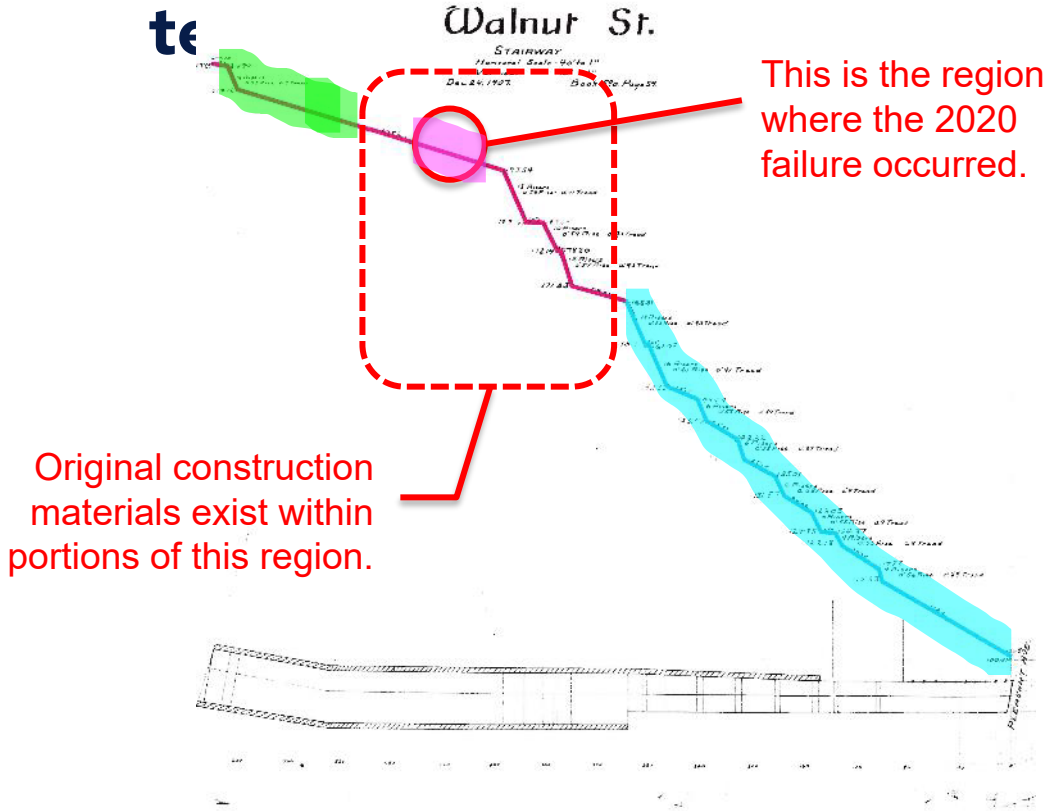
- Approximately 50% of the original stairway was removed and replaced by MnDOT in 1986.
- An additional 20% of the original system has been modified through major repairs or reconstruction.
- About 10% of upper wall structure (60' length) collapsed in 2020.
- As a result, around 20% of the original structure remains in an original state, or with a historic appearance (the 2013 repairs were also performed within this region).

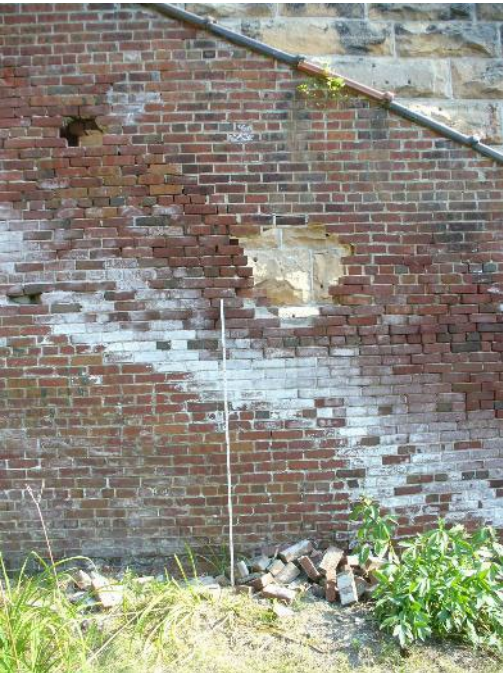
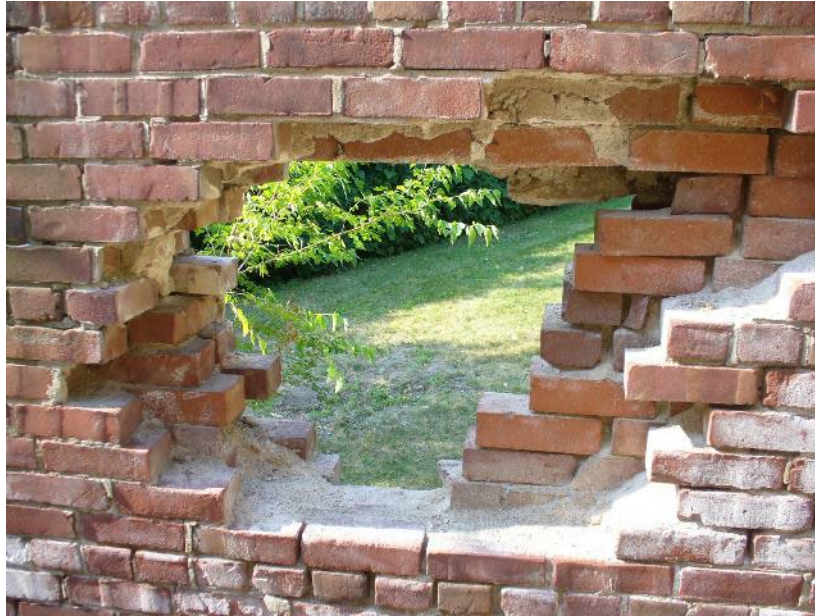
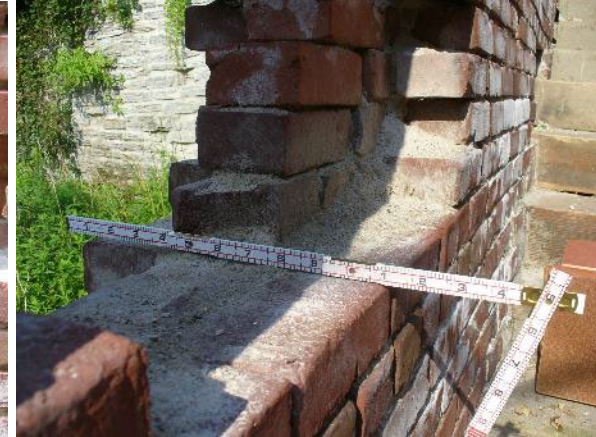
Public Works acquired the wall with immediate repair needs

Localized failures present:

- Bulging
- Displacement
- Significant mortar loss
- Missing bricks

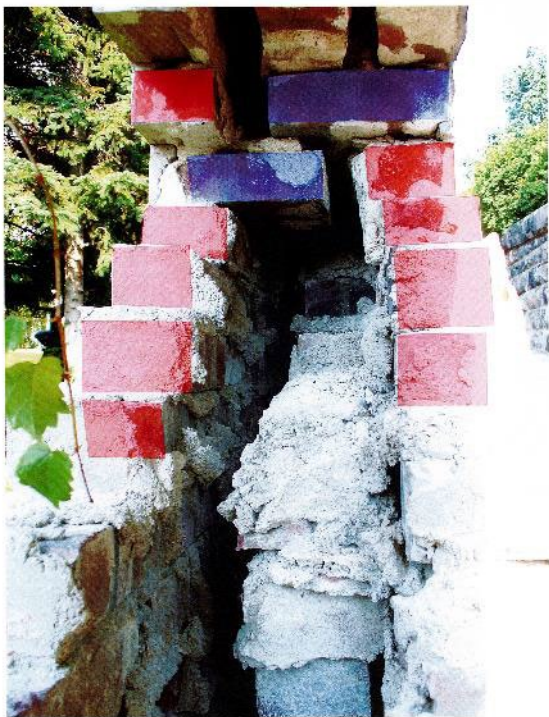
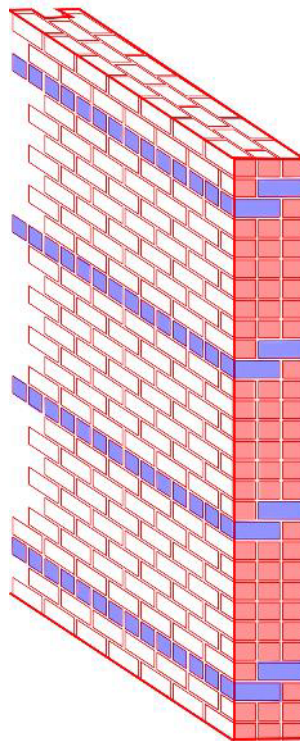
- Bulging or displacement failure can occur when the bonding courses fail

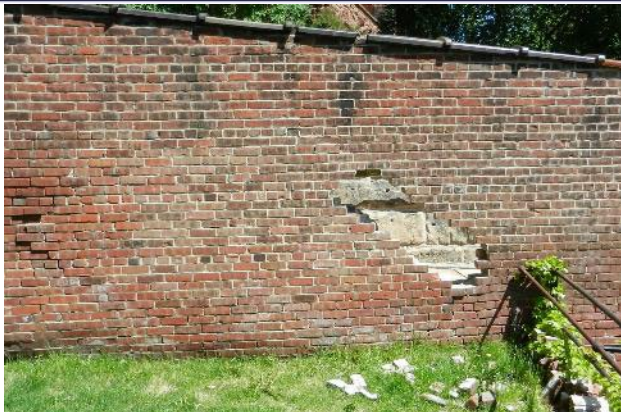
2012

A void and bulge was repaired here in 2013

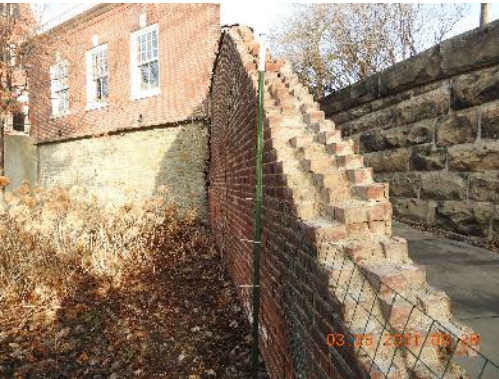
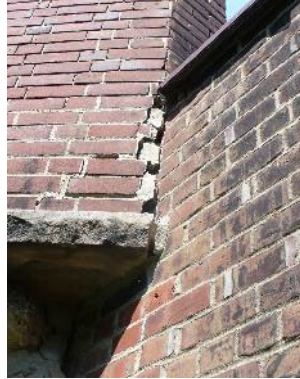
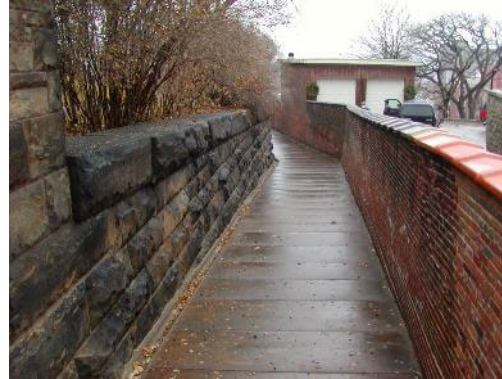
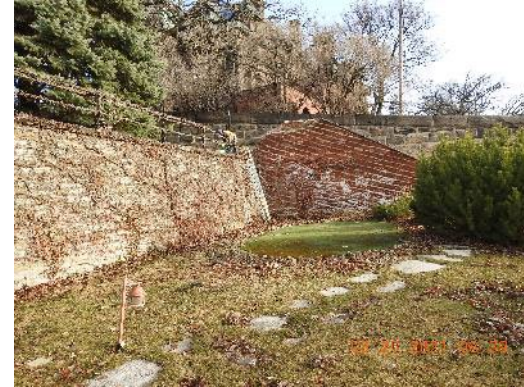
- The narrow worksite, adjacent private structures, and steep erosive bluff restricts access for conventional equipment.
- Portions of the wall and stair system are built integral with private structures that must be protected and stabilized.
- The bluff must be stabilized (likely with reinforced concrete walls) regardless of which option is chosen.
- Temporary construction easements will be required and may involve extensive site restoration.
