2023 STORMWATER QUALITY AND QUANTITY MONITORING PROGRAM

CITY OF ST. PAUL

MARCH 22, 2024

WSB PROJECT NO. 022099

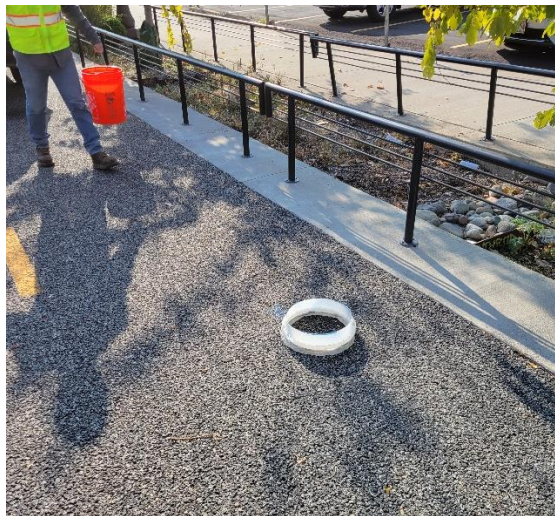
Photo 2-7: Permeable Pavement Infiltration Test

Infiltration tests were conducted according to the modified ASTM C1701 methods for measuring infiltration rates (**Photo 2-7**). Five locations at Victoria Street, eighteen locations at Jackson Street, and nine locations at Hamline Midway Library were evaluated to develop an average infiltration rate measurement for each site. Tests were taken at locations that remained consistent year to year and included a combination of high and low traffic areas. At each test location, a pre-wet test was conducted, followed by two infiltration tests. The two infiltration tests were averaged to generate the infiltration rate for each location. If after 15 minutes of monitoring during a pre-wet test no infiltration was observed, the test was concluded, and no subsequent tests were completed.

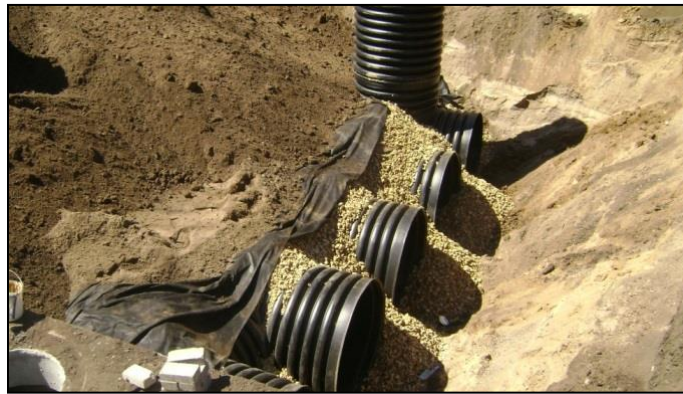
Photo 5-1: St. Albans 48” Perforated HDPE Installation

A manhole structure positioned along the main storm sewer under Aurora Avenue diverts stormwater into the underground infiltration system (**Photo 5-1**) via a 30-inch elliptical pipe. The system is also connected to the University Avenue storm sewer system. Any runoff that does not get treated by infiltration trenches and tree planters along University Avenue is directed to this system (**Photo 5-1**). When the system reaches its storage capacity, water flows west through the existing storm sewer system. The system includes a pretreatment structure comprised of a grit chamber and baffled weir to provide settling for sediment and skimming. Rainfall monitoring for the site is conducted on the roof of Fire Station 18, located across the street from the BMP. The BMP system details are provided in **Table 5-1**.

BMP water level was monitored in the access manhole at the northwest corner of the system. The 2023 water elevations and daily rainfall is provided on **Chart A.5** of **Appendix A**. Water level monitoring indicated that the infiltration gallery reached 100% capacity two times in 2023. The infiltration gallery drew down to empty in less than a 24 hour period after the conclusion of each rain event.

Infiltration rates are presented on **Chart A.6** of **Appendix A**. In 2023, the average infiltration rate of the BMP pipe was 11.7 in/hr (**Table 5-2**), which is below the design infiltration rate of 26.0 in/hr. Infiltration rate trends for the St. Albans Street BMP pipe are depicted on **Chart A.7**.

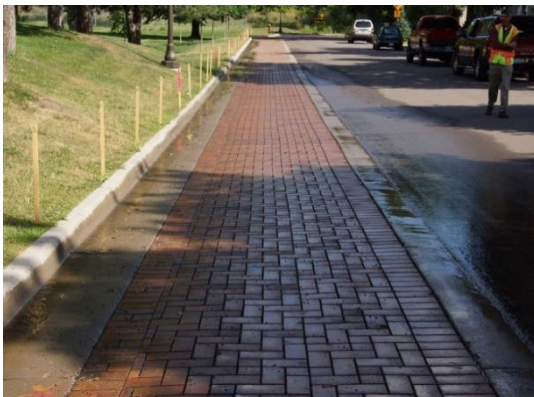
Photo 11-1: Victoria Street Pavers

The Victoria Street pervious surface consists of a parking area completed with permeable concrete pavers designed to receive stormwater runoff from Victoria Street and the properties adjacent to it. The pavers themselves are non-permeable and they are separated with aggregate fill (**Photo 11-1** and **11-2**). The spaces between the pavers allow stormwater runoff to infiltrate into the parking surface instead of running off and being collected by the storm sewer system. The pavers were installed in 2011 and infiltration rates have been monitored annually since 2012. The site and the infiltration test locations are provided on **Figure 11-1**.

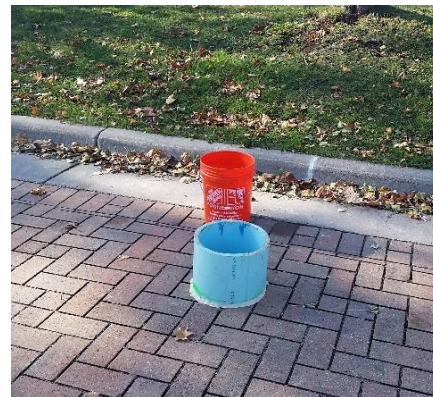
Photo 11-2: Victoria Street Infiltration Testing

Five locations were tested for infiltration at the Victoria Street site. In 2015, the exact test locations from 2014 could not be located, so new locations were established in the immediate area and identified as A-E (these locations were used since 2016). Those locations are depicted on **Figure 10-1** and the results of the testing are presented in **Table 11-1** and **Chart D.1** in **Appendix D**.

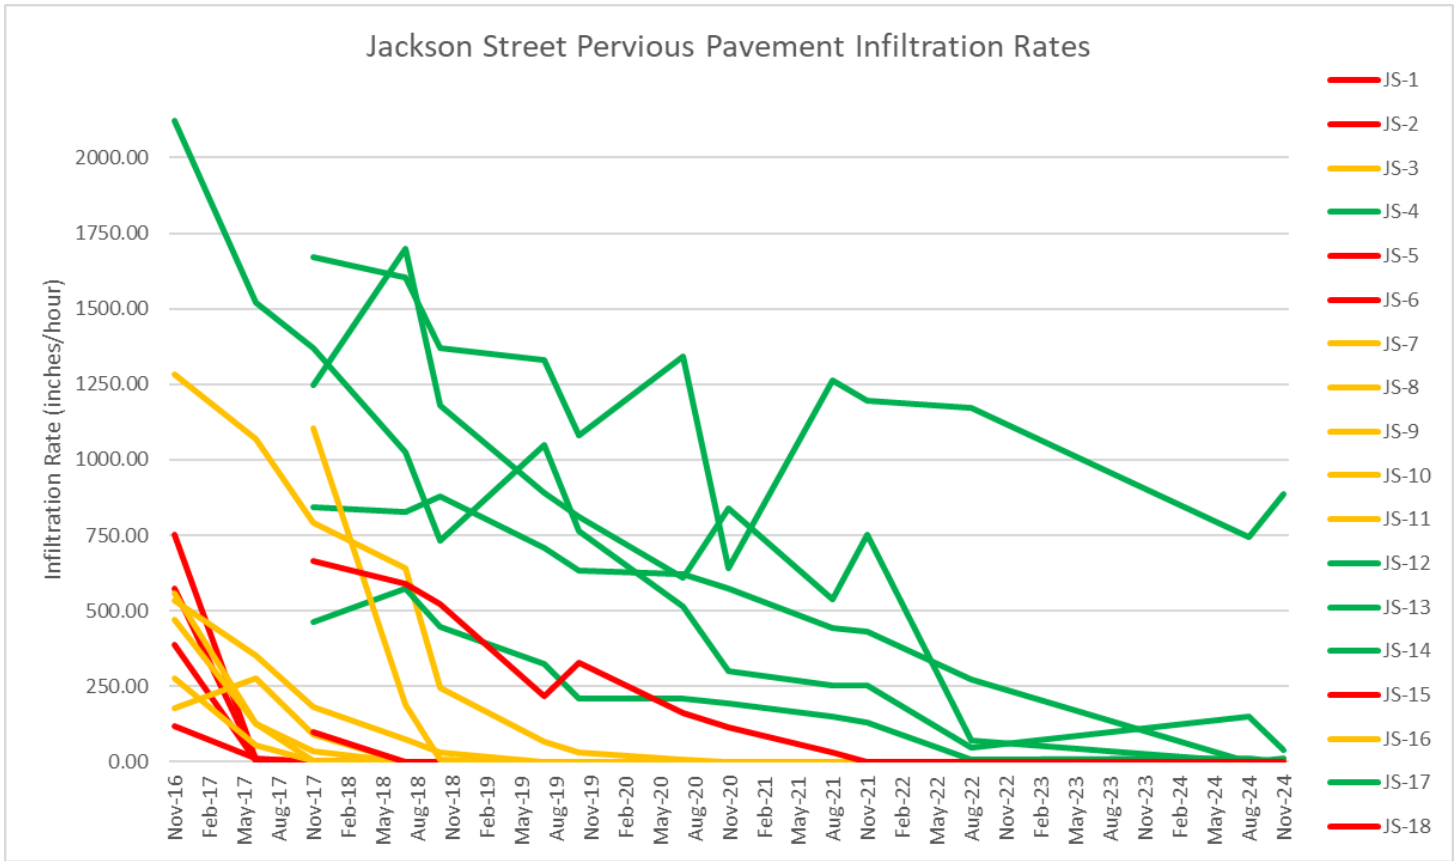
Chart 11-1: Jackson Street Infiltration Rate Summary (in/hr)

The site was tested for infiltration in August 2023. The infiltration test results from the 18 locations are summarized in **Chart 11-1** and **Chart D.2** in **Appendix D**, which includes all infiltration test results completed to-date. **Table 11-3** is color coded to identify the site traffic characterizations described above. The infiltration tests results are also summarized in **Table 11-3**, which presents an average infiltration rate based on the monitoring location traffic characterization. The infiltration test locations are depicted on **Figure 11-2**.

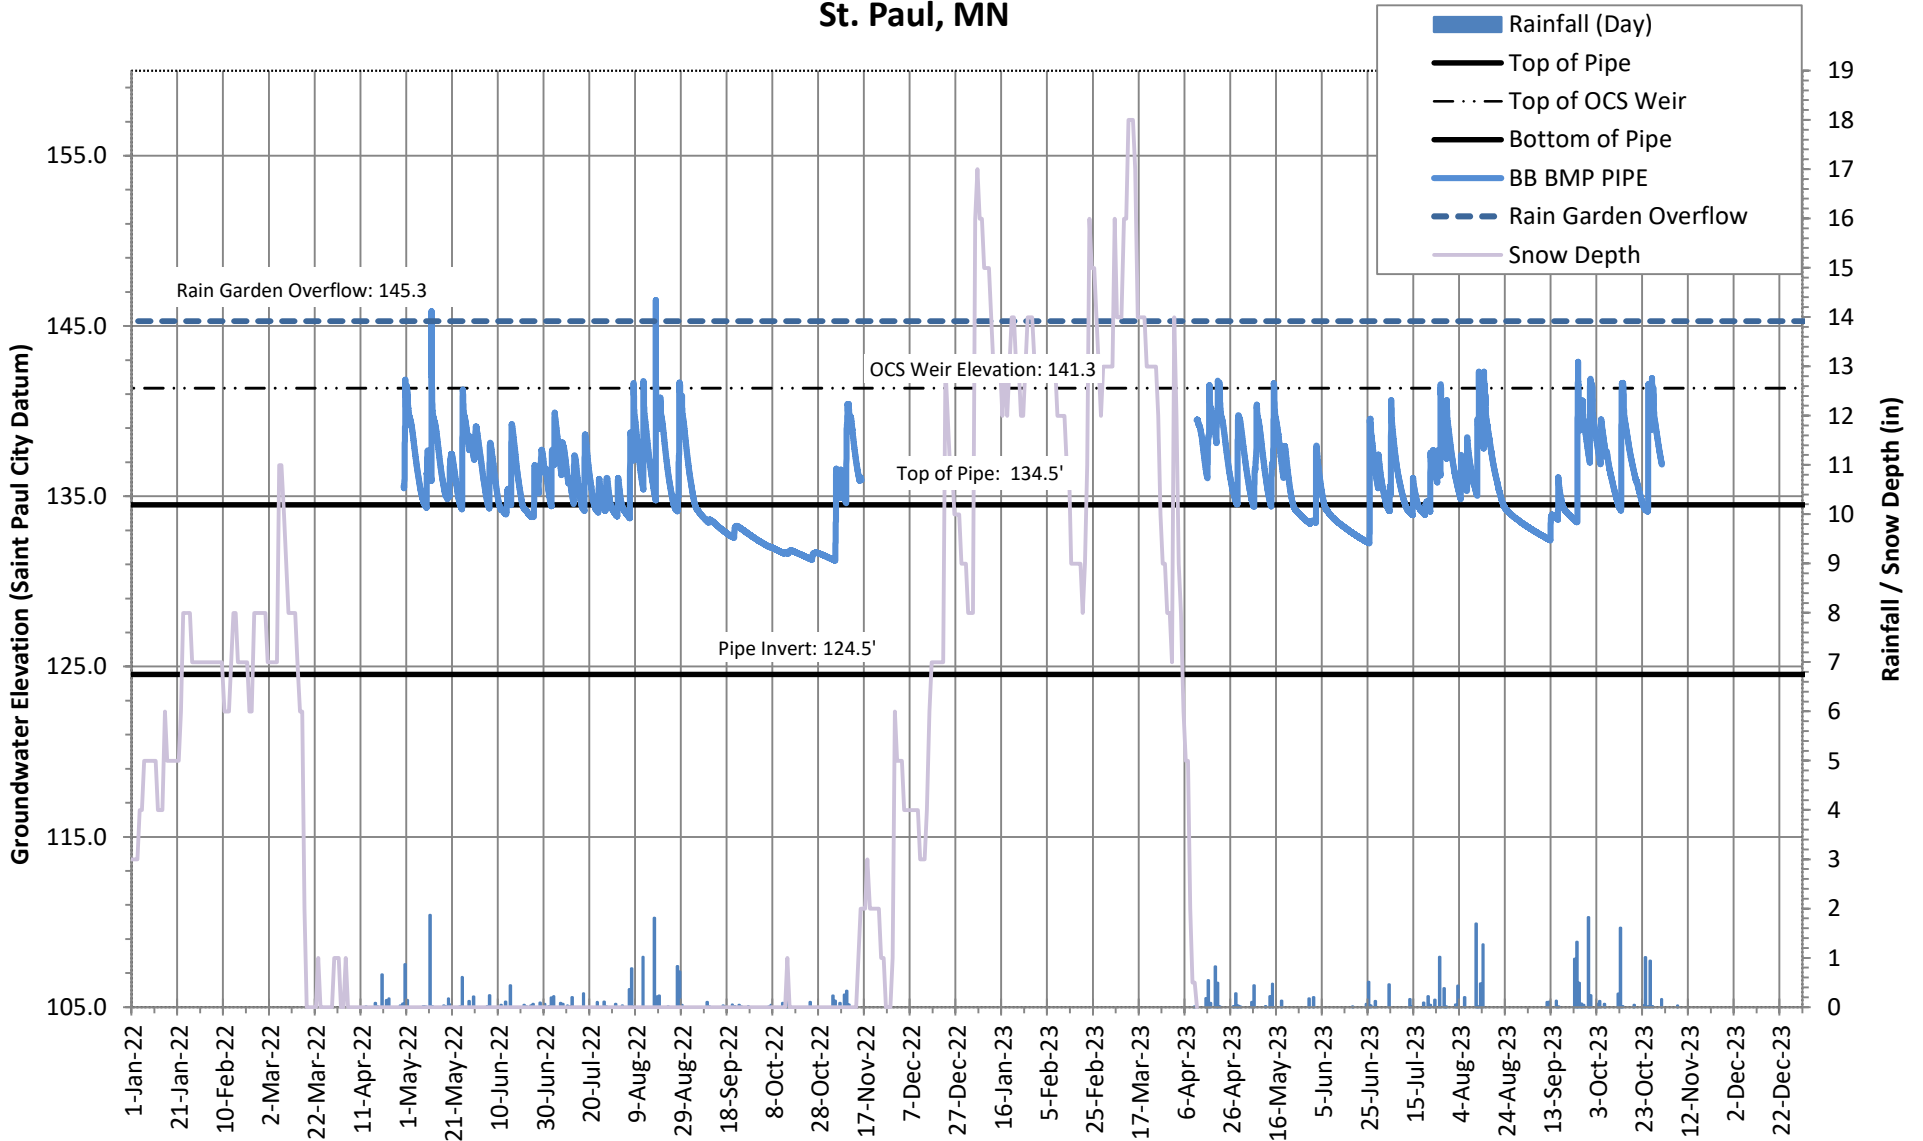
Beacon Bluff Underground System - Infiltration Rate Graph (BMP Pipe)

The water level in the underground system ranged from 7.6 ft to 18.3 ft deep. Depths greater than 10 feet indicate the water is rising into the substrate above the 10-ft diameter corrugated metal infiltration pipes. The data indicates that the system did not drain to empty during the 2023 monitoring period, including over the winter months. The underground system discharged back to the storm sewer (system outflow) during 8 storm events in 2023. Discharge events occurred in 2015 (five), 2016 (nine), 2017 (ten) 2018 (fourteen), 2019 (fifteen), 2020 (seven), 2021 (nine), and 2022 (6). Groundwater elevations at the site were a minimum of 11 ft below the bottom of the underground chamber, which suggests that groundwater mounding is not the cause of standing water in the system.

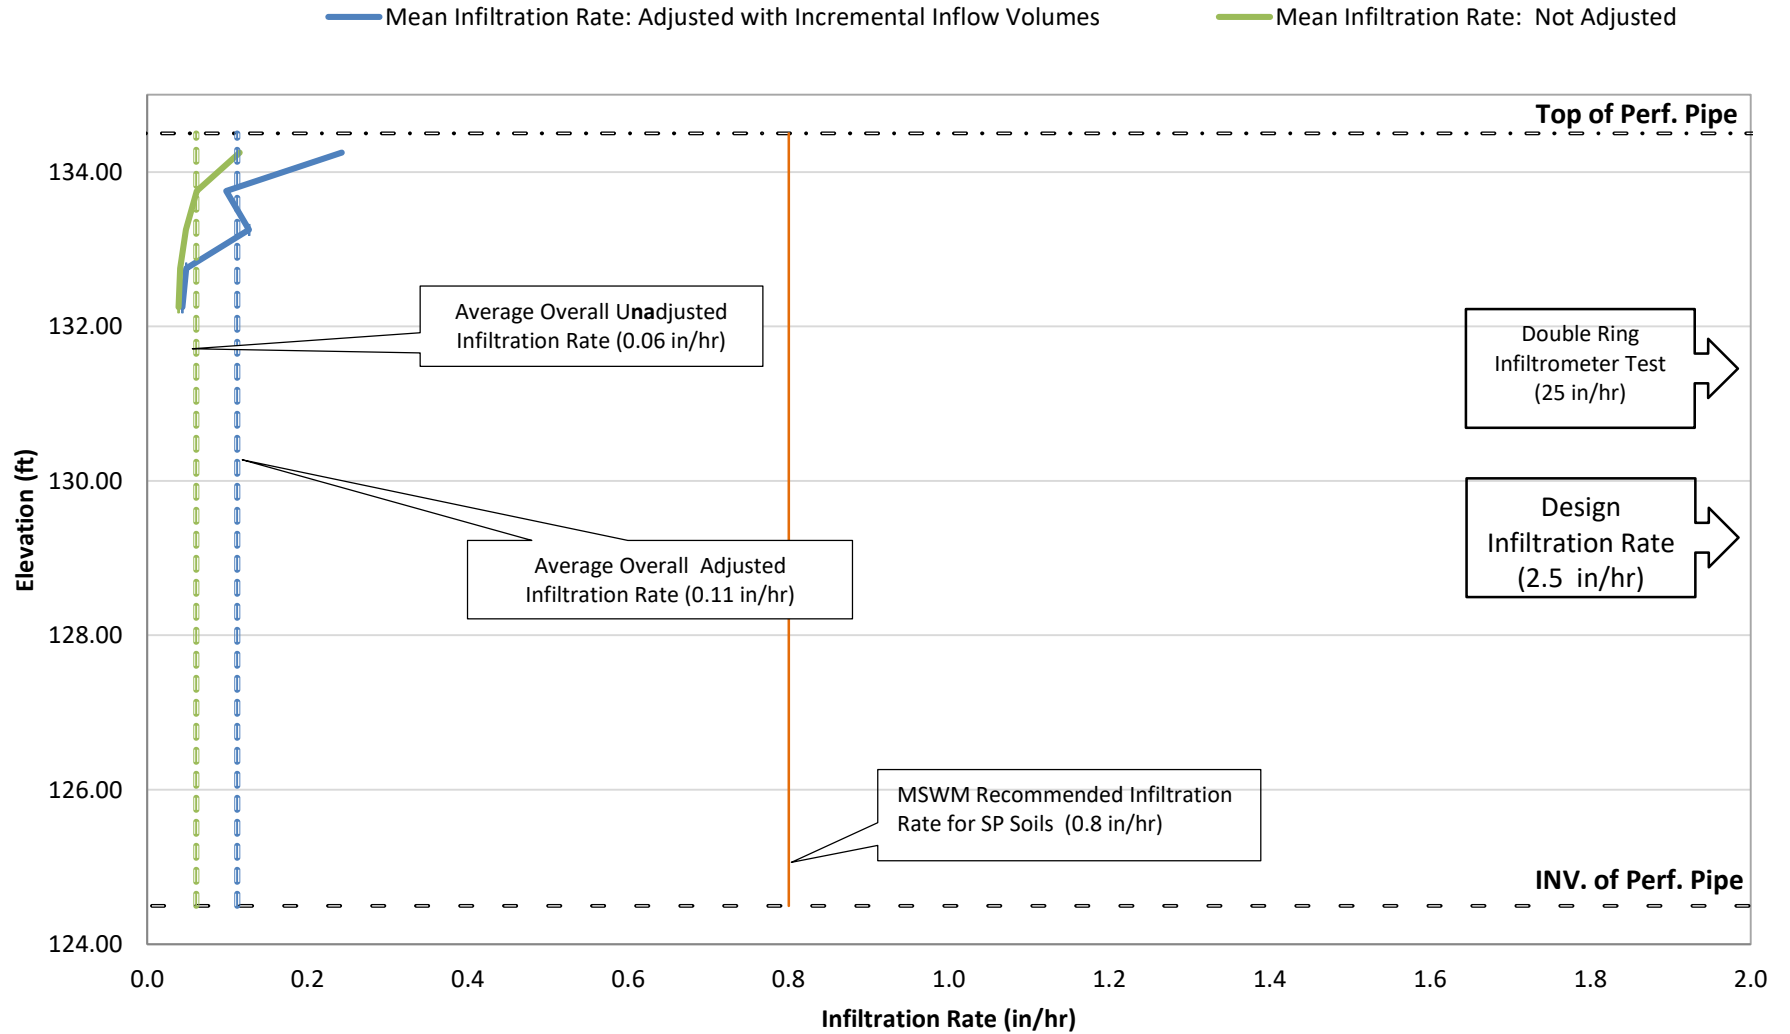
Infiltration Rate Trends Beacon Bluff Underground System Adjusted with Incremental Inflow Volumes

The 2023 underground chamber infiltration rate trends are provided on **Chart A.4** of **Appendix A**. From 2012 to 2023, the infiltration rate has decreased from 2.55 in/hr to 0.11 in/hr, with the largest decline following the first year of monitoring in 2012. As mentioned above, standing water in the underground system has resulted in a decrease in infiltration rates.

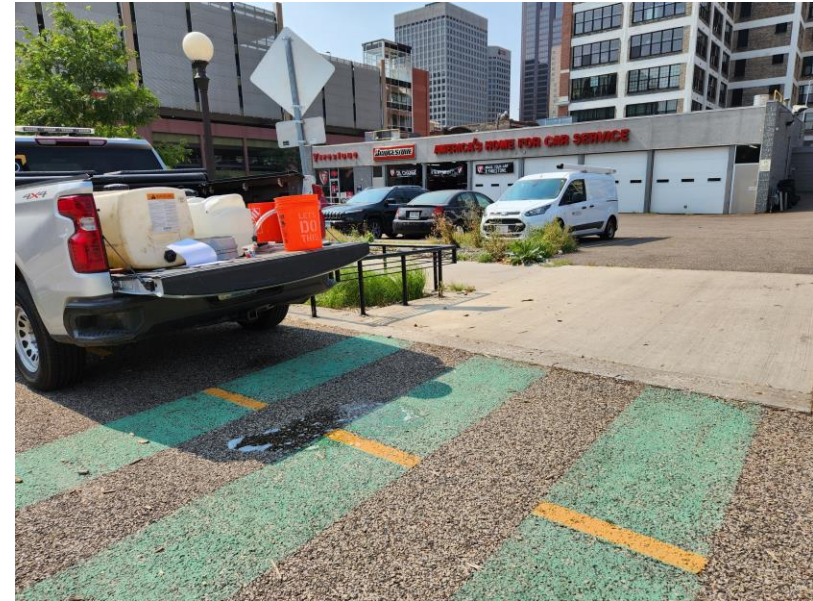
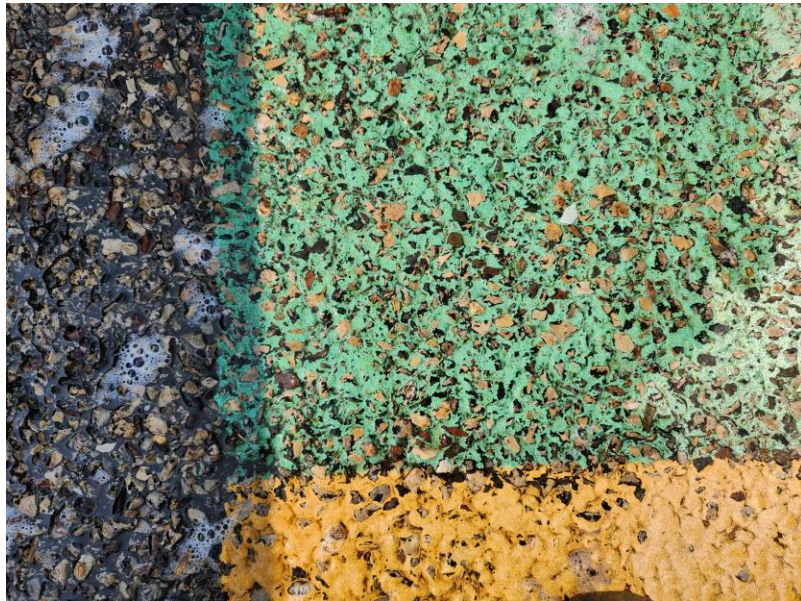
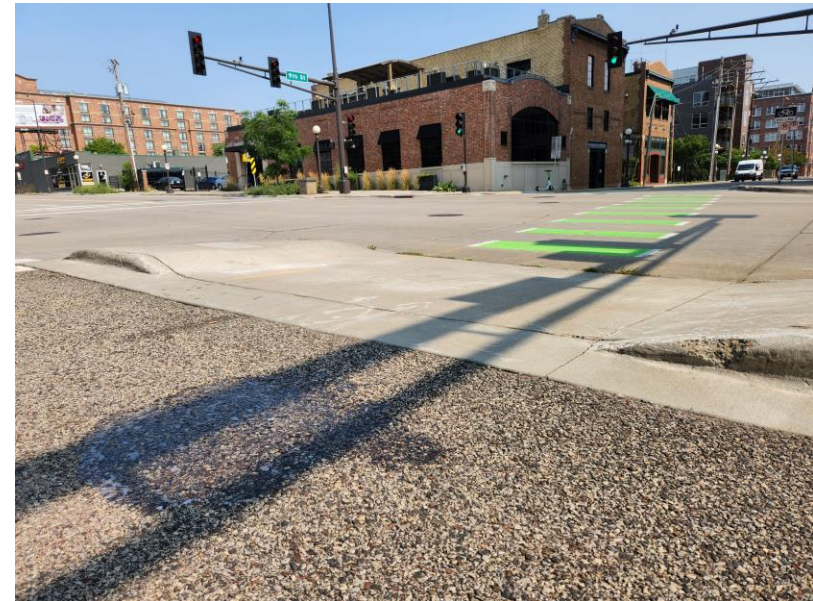
Pervious Pavement Testing – 8/29/23

Infiltration testing was conducted at the Victoria Street permeable pavers and Jackson Street pervious asphalt in 2023. The Victoria Street 2023 average infiltration rate of 3.0 in/hr and is less than 2% of post-construction monitored infiltration rate.

The August 2023 infiltration rate at the Jackson Street Site was 50.3 in/hr, which is 7.6% of the infiltration rate observed during the first year of monitoring (2016). Low traffic areas were observed to have a significantly greater infiltration rates on average (180.9 in/hr) than medium traffic (0 in/hr) and high traffic (0 in/hr) areas.
