2016 Water Quality & Quantity Monitoring Program

Monitoring Report

June 2017

**PREPARED BY:
WSB & ASSOCIATES, INC.
701 XENIA AVENUE SOUTH, SUITE 300
MINNEAPOLIS, MN 55416**

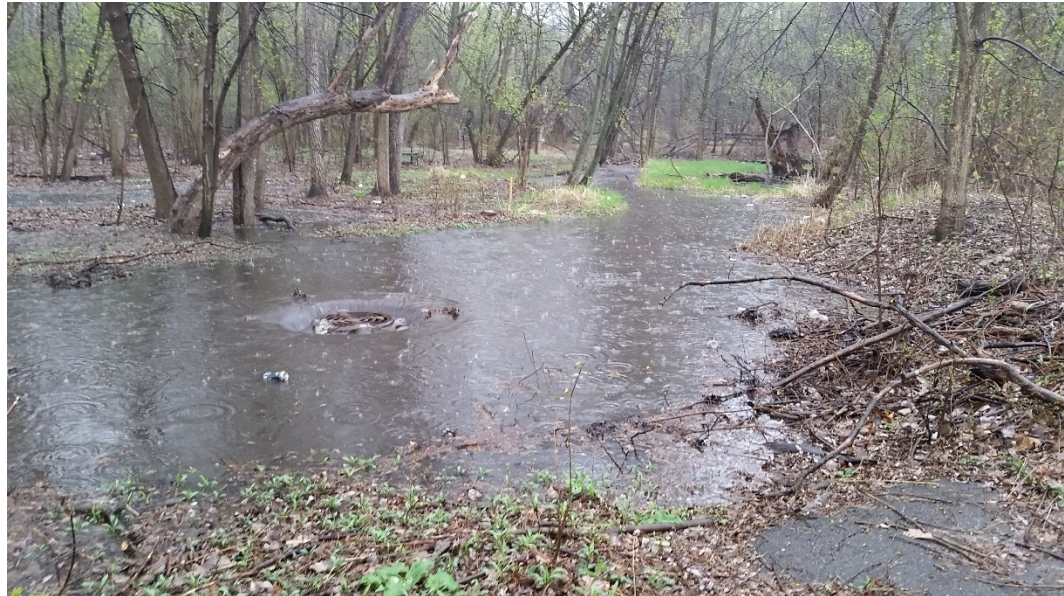
In 2016, water levels in the pond ranged from 191.6 ft SPCD on July 8, 2016 to 195.6 ft SPCD on August 4, 2016. The maximum level occurred as a result of 1.82 inches of rain on August 4, which increased the level by 3.6 ft to a depth of 1.6 ft above the outlet control structure. Nine rain events ranging from 0.18 inches to 3.09 inches resulted in water level elevations that exceeded the top of the outlet control structure. Water levels exceeded the top of the outlet control structure on eight occasions in 2016. Following those events, the level decreased to below the top of the outlet control structure within 6 hours.

Photo 9-2: Sackett Park Pond outlet control structure – runoff exceeds channel bank and enters flood plain.

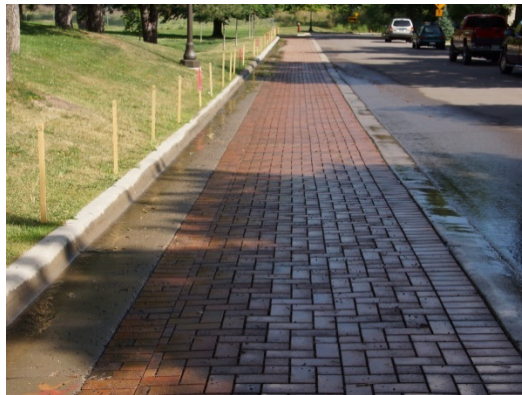
Photo 13-1: Victoria Street pavers

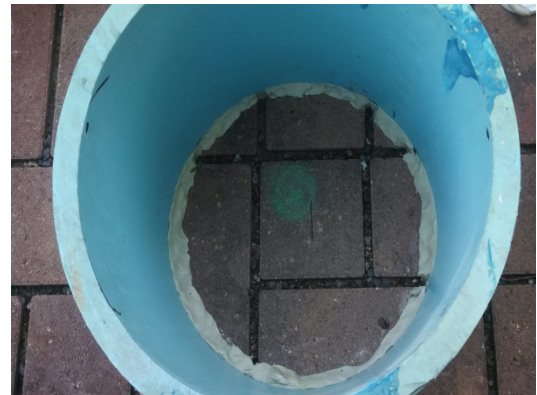
Photo 13-2: Victoria Street infiltration testing

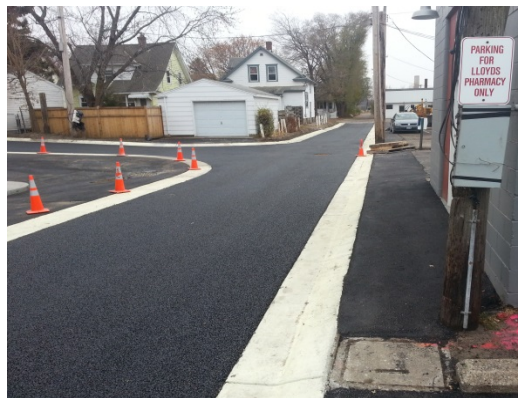
Photo 13-3: Hamline Midway Library porous asphalt (post-construction)

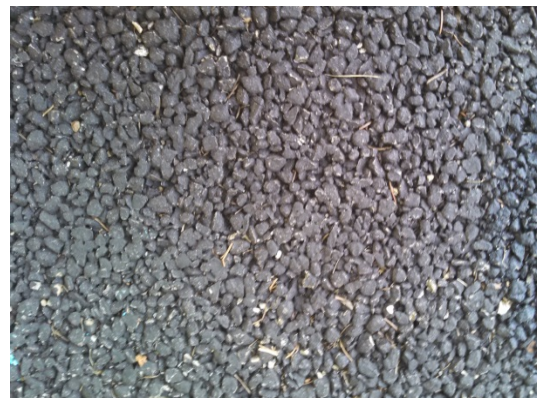
Photo-13-4: Hamline Midway Library porous asphalt

The Hamline Midway Library pervious surface consists of 920 square yards of porous asphalt within the two alleyways adjacent to the Hamline Midway Library and the center alleyway connecting the sections (**Photos 13-3** and **13-4**). The asphalt content of the mix is 6.3 percent and the specific voids ratio is 18 percent. The asphalt was installed in 2012 and infiltration rate monitoring has been completed annually since 2013. The site and the infiltration test locations are provided on **Figure 13-2**.

Significant sediment accumulation has been observed in the alleyway, specifically along the western pavement section. The condition and lack of surface lot maintenance of the adjacent properties in that area is believed to be a major factor in sediment loading to the pavement. In contrast, the eastern alley does not see significant contributions from adjacent properties. This is evident when comparing infiltration rates between the two sections. In 2014, the infiltration rate of the western section was 0.0 in/hr compared to 70 in/hr for the eastern section. It should also be noted that the City does not facilitate snow and ice control for the alley. This is typically contracted by adjacent properties owners, therefore the extent of salt and/or sand application to the alley is unknown.
