# 2017 Water Quality & Quantity Program

## Monitoring Report

April 2018

Project No. 01610-10

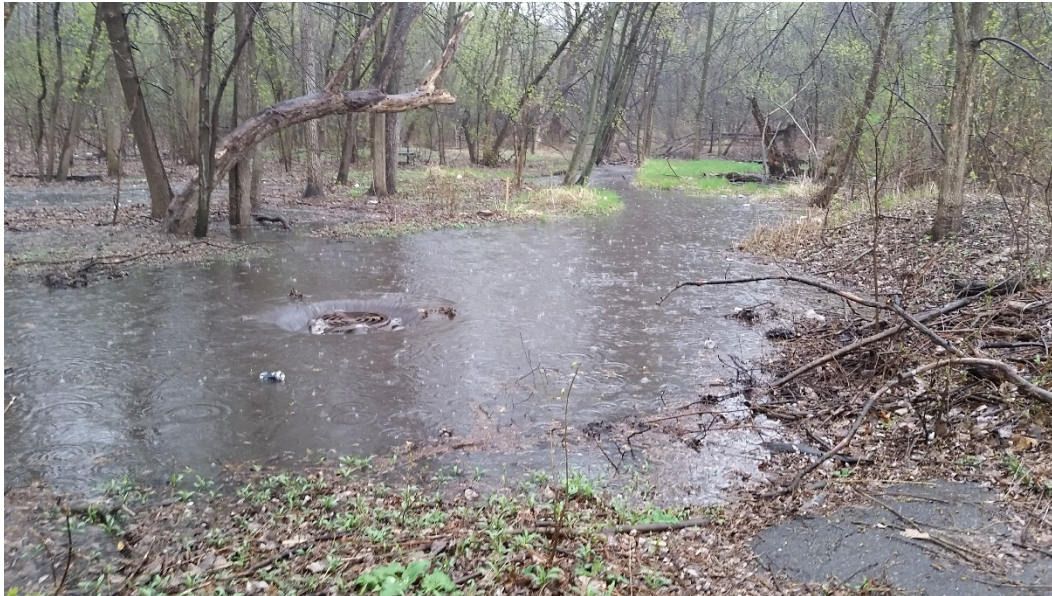
**Photo 10-2: Sackett Park Pond outlet control structure – runoff exceeds channel bank and enters flood plain (4/19/2017).**

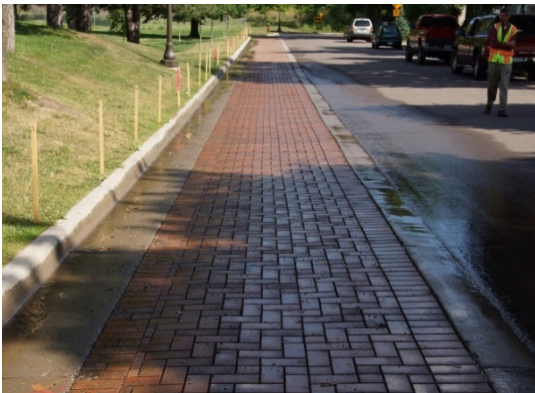
The Victoria Street pervious surface consists of a parking area completed with permeable concrete pavers designed to receive stormwater runoff from Victoria Street and the properties adjacent to it. The pavers themselves are non-permeable and they are separated with aggregate fill (**Photo 14-1** and **14-2**). The spaces between the pavers allow stormwater runoff to infiltrate into the parking surface instead of running off and being collected by the storm sewer system. The pavers were installed in 2011 and infiltration rates have been monitored annually since 2012. The site and the infiltration test locations are provided on **Figure 14-1**.

Photo 14-1: Victoria Street pavers

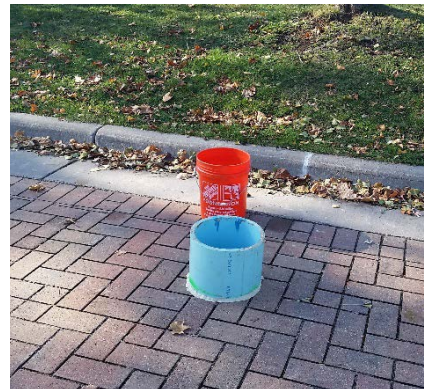
Photo 14-2: Victoria Street infiltration testing

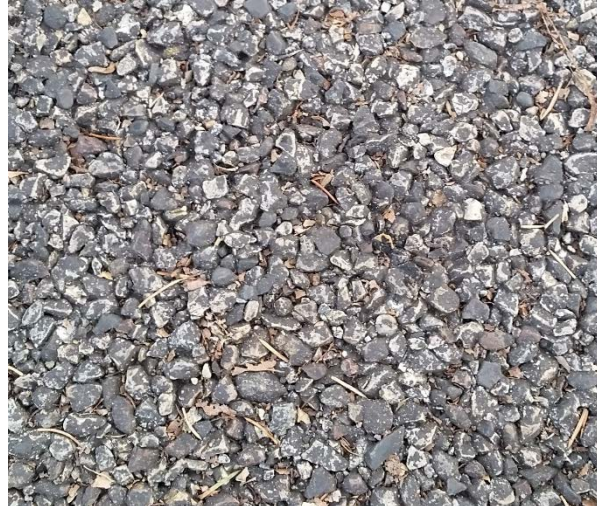
- The overall site infiltration rate decreased from 3.4 in/hr in 2016 to 2.6 in/hr in 2017
- No infiltration was observed at IR-1, IR-2, IR-3, IR-4 (**Photo 14-7**), IR-7, IR-8, and IR-9, which is consistent with testing completed in 2015 and 2016
- The 2017 infiltration rate is 1% of the post-construction rate monitored in 2013.
- Visual observations at the site indicate significant sediment accumulation and asphalt compaction, although locations IR-5 and IR-6 (**Photo 14-8**) were noticeably less affected

**Photo 14-8: IR-6, less compaction & silt**

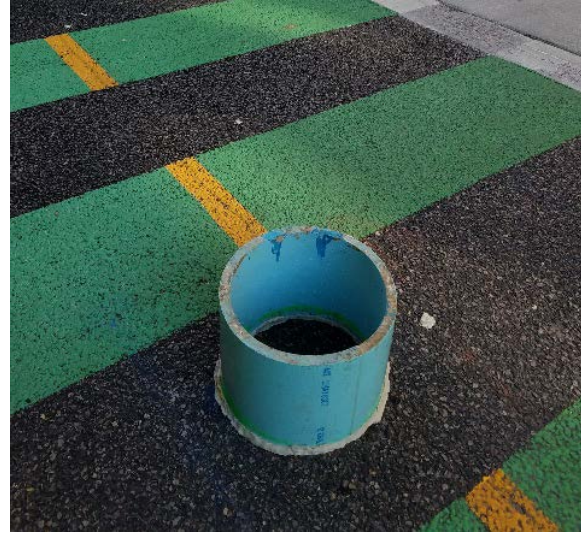
Photo 14-10: Jackson Street Infiltration Test
