**CITY OF SAINT PAUL
HERITAGE PRESERVATION COMMISSION STAFF REPORT**

FILE NAME: 26 Exchange Street

DATE OF PUBLIC HEARING: March 22, 2018

CLASSIFICATION: Restoration / Renovation

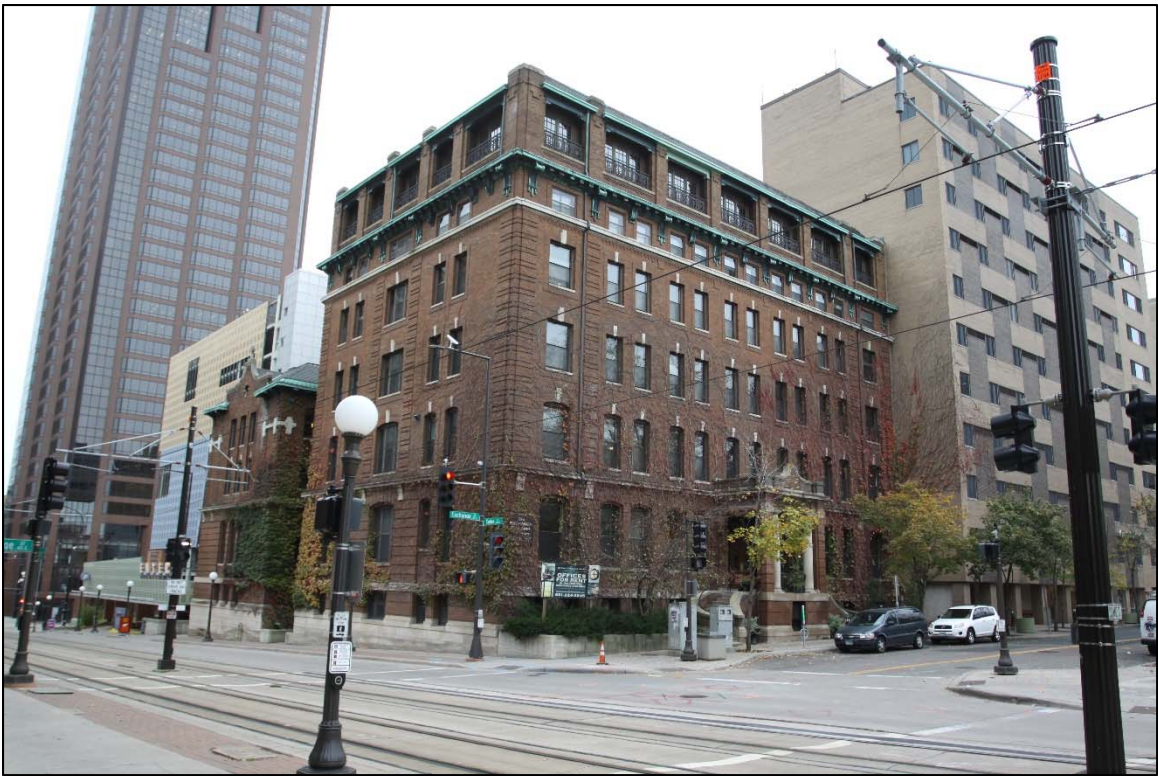
Photo 1 (November 1, 2017)

View: The north facade (right) and east facades (left) of the building; looking southeast

Description: View of the north and east facades of the Exchange Building; the north building is in the foreground, the south building is in the background

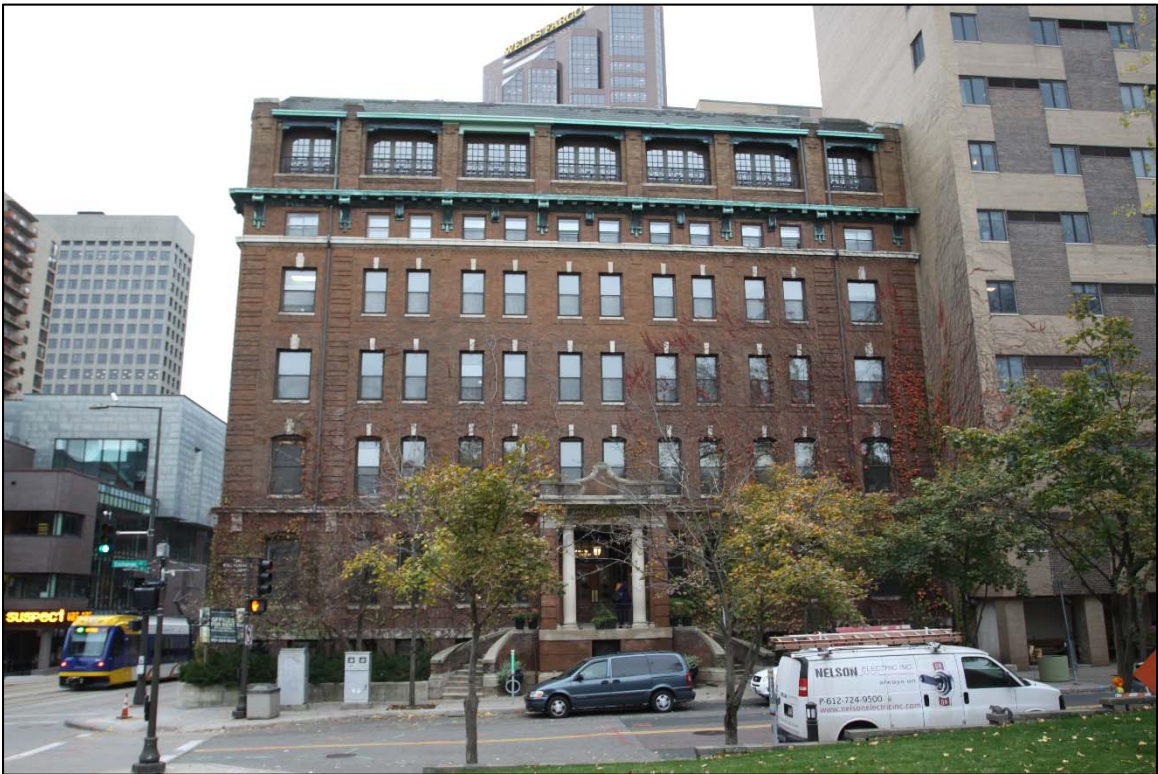
Photo 2 (November 1, 2017)

View: The north facade of the north building; looking south

Description: View of the north facade of the north building

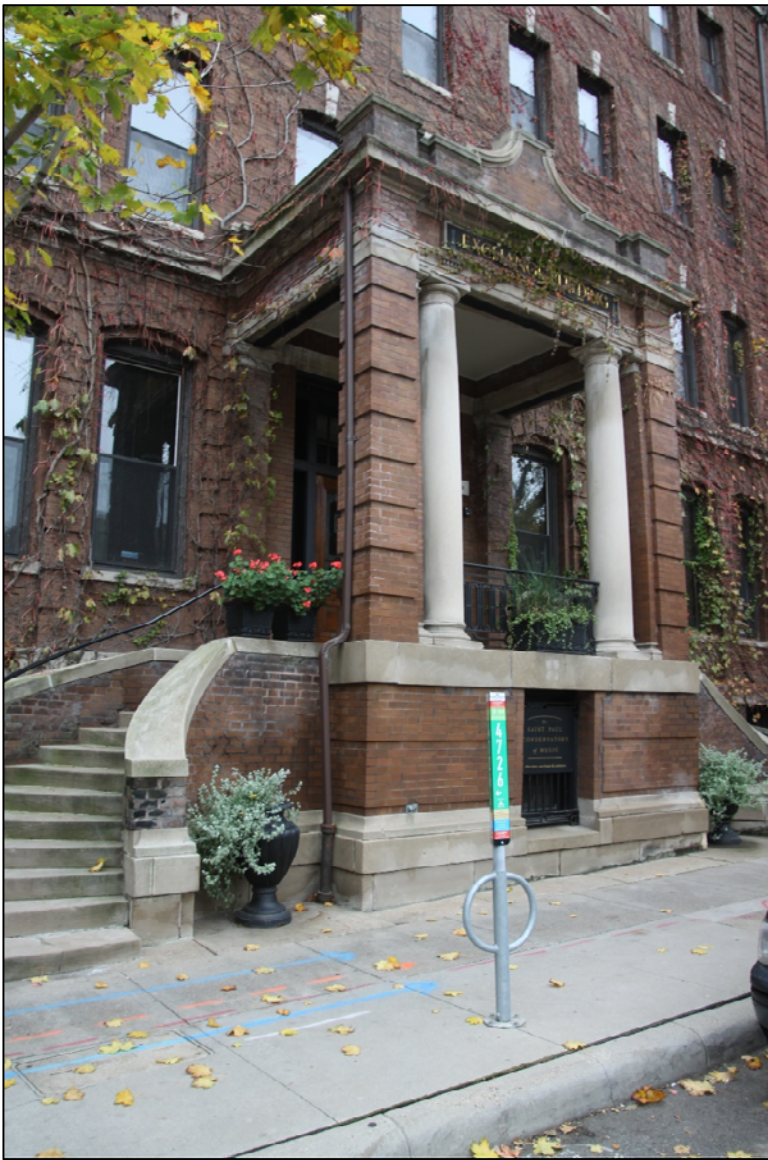
Photo 3 (November 1, 2017)

View: Entrance portico, north building, north facade; looking southwest

Description: View of the main entrance portico showing overall masonry conditions including discoloration at the parapet

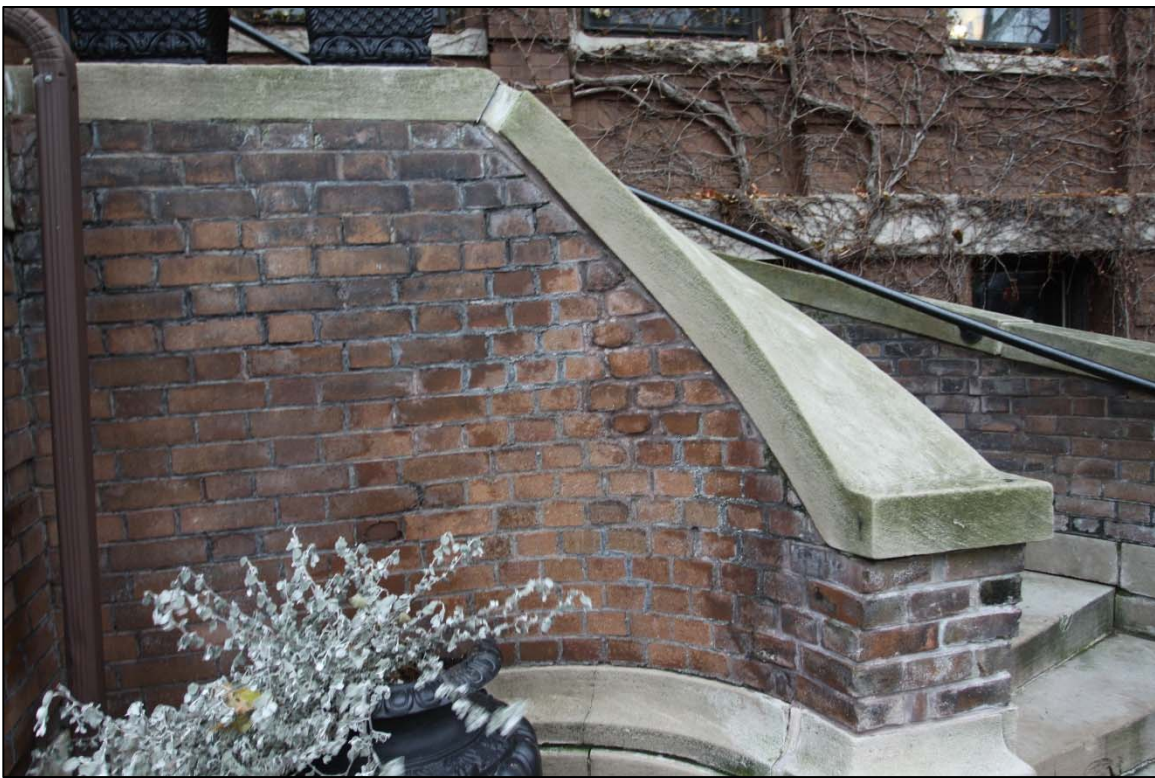
Photo 5 (November 15, 2017)

View: Entrance portico, west staircase; looking southwest

Description: View of the masonry conditions at the north entrance

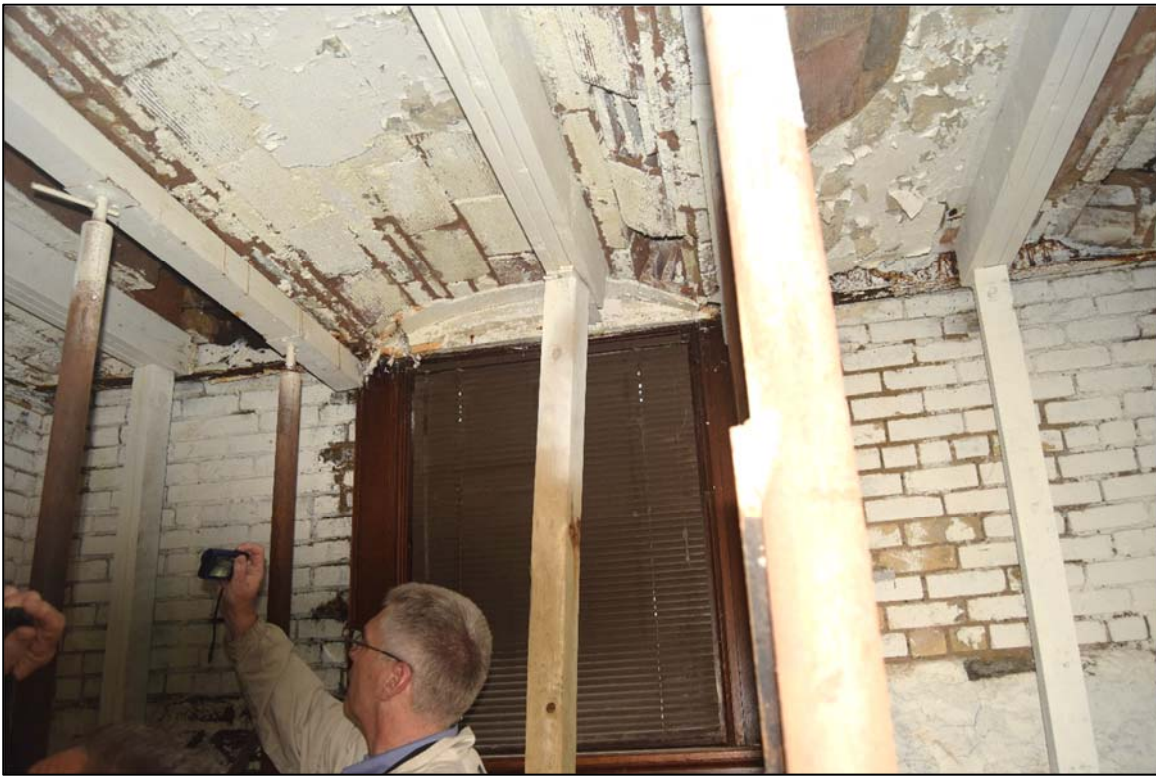
Photo 9 (November 15, 2017)

View: North Building, crawl space beneath portico; looking north

Description: View of the structure supporting the north entrance portico; the metal pole and wood posts were added to reinforce the failing concrete and clay-tile slab

- DEMOLISH PORTION OF EXISTING CLAY TILE REINFORCED CONCRETE ROOF/CEILING STRUCTURE UNDER PORTICO FOR STRUCTURAL REPAIR/RESTORATION - SEE STRUCT - PROTECT ALL OTHER ELEMENTS TO REMAIN INCLUDING BUT NOT LIMITED TO MASONRY AND STONE COLUMNS, ORNAMENTAL IRON RAILING, ORNAMENTAL STONE WORK, ETC.

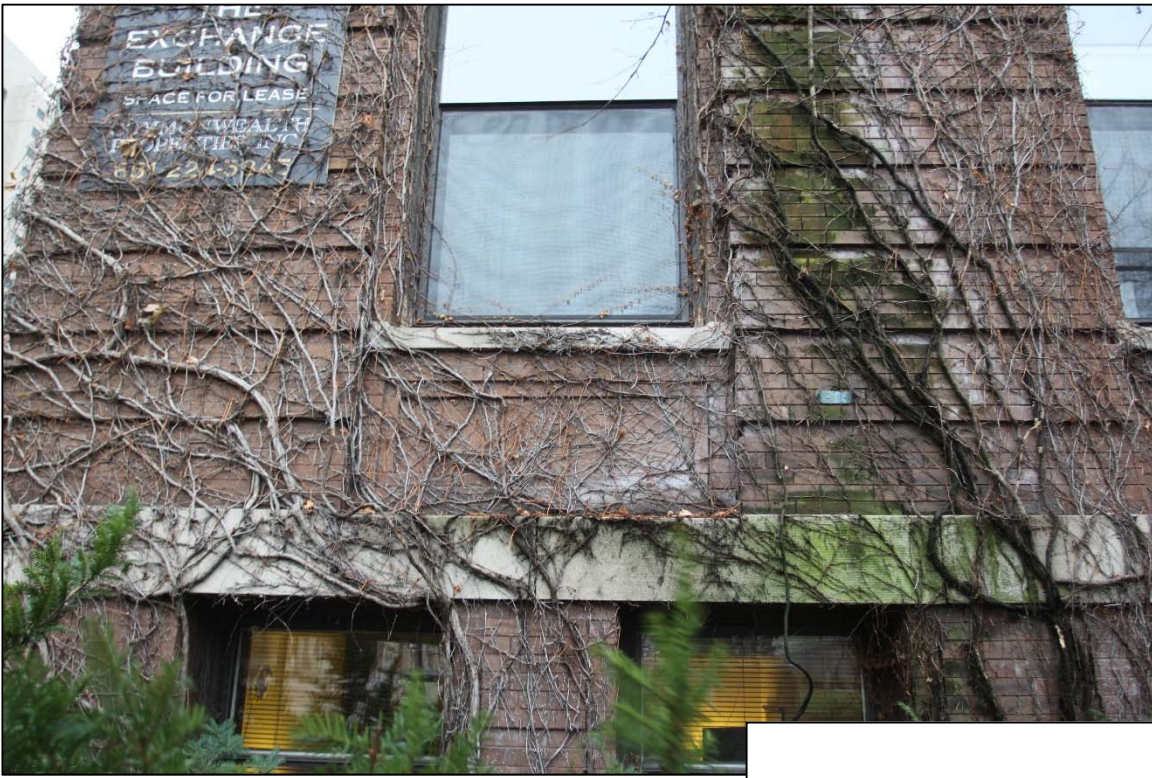
Photo 11 (November 15, 2017)

View: North building, north facade; looking south

Description: View of the masonry conditions on the exterior walls, including discoloration and efflorescence exacerbated by the ivy

- ALL SHUTDOWNS OF MECHANICAL, SPRINKLER, FIRE ALARM AND/OR ELECTRICAL SYSTEMS SHALL BE COORDINATED WITH OWNER AND LOCAL FIRE AUTHORITIES.
- REMOVE IN THEIR ENTIRETY ALL VINES AND PLANT MATERIAL FROM THE STRUCTURE. WORK SHALL BE PERFORMED IN THE GENTLEST MEANS POSSIBLE TO AVOID DAMAGE TO BUILDING MATERIALS.

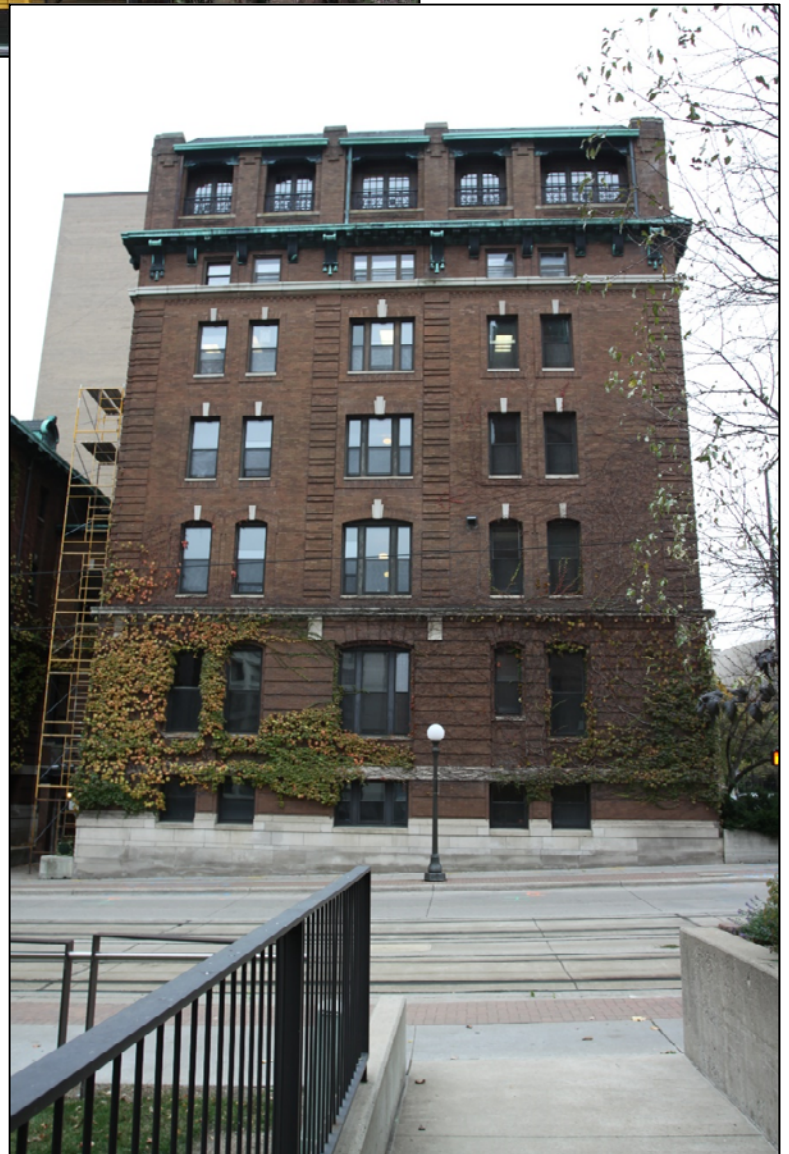
Photo 12 (November 1, 2017)

View: North building, east facade; looking west

Description: Overall view of the east wall of the north building

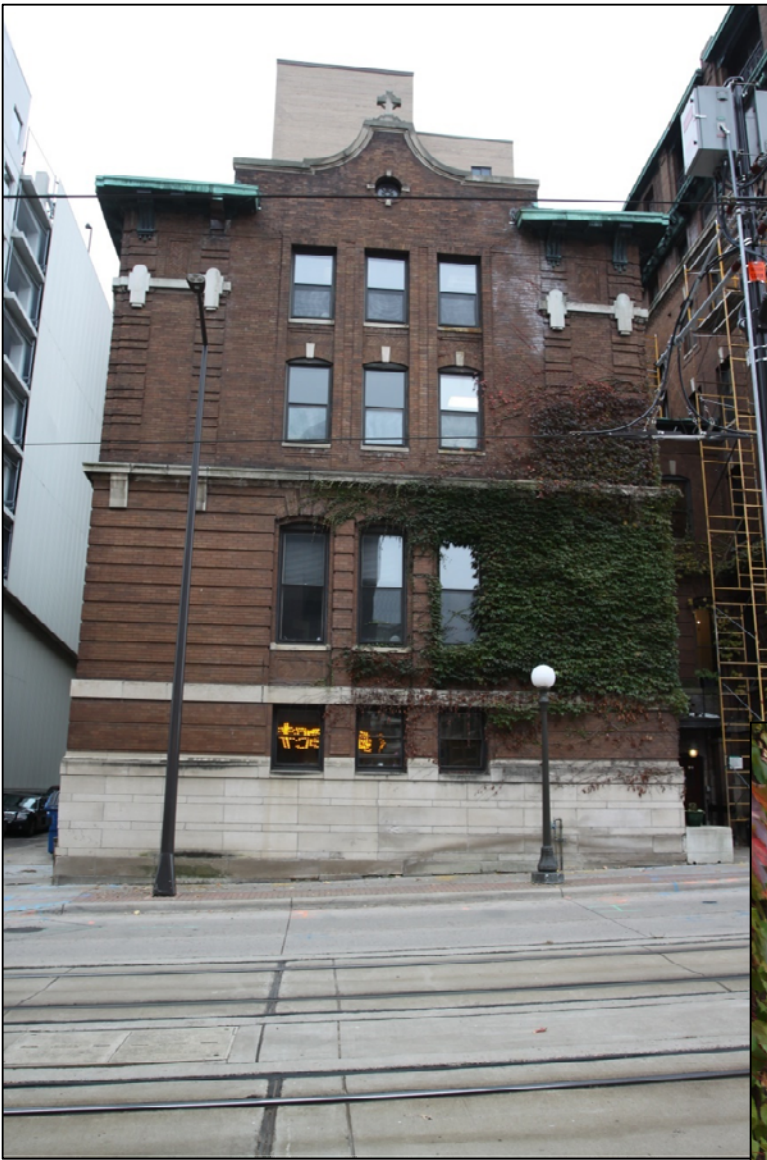
Photo 13 (November 1, 2017)

View: South building, east facade; looking west

Description: East facade of the south building

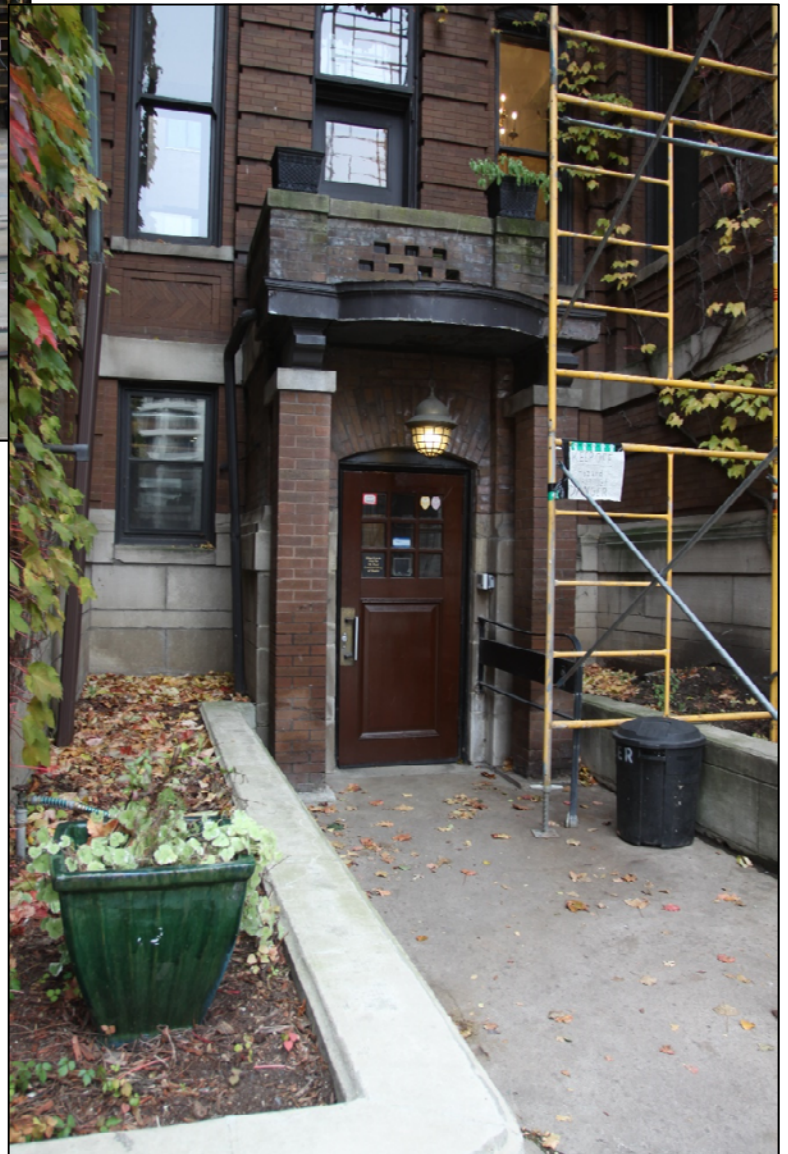
Photo 14 (November 1, 2017)

View: East entrance in link between the north and south buildings; looking northwest

Description: View of east entrance with balcony on top of the entryway; the north wall of the south building is on the far left and the south wall of the north building is on the far right

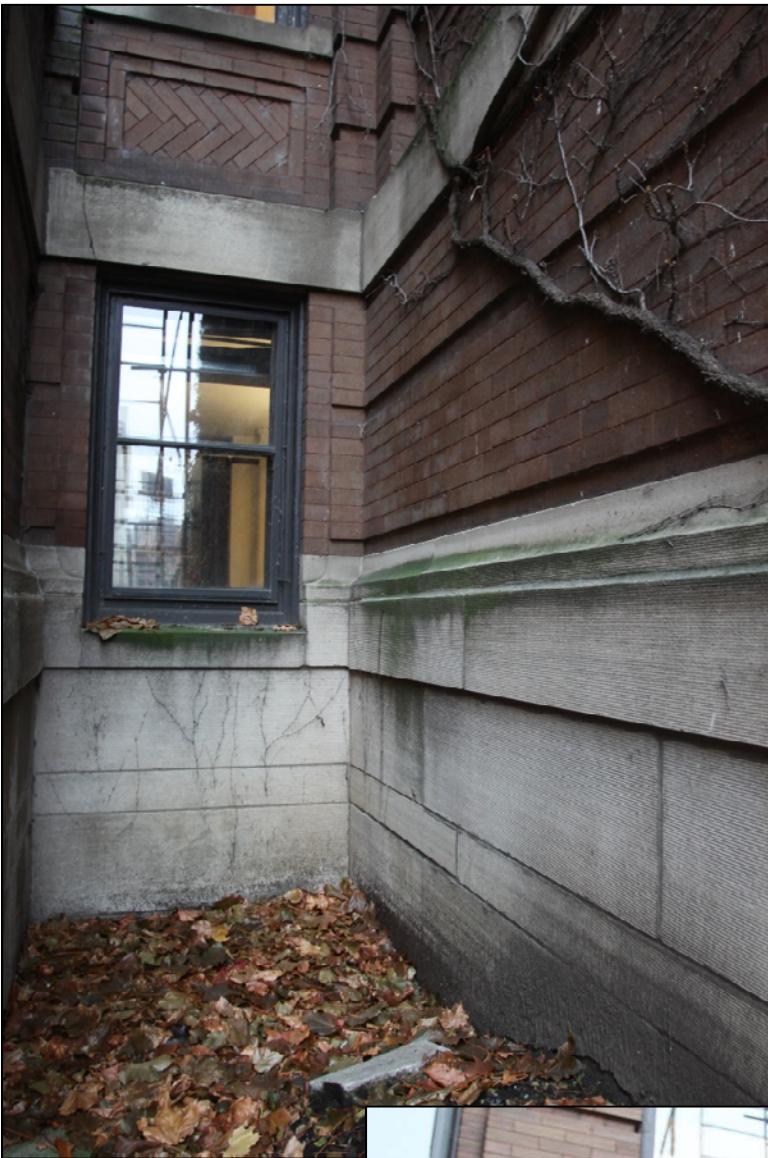
Photo 15 (November 15, 2017)

View: East entrance in link between buildings; looking northwest

Description: Detail of masonry conditions surrounding the east entrance; the south wall of the north building is on the right and the east wall of the link is on the left; discoloration of the stone foundation is typical of the entire building

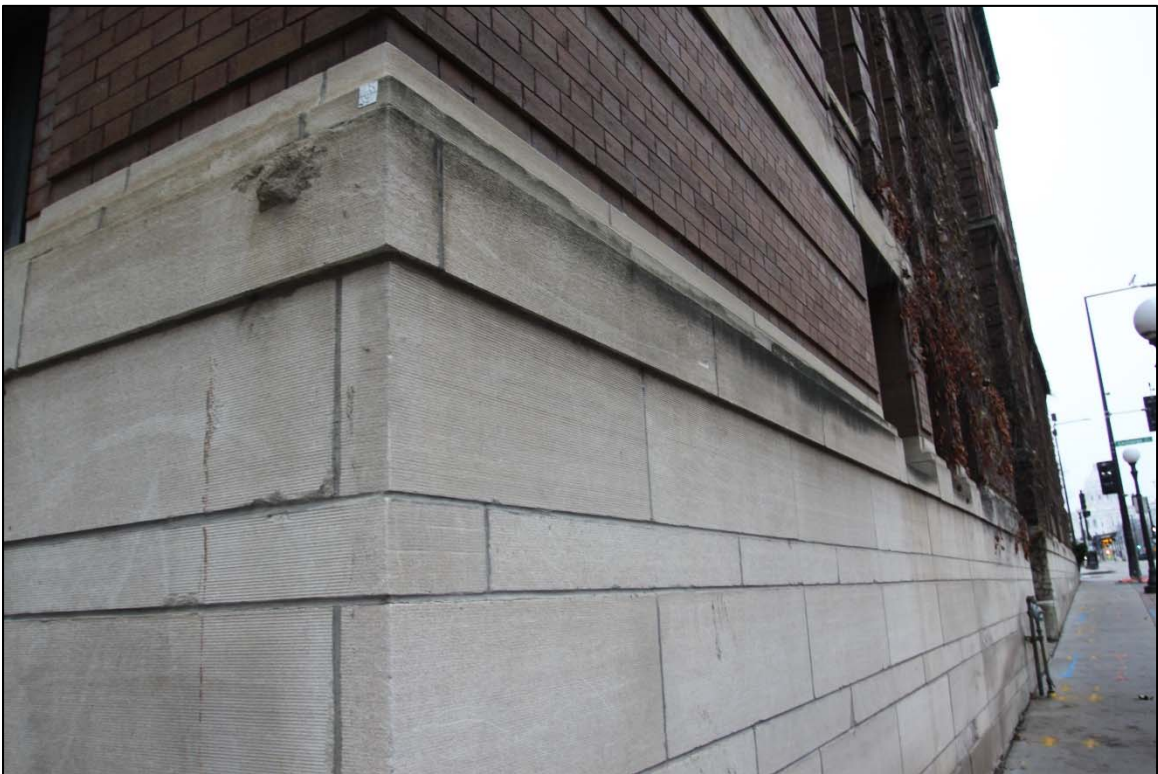
Photo 18 (November 15, 2017)

View: Southeast corner of south building; looking northwest

Description: View of staining on exposed stone foundation; condition is typical of building

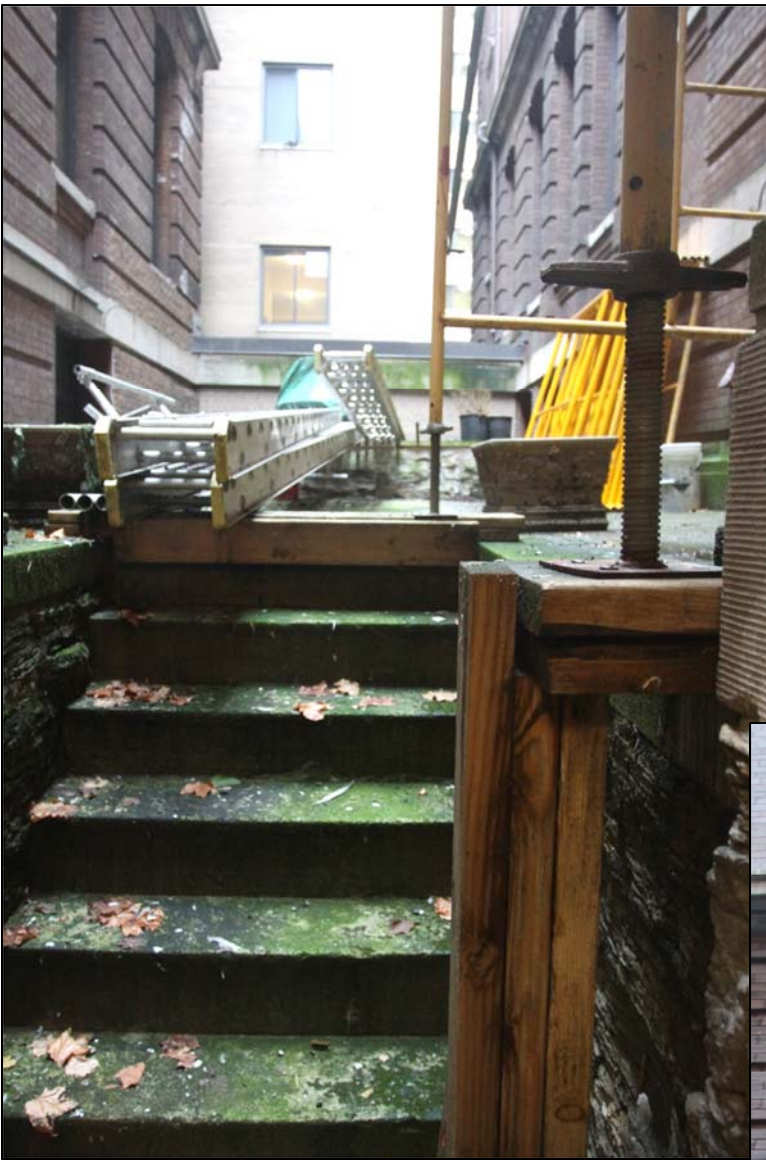
Photo 23 (November 15, 2017)

View: Courtyard; looking west

Description: Detail of the masonry conditions at the courtyard staircase showing heavy lichen growth and discoloration
