RE: HUD Lead-Based Paint Inspection and Risk Assessment at the Single Family Residential Property, 914 Jessamine Avenue East, St. Paul, Minnesota (All Phase Phone: 651-436-2930)

At your request, Midwest Environmental Consulting, L.L.C. (MEC) performed a HUD lead-based paint inspection and risk assessment of the single family property located at 914 Jessamine Avenue East, St. Paul, Minnesota on January 21, 2012.

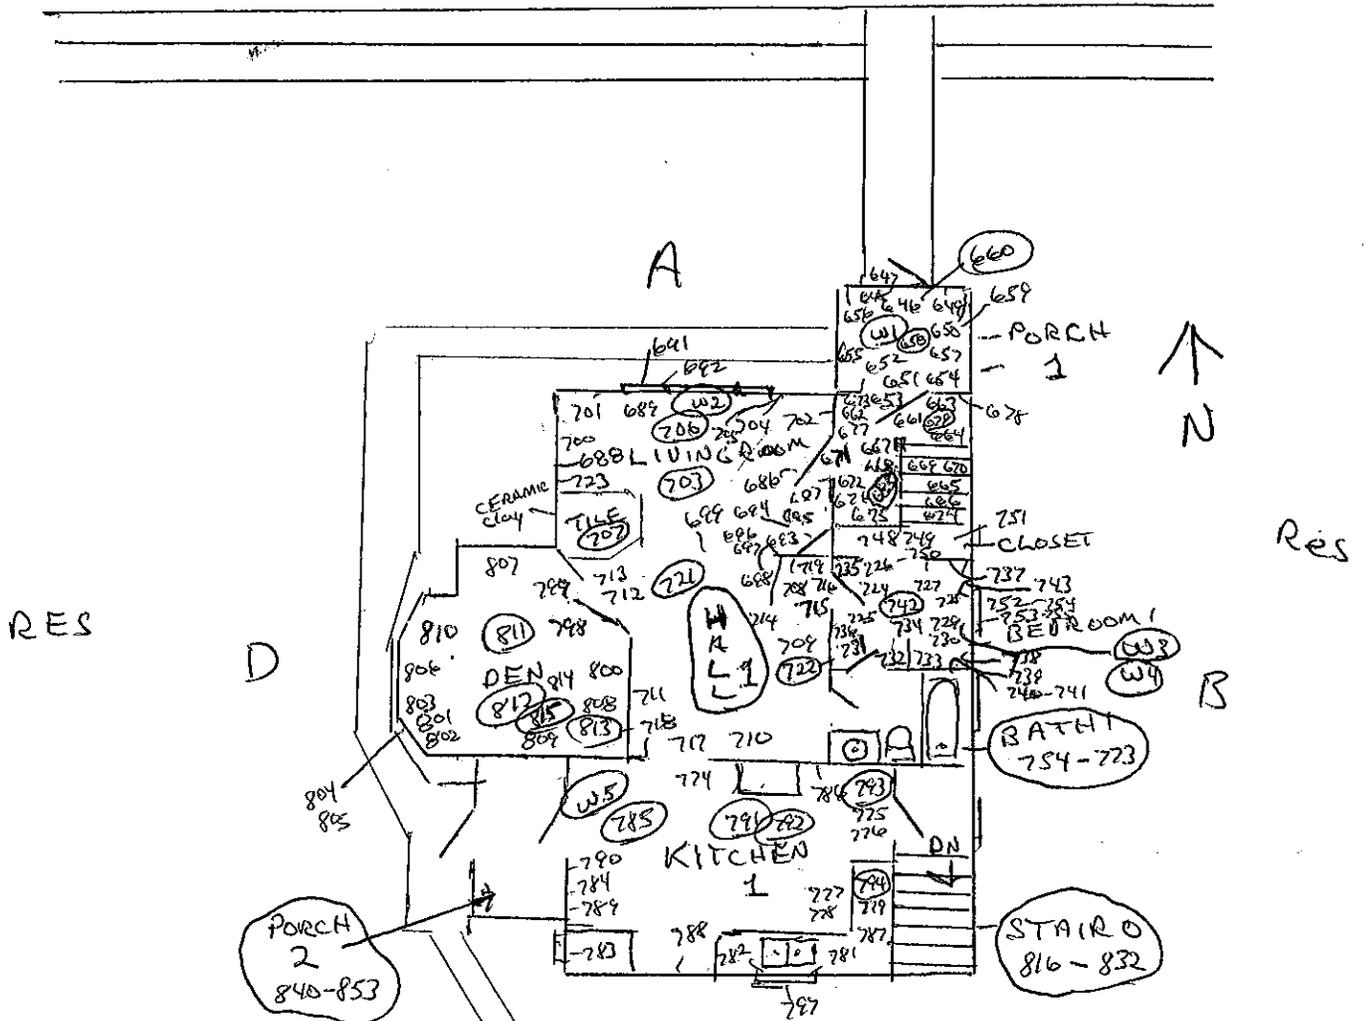
SITE PLAN
 FIRST FLOOR
 914 JESSAMINE AVENUE EAST
 ST. PAUL, MN
 SKETCH NOT TO SCALE
 DRAWN BY: GREG MYERS
 MIDWEST ENVIRONMENTAL
 CONSULTING
 DATE: 01/21/12
