Code Compliance Report

Re: 47 Douglas St
File#: 09 271450 VB2

47 DOUGLAS STREET

THE GALVIN-SHEAREN HOUSE, 1883

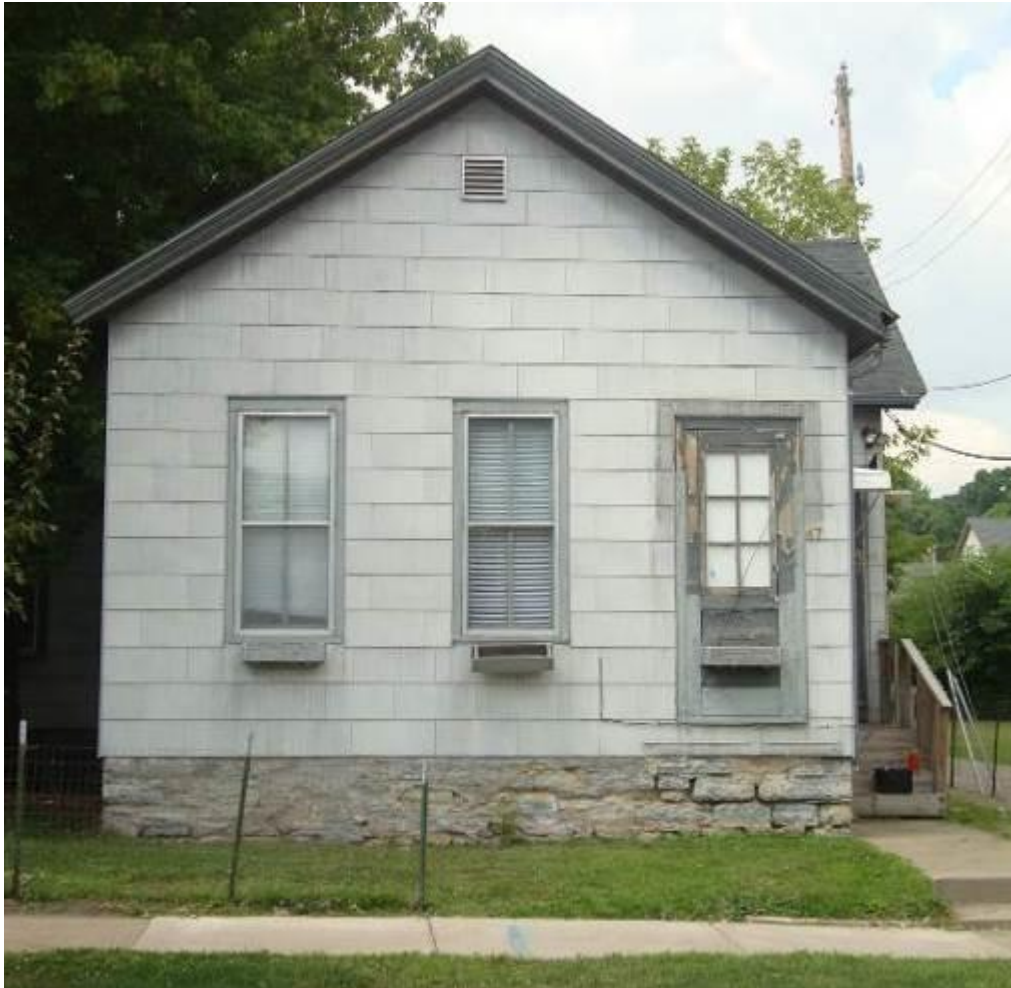
Category 2 Registered Vacant Building: 09/16/2009
Owner: City of Saint Paul/Housing and Redevelopment Authority
Developer: West 7th/Fort Road Federation, Phase II
