# Como Regional Park Stormwater BMPs Feasibility Study

Capitol Region Watershed District  
Saint Paul, MN

June 28, 2018

Report prepared by:  
Houston Engineering Inc.

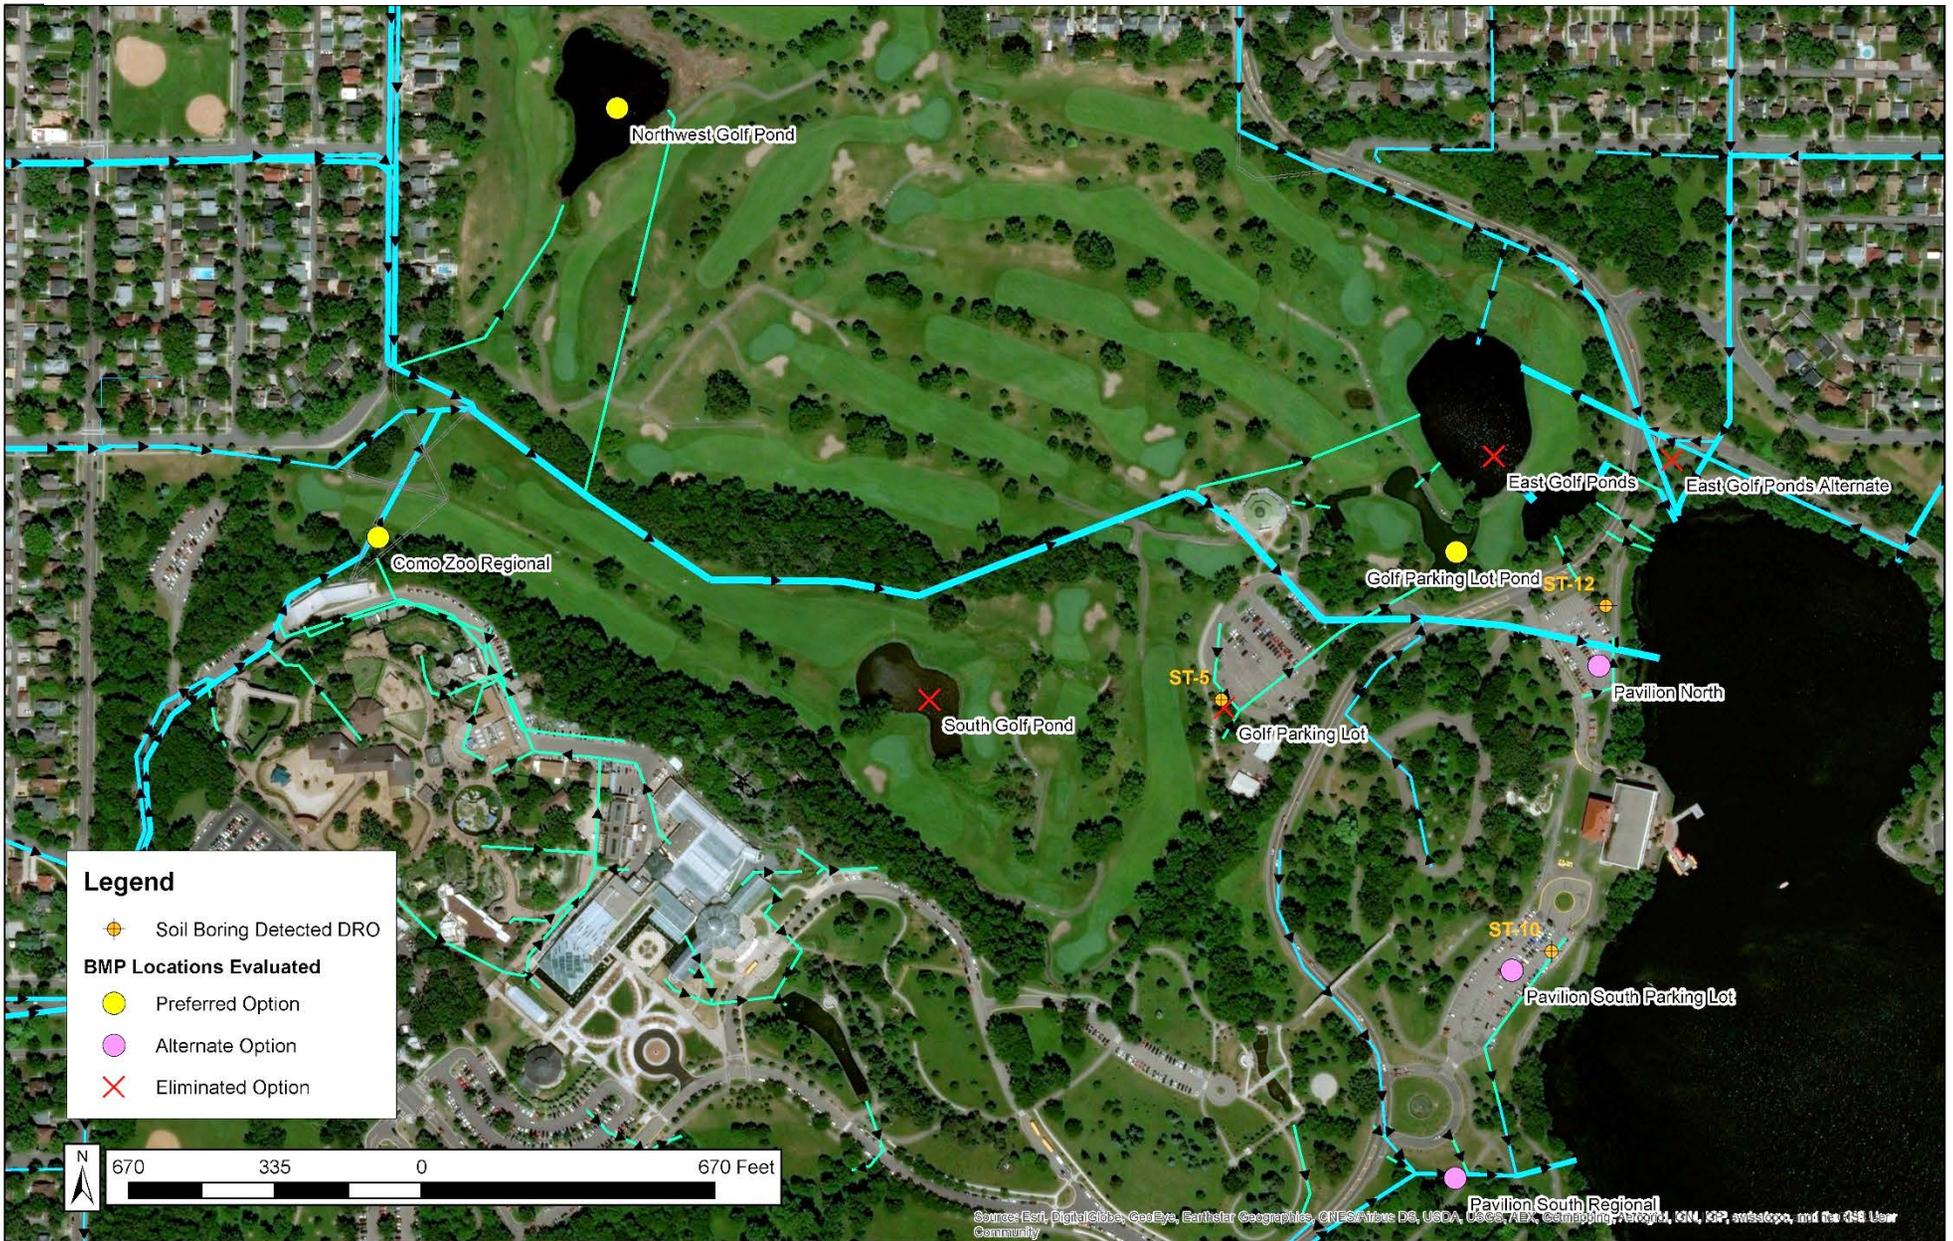
Figure 2 - Locations Selected for BMP Analysis with Stormsewer

Ten locations within Como Park were evaluated for placement of BMPs to treat stormwater. Subsequently, six of the ten locations were selected for feasibility analysis and concept BMP designs. See **Figure 2** for a map of these locations. Como Park has many advantages for stormwater management design at these locations. Multiple locations have existing ponds or are adjacent to collector stormsewer lines. Many of these locations were chosen for their location relative to anticipated park improvement projects so that the BMPs may be used to treat the upcoming projects. Priority was placed on the feasibility of designs that would collect and treat runoff from a larger, regional area.

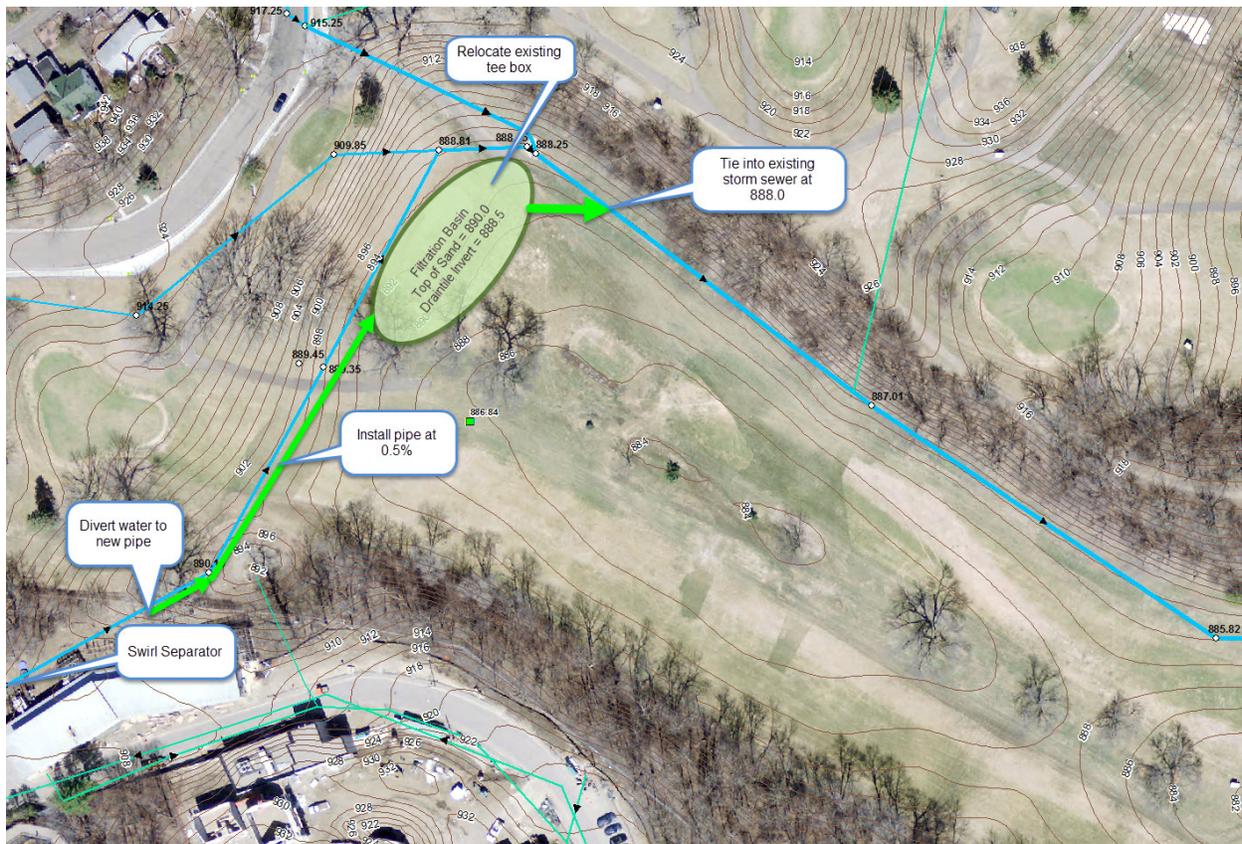
Figure 4 – Zoo 1 Filtration Basin

**Description** - Runoff could be diverted through a new, smaller stormsewer at a flatter grade to provide sufficient flow to the filtration BMP. Pretreatment could be provided by a hydrodynamic separator in an accessible, upstream manhole. **Figure 4** below shown the concept plan for this filtration basin.

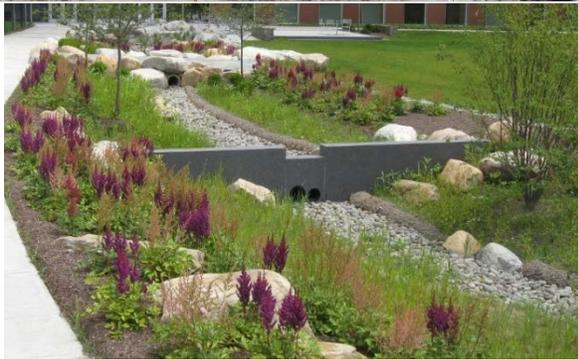
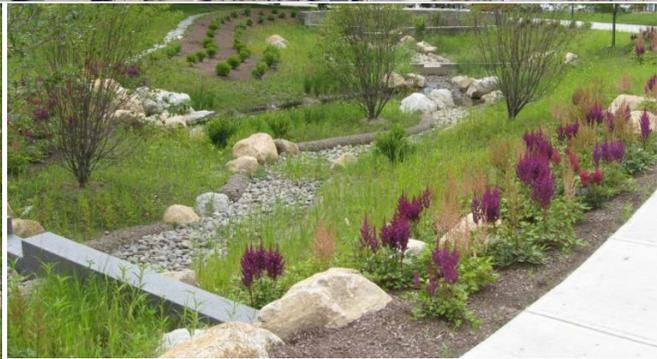
Figure 10 – Pavilion South Regional 2 – Recirculating Infiltrating Stream

**Description** - Runoff from the stormsewer to the southwest can be treated through a design consisting of 3 features outlined below. Each feature is sized to capture approximately one third of the 1.1” volume reduction goal for the purpose of this study.

**Storage Tank** – Runoff could first be captured by a large underground storage tank. Pretreatment would be provided in the storage tank, or, alternatively, by an upstream hydrodynamic separator for ease of maintenance. The underground storage would retain runoff that would then be pumped to the upstream end of the infiltrating stream (see below) and ‘recirculated’ through the meandering-infiltration stream or allowed to infiltrate via underground infiltration.

**Meandering-infiltrating stream** – An infiltration design consisting of an intermittent meandering stream, plantings, landscaping, weir structures to provide storage, and infiltration throughout the stream corridor (see example photo in **Figure 10**). A normally dry, rock stream bed would meander through the park at about two feet below the existing ground elevation. During rain events, stone weirs would store runoff in the ‘floodplain’ of the stream, and runoff would subsequently infiltrate. Runoff which would not infiltrate in the stream would overflow into a recirculation manhole, which would pump water to the upstream end of the stream. The cycle would continue until all of the runoff in the system is infiltrated. This would provide a water feature amenity as the stream bed would be flowing with water after the rain event is over. The benefits of this system is that it provides treatment for a greater volume of water, while providing an amenity to Como Park.

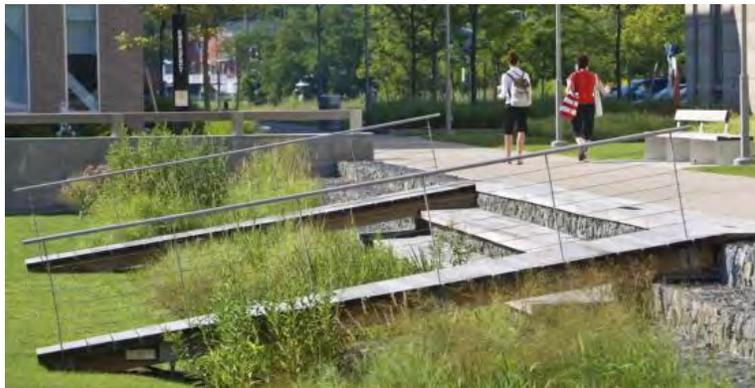
### 1) Infiltration swale and filtration basin for parking lot

- This concept BMP is a treatment train of a infiltration swale overflowing to a filtration basin. The parking lot would sheet flow to curb cuts that would lead to a bio-infiltration swale with terraced seating (see example photo below). Runoff that is not captured in the infiltration swale will overflow to a filtration basin.
- Option to include iron-enhanced filtration practices
- Option to include pervious pavers in parking lot

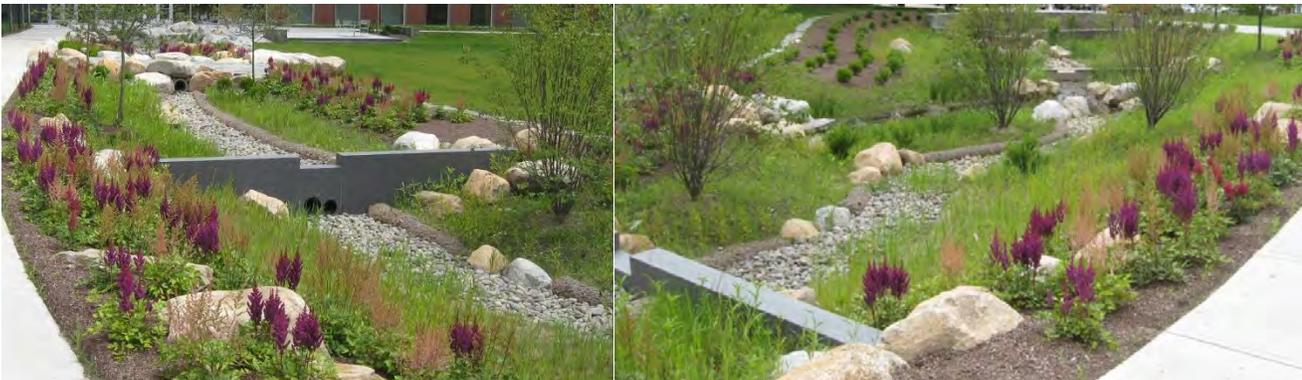
#### 4) Meandering infiltrating stream corridor with weirs

- a) **Infiltrating Stream** - Runoff from the storm sewer to the southwest can be treated through an infiltration design consisting of an intermittent stream, plantings, landscaping, weir structures to provide storage, and infiltration throughout the system (see example photo below). A normally dry, rock stream bed would meander through the park three to five feet below the existing ground elevation. During rain events, weirs or ditch checks would store runoff in the 'floodplain' of the stream, and runoff would subsequently infiltrate.
