Midwest
Environmental
Consulting, L.L.C.

RE: HUD Lead-Based Paint Inspection and Risk Assessment at the Duplex Multi-Family Residential Property, 700 - 4th Street East, St. Paul, Minnesota (All Phase Phone: 651-436-2930)

The purpose of this project was to determine whether lead-based paint or other lead hazards are present on the interior or exterior surfaces of the residential property. This report contains the results of the HUD lead-based paint inspection and risk assessment.

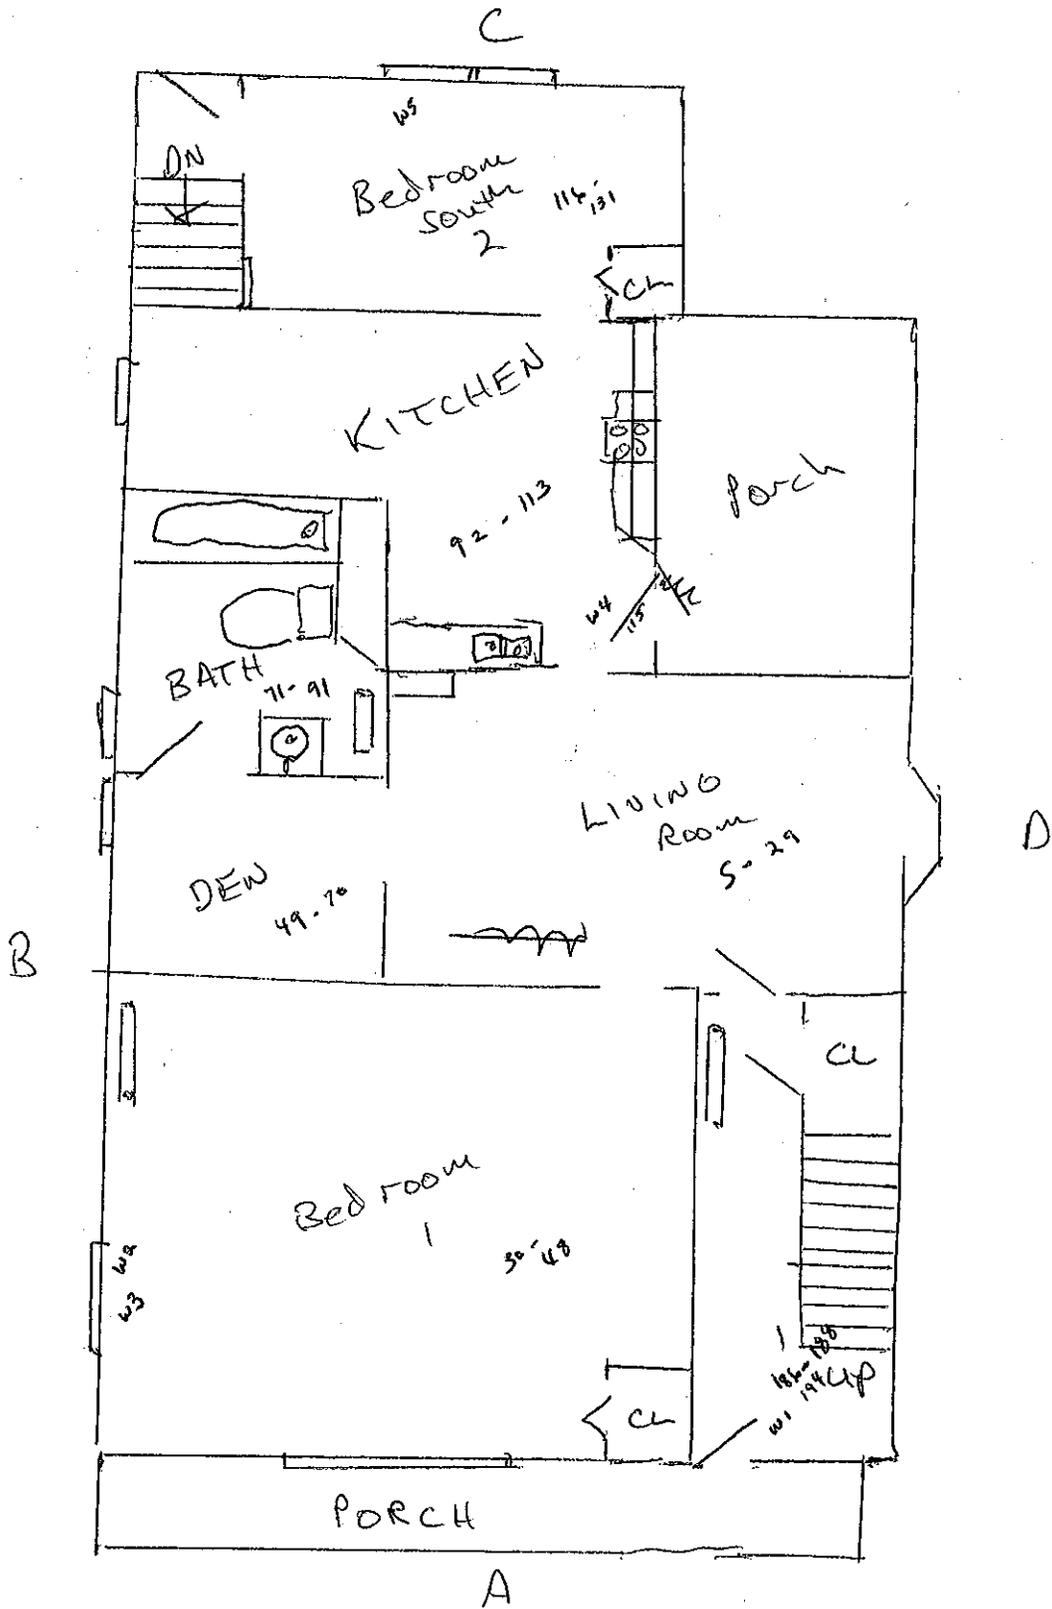
FIRST FLOOR
 700 FOURTH STREET
 ST. PAUL, MINNESOTA

SKETCH NOT TO SCALE
 DRAWN BY: GREG MYERS
 MIDWEST ENVIRONMENTAL
 CONSULTING LLC
 DATE: SEPTEMBER 12, 2013

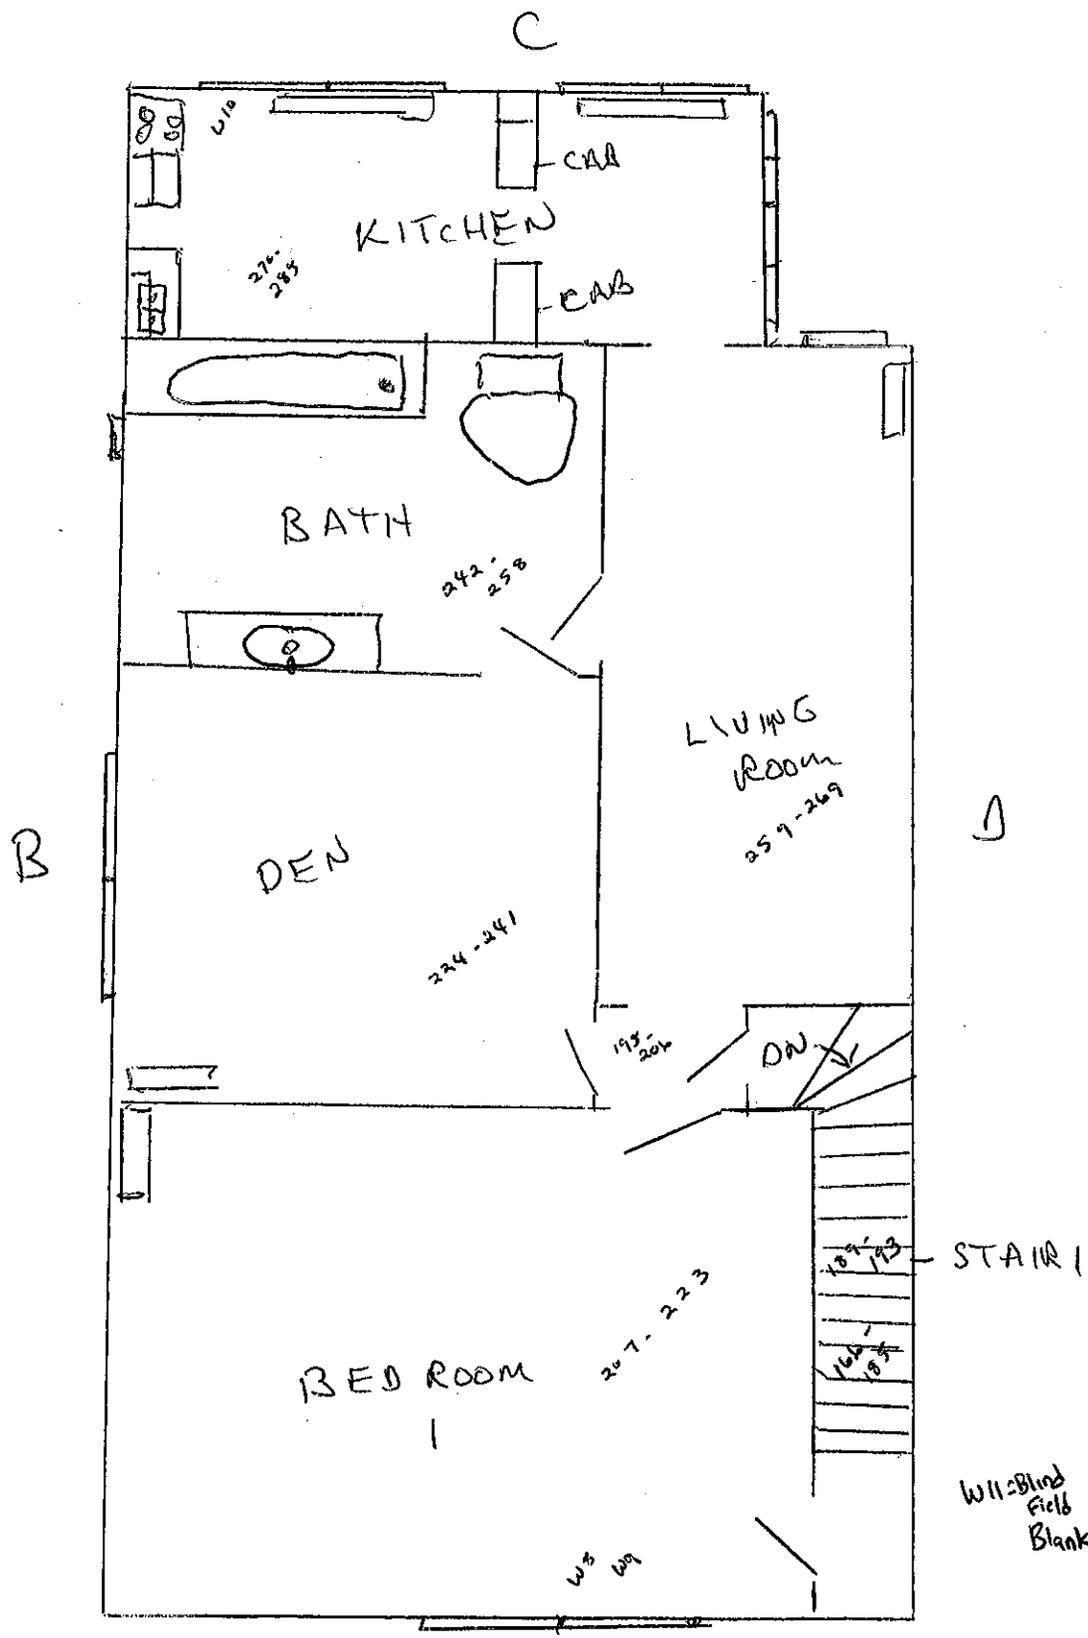
SECOND FLOOR
 700 FOURTH STREET
 ST. PAUL, MINNESOTA
 SKETCH NOT TO SCALE

DRAWN BY: GREG MYERS
 MIDWEST ENVIRONMENTAL
 CONSULTING LLC
 DATE: SEPTEMBER 12, 2013

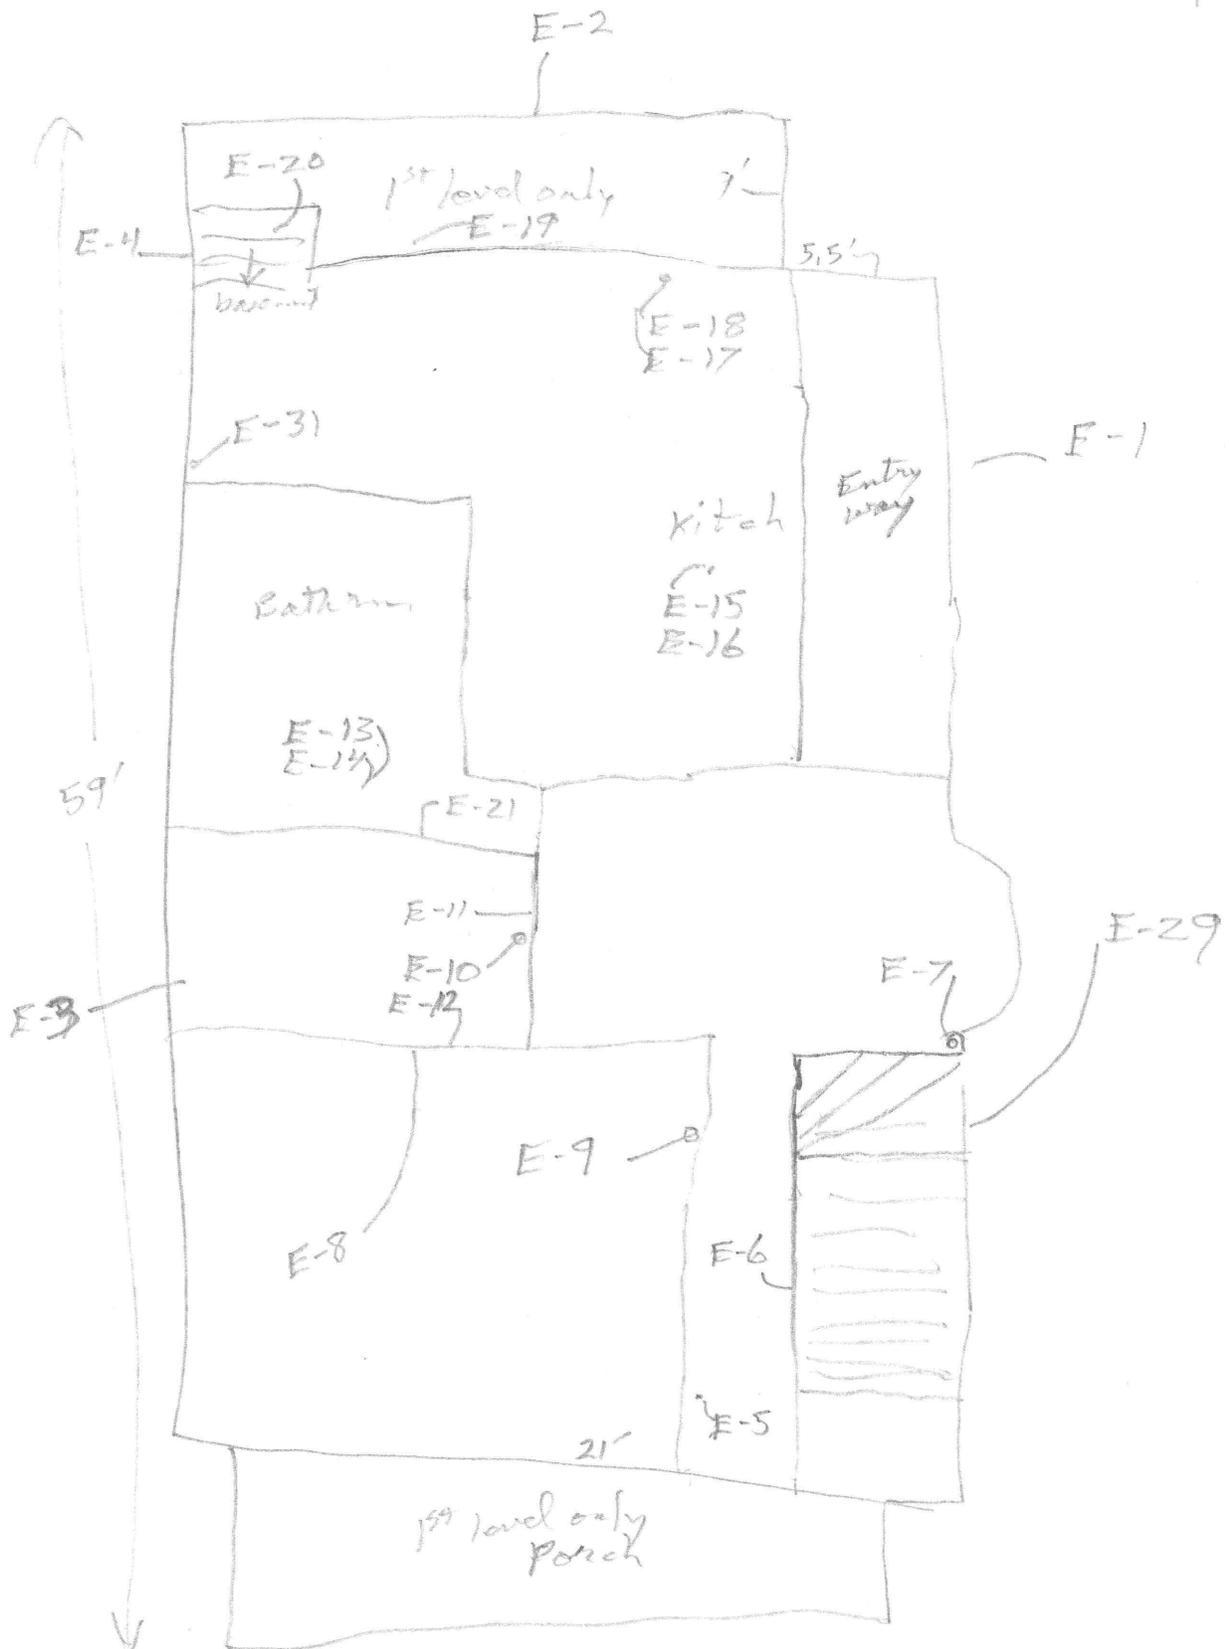
1st level

700 E. 4th St.

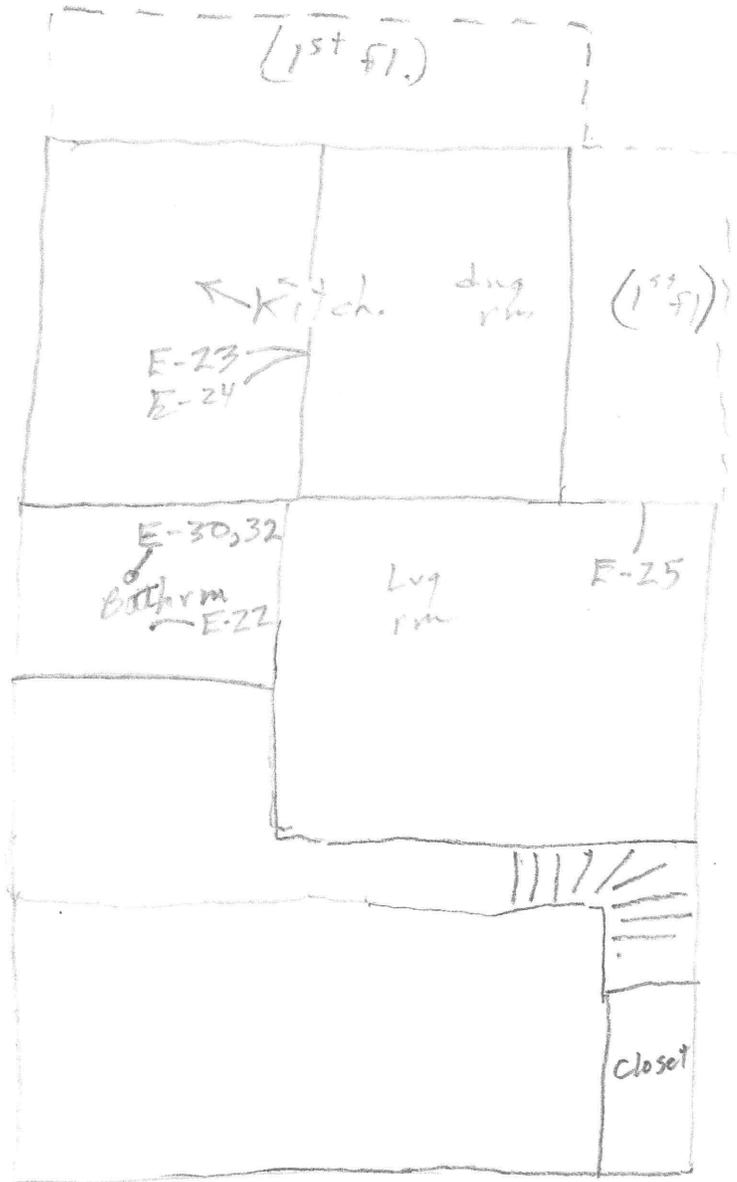
2nd Fl.

700 E. 4th St.
