Midwest  
Environmental  
Consulting, L.L.C.

RE: HUD Lead-Based Paint Inspection and Risk Assessment at the Duplex  
Residential Property, 767 - 4<sup>th</sup> Street East, St. Paul, Minnesota (All Phase  
Phone: 651-436-2930)

At your request, Midwest Environmental Consulting, L.L.C. (MEC) performed a HUD lead-based paint inspection and risk assessment of the duplex residential located at 767 - 4<sup>th</sup> Street East, St. Paul, Minnesota on January 24, 2012.

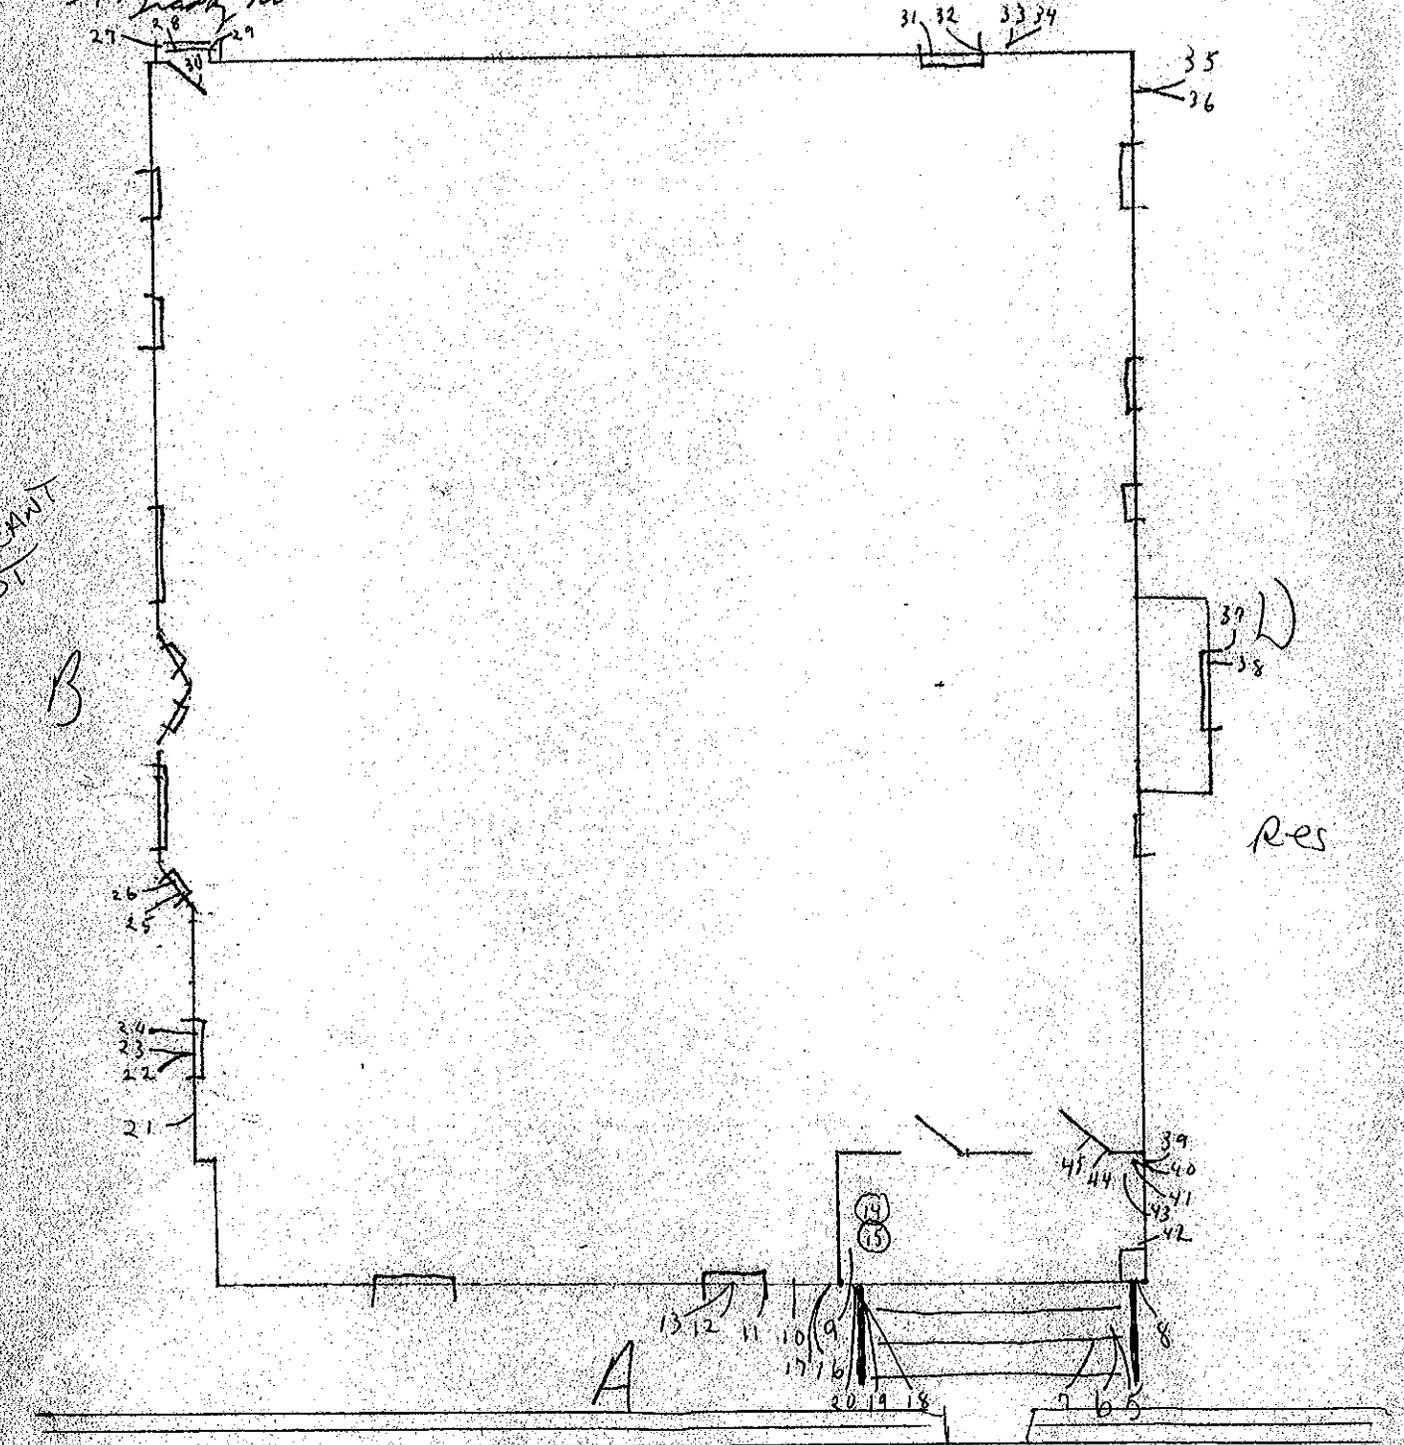
↑ N  
767 4th St. E.  
St. Paul, Minnesota  
First Floor

SKETCH NOT TO SCALE  
MIDWEST ENVIRONMENTAL  
CONSULTING

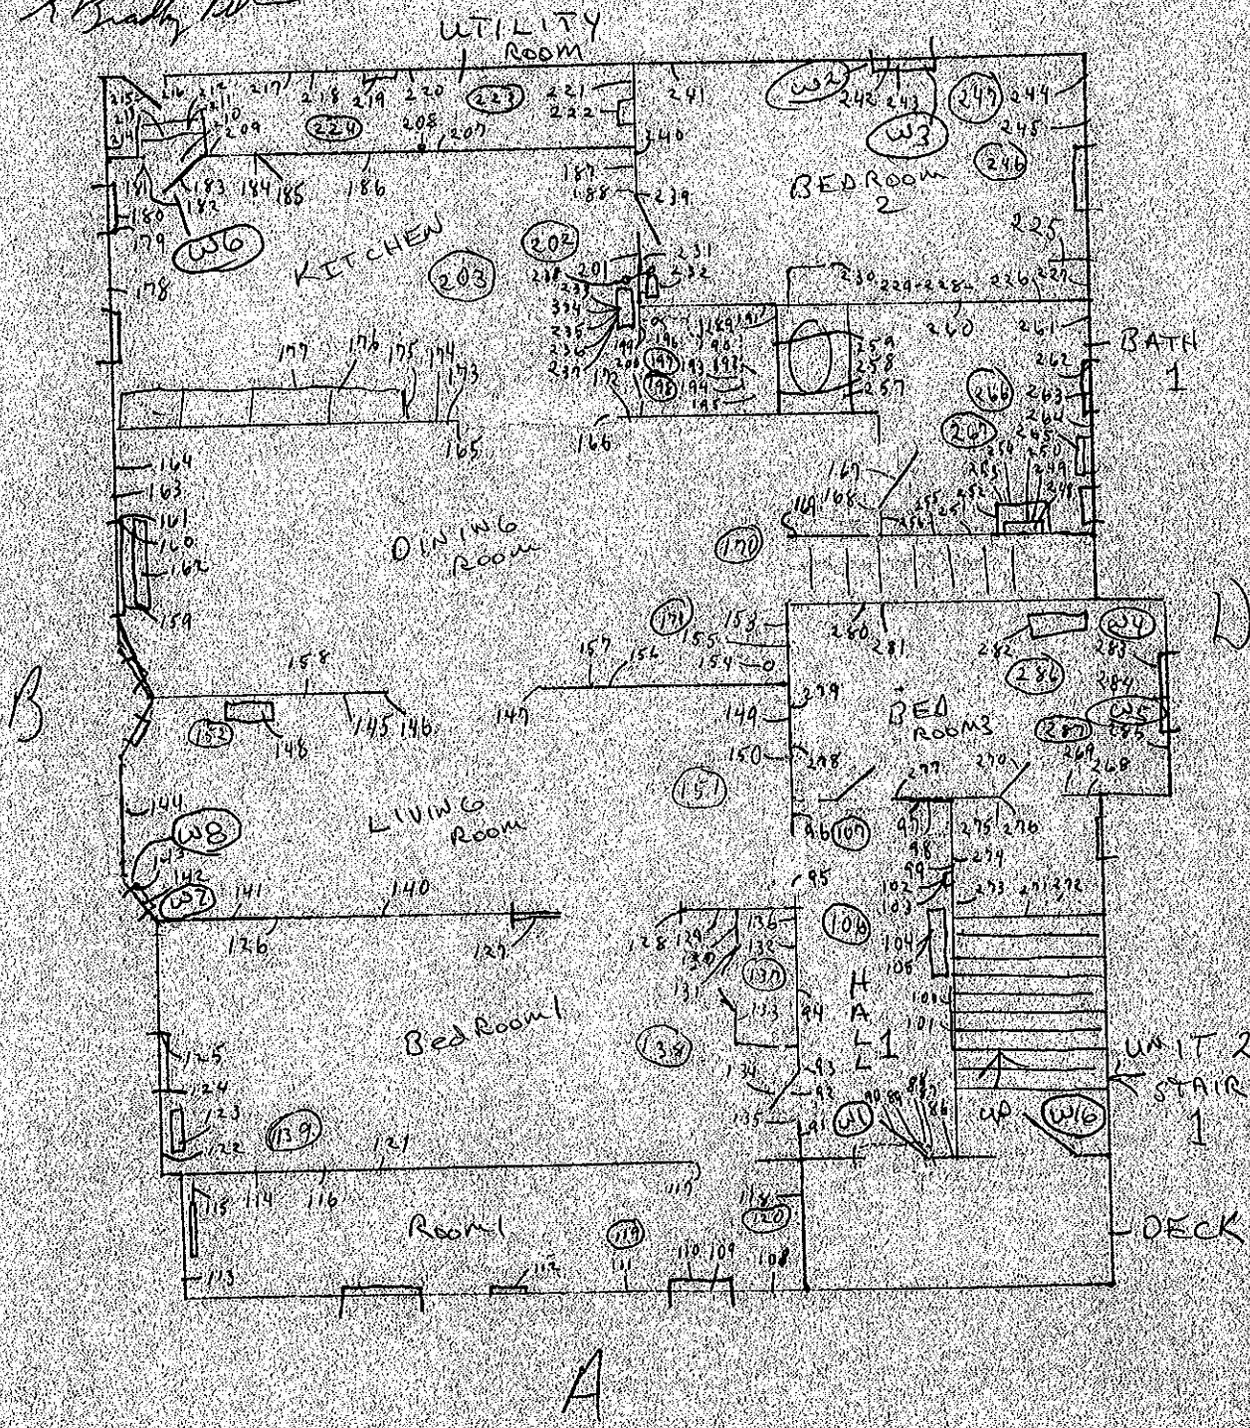
↑  
N  
767 4th St. East  
ST. PAUL, MINNESOTA  
2<sup>nd</sup> FLOOR

SKETCH NOT TO  
SCALE  
MIDWEST ENVIRONMENTAL  
CONSULTING  
January 24, 2012  
A. Bradley

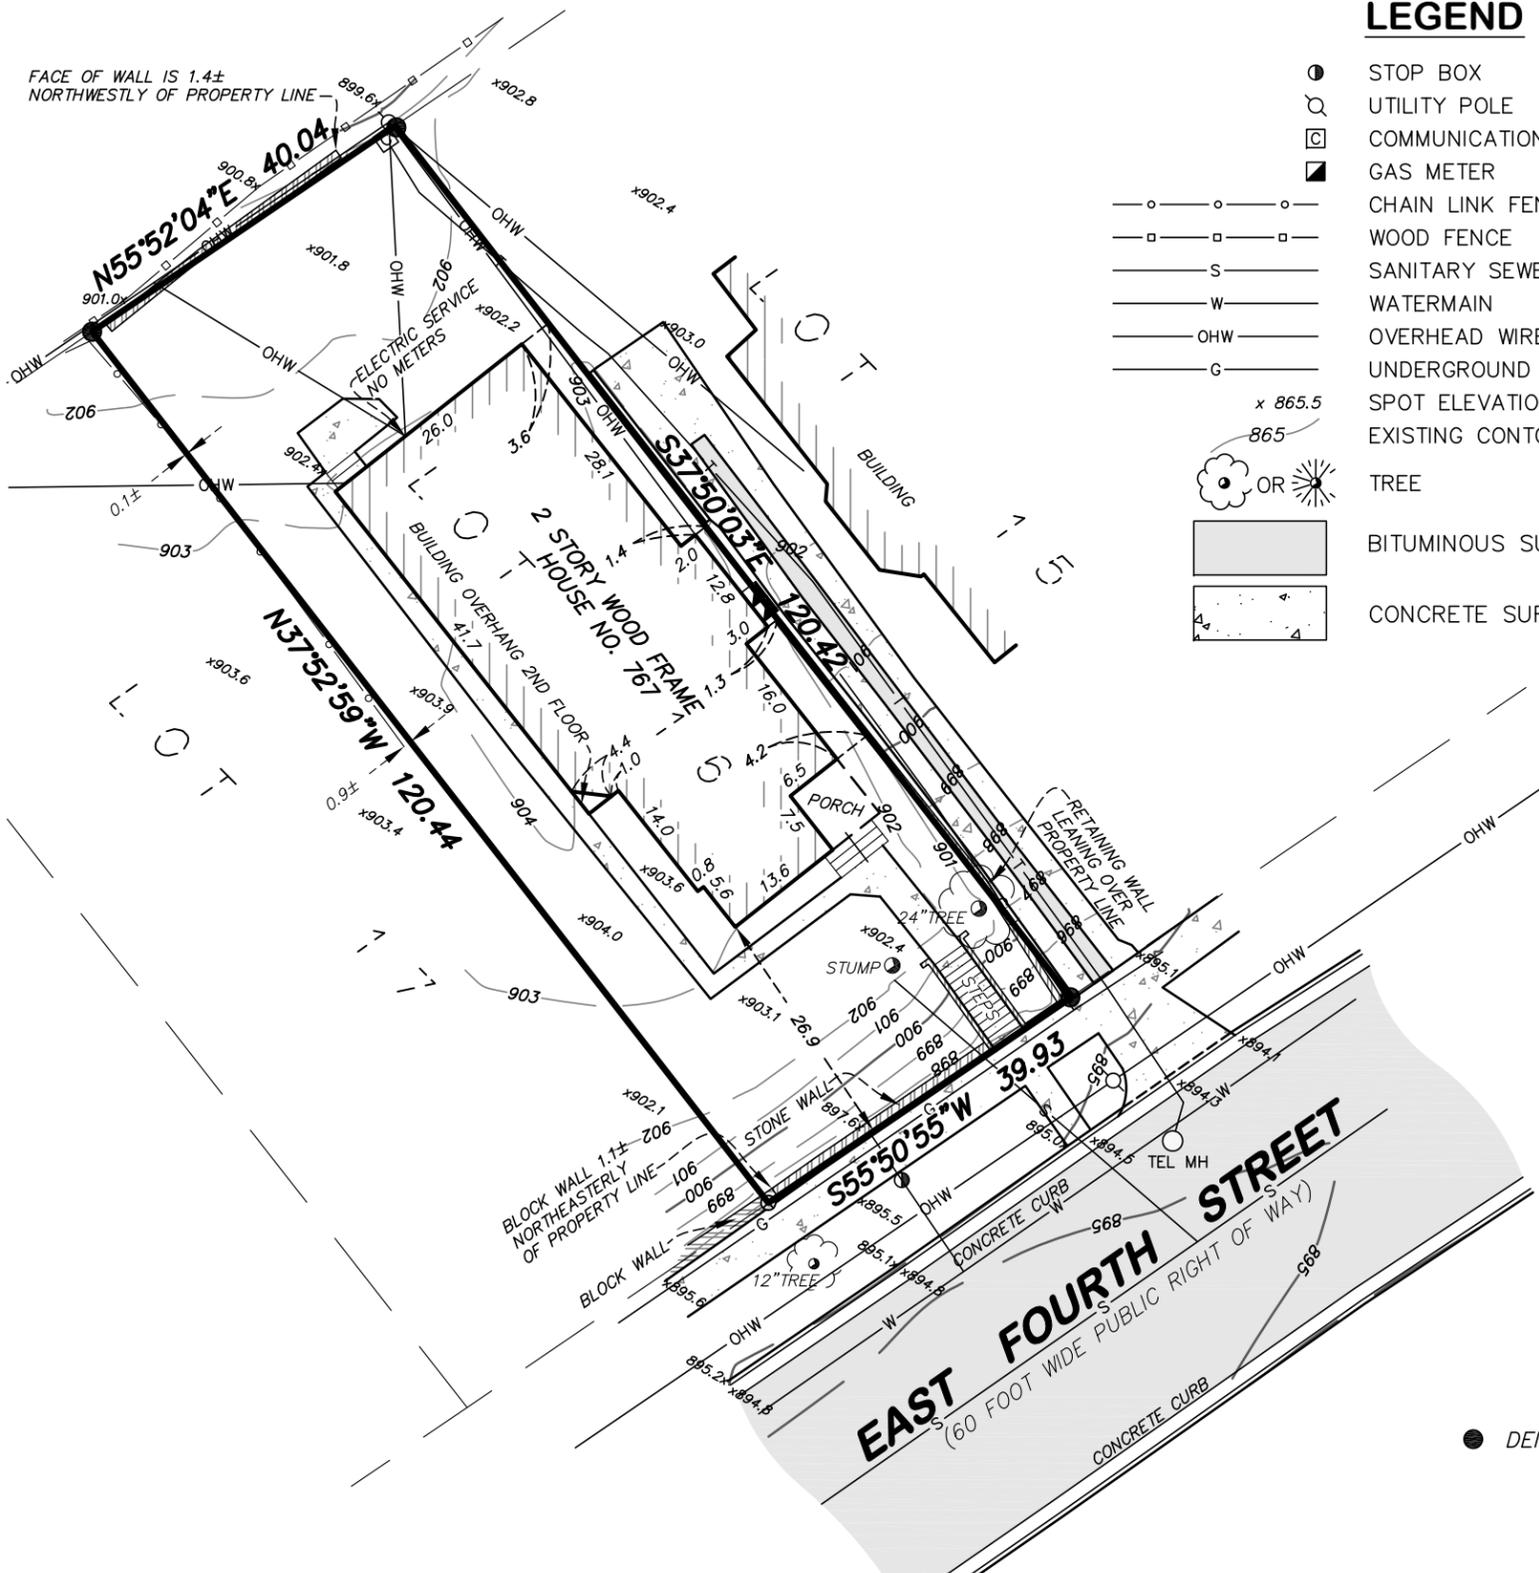
# CERTIFICATE OF SURVEY FOR: HOUSING AND REDEVELOPMENT AUTHORITY OF THE CITY OF SAINT PAUL, MINNESOTA

Date of survey: September 12, 2012.  
Date of signature: September 24, 2012.
