700 Laurel Ave. Saint Paul, MN 55104 | Saint Paul Parks and Recreation

## Webster Play Area Improvements

site analysis

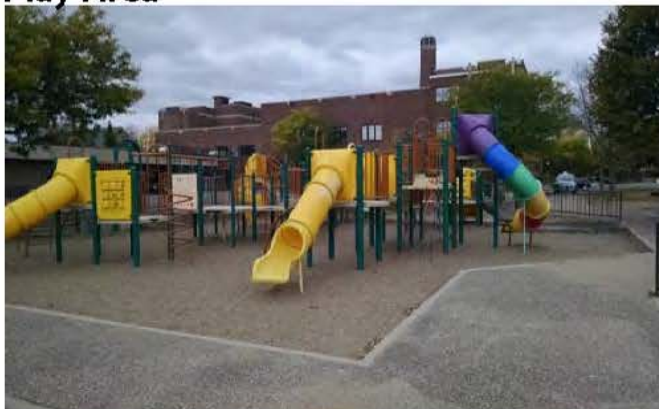
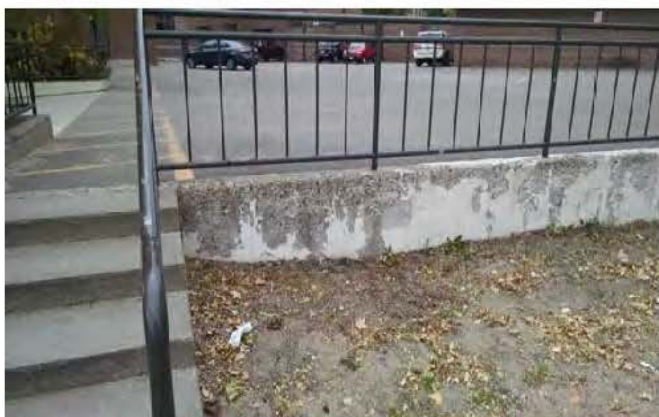
## Play Area

- Play area is out of date and needs to be updated to meet CPSC Standards for safety and accessibility.
- Despite some rough areas, the concrete wall separating the play area from the parking lot is in good condition.

- 3 Refinish concrete wall, provide opportunity for public art mural.
- 4 Update Play equipment and Surfacing. Improve circulation within the play area. Make 2-5 play area ADA accessible.

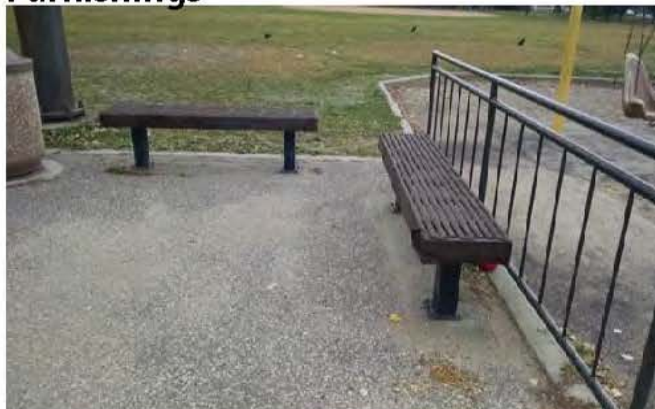
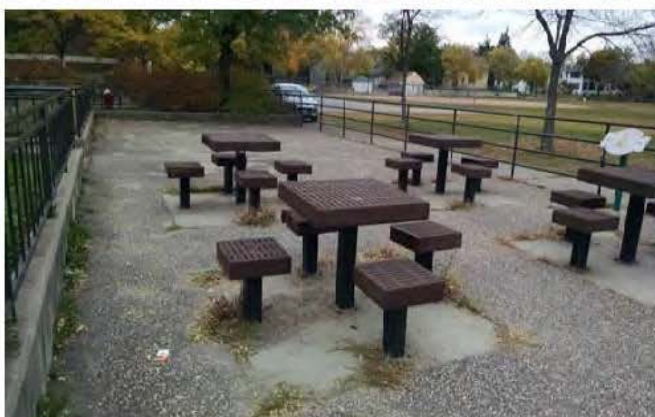
## Furnishings

- Benches and picnic tables are in rough condition. Need updating.
- Drinking Fountain in good condition, but would benefit from a touch-up.
- Trash receptacles are in good condition
- Picnic area is a nice amenity. How much is it used?

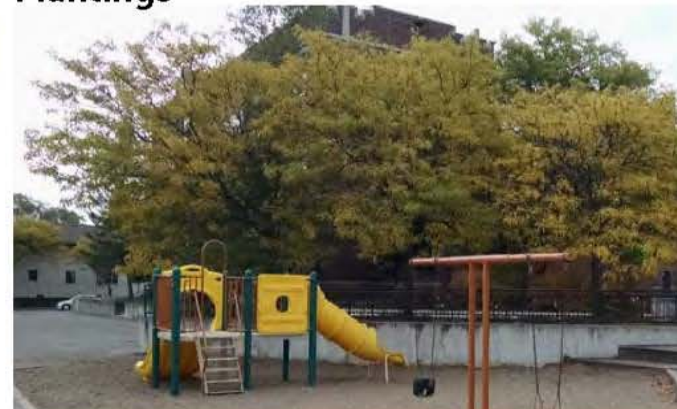
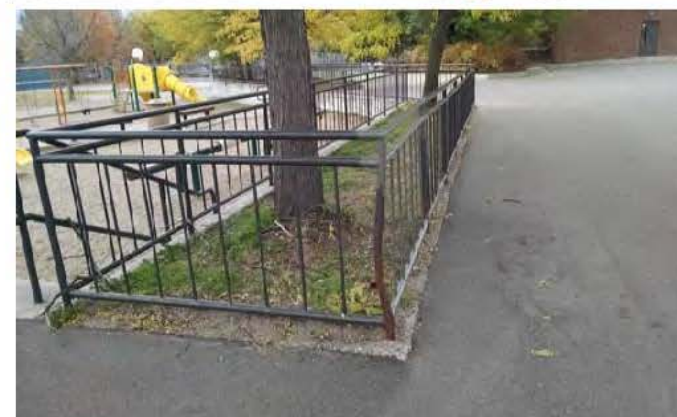
## Plantings

- Trees within the planting beds are in good condition.
- Planting areas in need of maintenance.
- Guard rail in rough condition in some spots.
- Is ALL the guardrail around the planting beds necessary?

- 1 Planting beds. Explore options for plantings. Remove unnecessary guardrail
- 2 Move pavement games, out of the parking area to avoid conflicts with vehicles

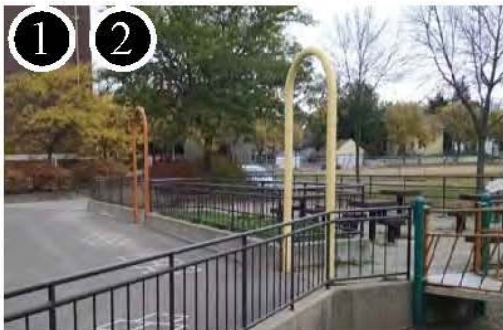
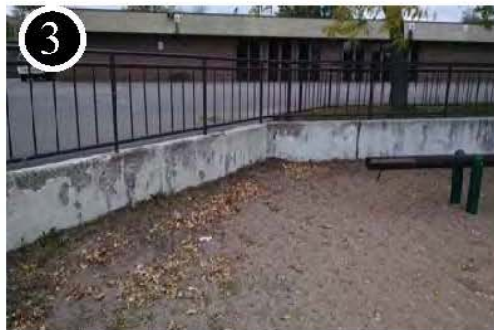
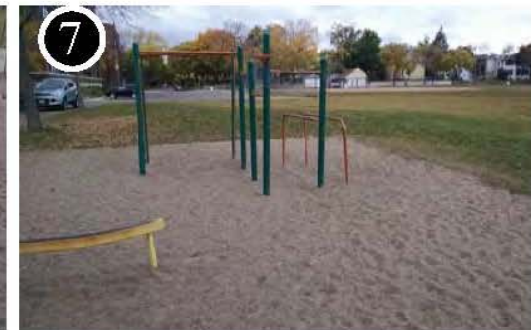
- 5 Move back curb a few feet to accomodate new swings, if desirable.
- 6 Straighten out walkway to improve circulation and provide potential space north. Install collapsible bollards to aid maintenance vehicles, but prevent unauthorized traffic.

- 7 Existing play area. Explore options for additional recreational space such as sand volleyball, badminton, etc.
- 8 Play Area sees heavy use and covers a large space. Goal: Make the most out a limited area by focusing on play equipment.

- 9 Plant trees along edge of easement to set edge of play space.

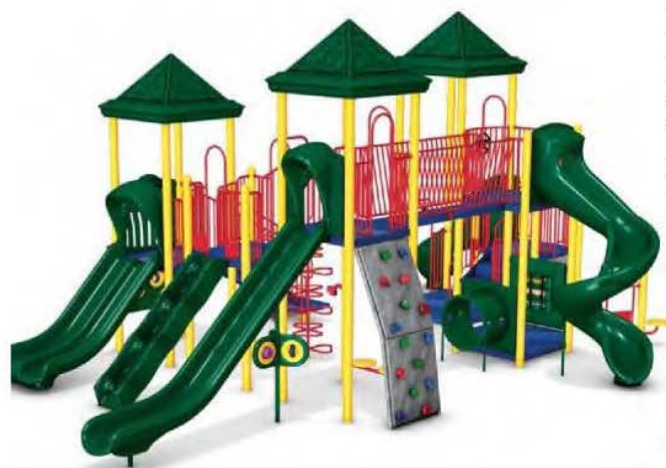
### TRADITIONAL PLAY

- Familiar to most users
- Provides for a variety of age groups
- Tend to provide shade, defined spaces
- Provides resting, hang-out points
- Large variety of play opportunities

- Impedes visibility
- Common
- High amount of plastic leads to colors fading
- A lot of flat surfaces

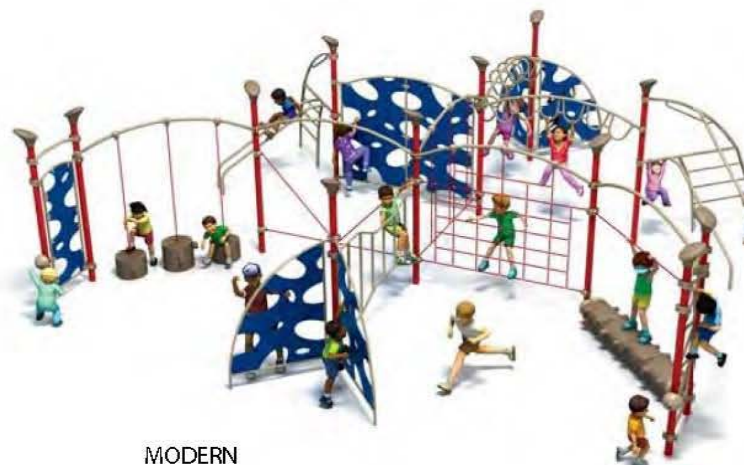
### MODERN

- High volume of users
- Works upper body and core, develops coordination
- High visibility (can see through the equipment)
- Provides for new play experiences
- Helps develop coordination

- Unfamiliar to many users
- May not provide for all strength levels, limits accessibility
- A lot of the play features are similar
- May require a lot of space
