ANALYSIS

CONWAY PLAY AREA RENOVATION SITE ANALYSIS

introductory meeting
March 3, 2011

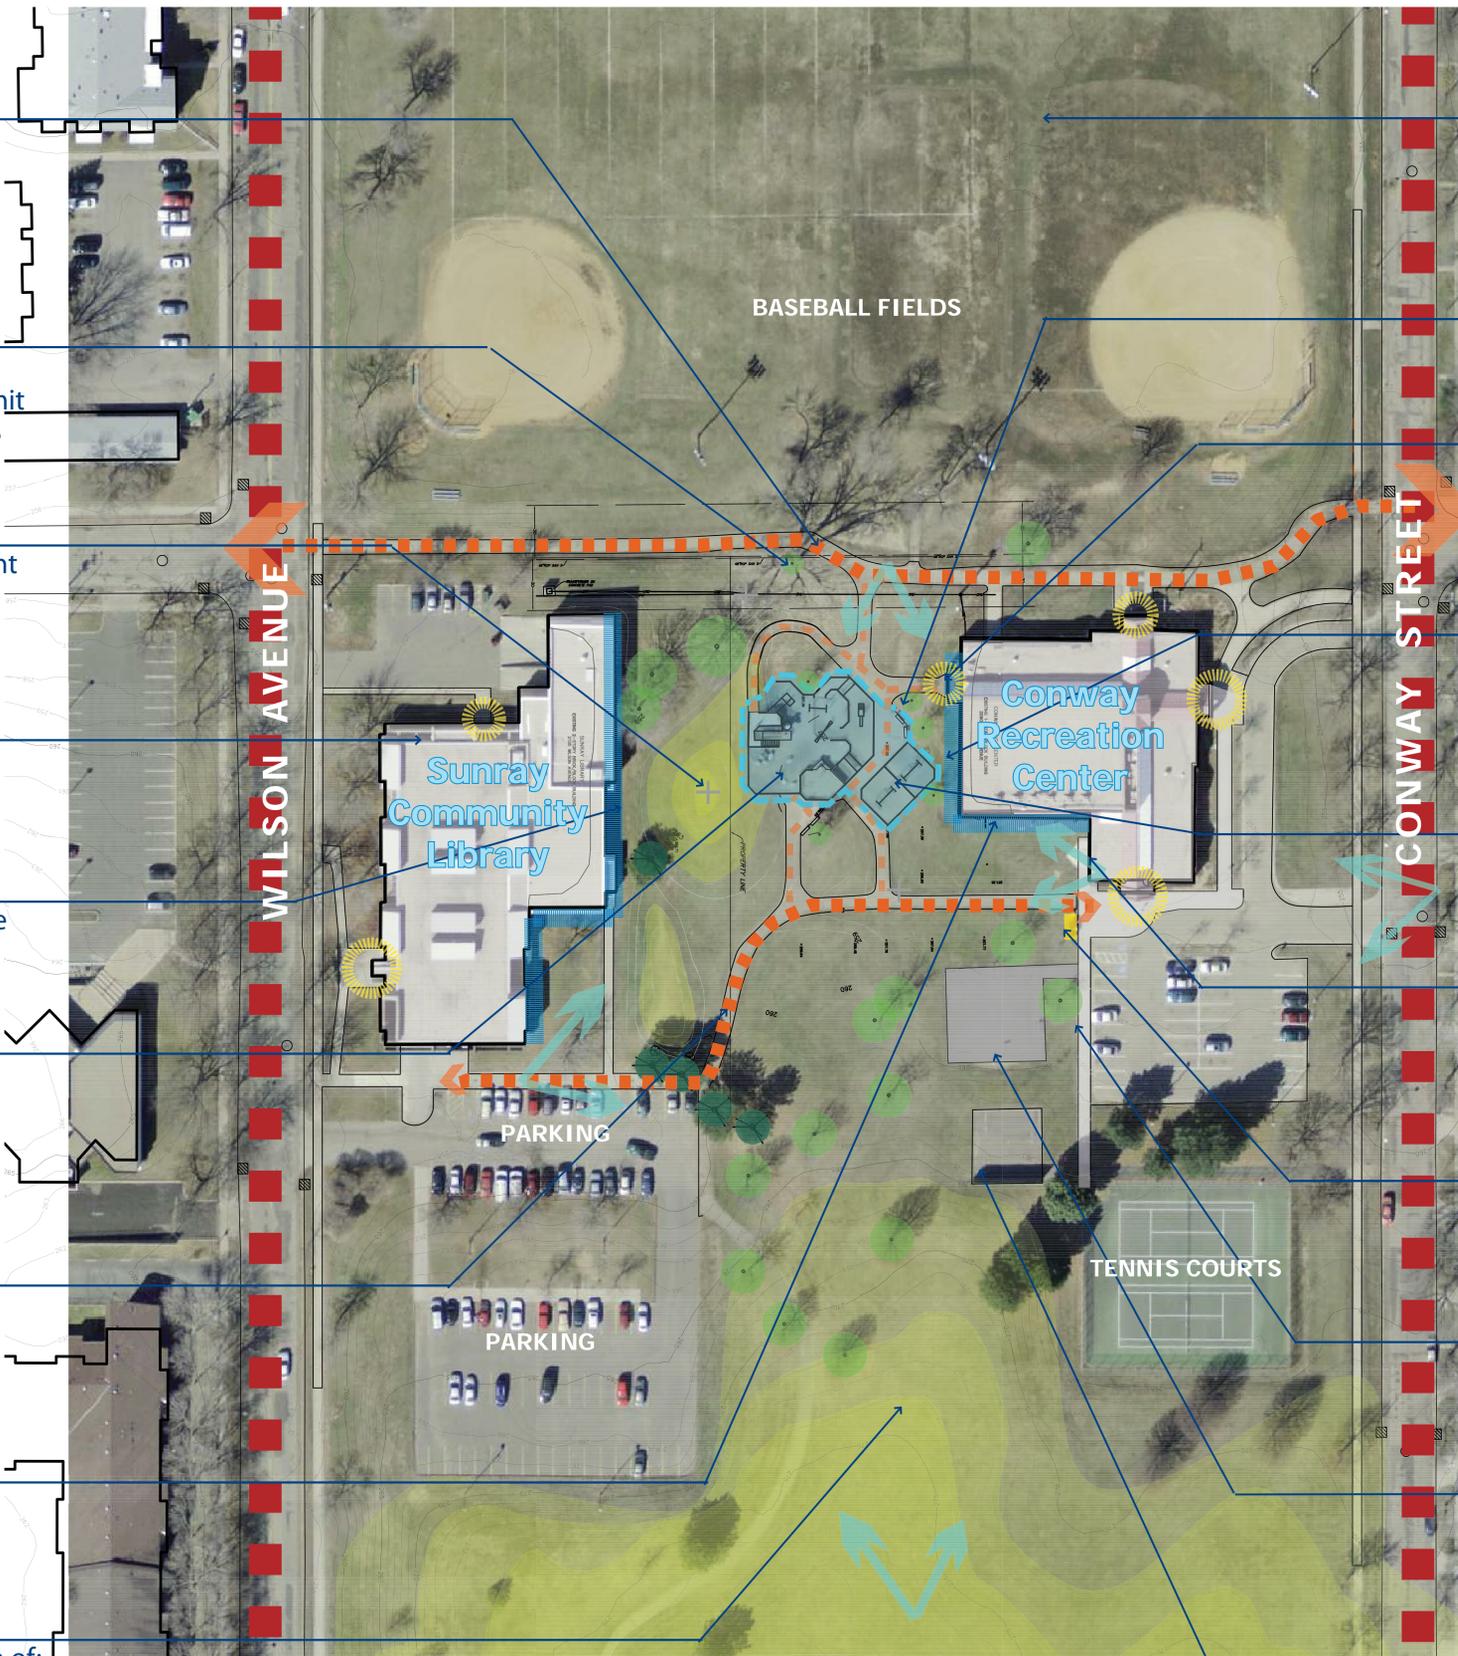
Regrade and replace pathway to address grading and drainage. This is a major pedestrian connection to Sunray Shopping Center.

Save and protect existing mature trees. Trees provide shade, but limit the expansion or relocation of the playground to the west.

Provides an interesting component of the existing play area- the landform is integral to the playground.

There are no views from inside the library towards existing play area nor a direct connection.

Aged play equipment is a safety hazard. Need to replace with attractive equipment that is handicap accessible with resilient surfacing.

Pedestrian connection from the recreation center to the library. Consider benches along path for places to rest.

Explore options to capture roof runoff to allow water to infiltrate prior to entering the storm sewer.

System plan suggests renovating existing fields space as two dedicated high-quality multiuse artificial turf fields.

Save and protect during construction

This is the only location where there is a view of the play area from the building. Evaluate significance of access.

There are no views to the play area from the majority of the building a safety concern as there are no sightlines to the play area.

The swingset may be restored with paint and new swings. Consider in the design process for the play area.

There is a direct connection to the exterior and views to the south from the classroom and director's office.

Dumpster may need to be relocated to open views and sightlines from the adjacent neighborhood.

Limited site lighting for parking lot only. Explore providing lighting for play area to increase safety.

Half court is used by older kids and adults who bring younger children to the play area. Evaluate use of court and possible relocation.

Bang Board to be removed due to safety reasons. Consider reuse or removal of court.
