Stinson Play Area Improvements

996 Stinson St. Saint Paul, MN 55103 | Saint Paul Parks and Recreation

existing conditions

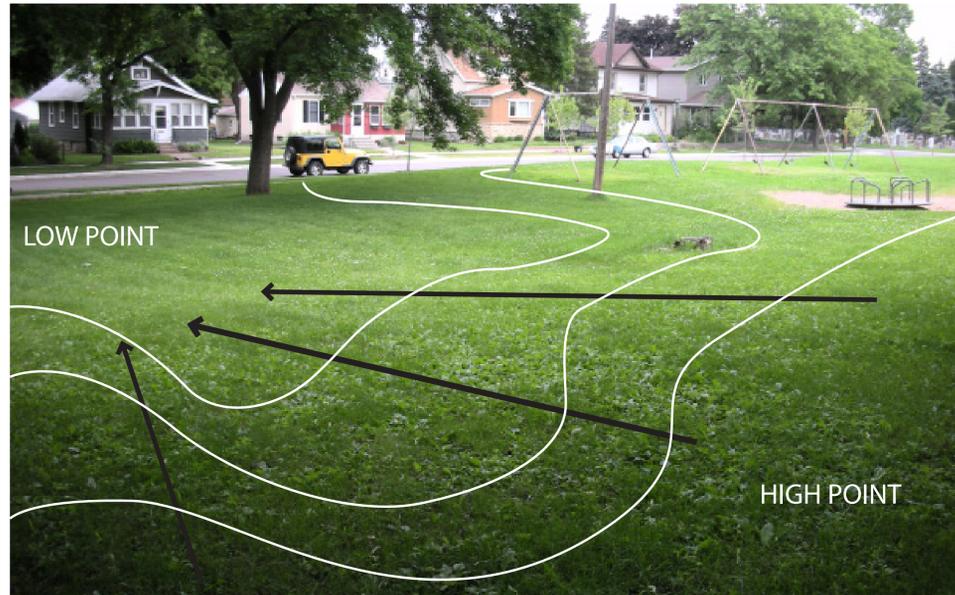
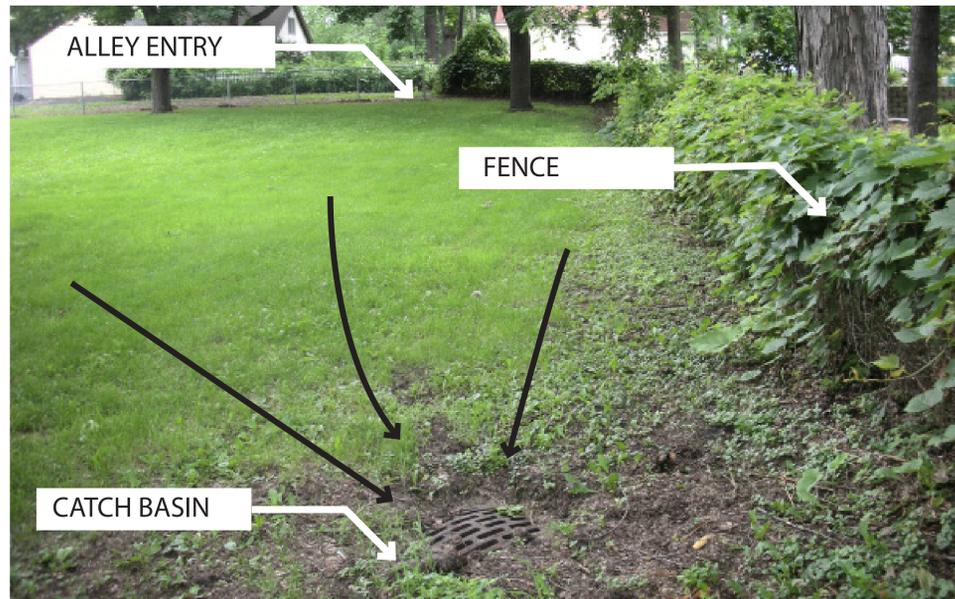
- Fence is in rough condition and located - 3 feet inside the property line. May have to replace.
- Water in Zone 1 drains towards catch basin located at the park's low point.
- Fence along the alley limits access into the park.
- Zone 1 serves as a buffer space between the existing play area and adjacent property to the west.
- Access play area/Stinson Street is currently from the alley. Is this adequate?
- Lots of shade. May be reduced if removals are required.
- Topography may offer visual interest if play area is expanded into this zone.

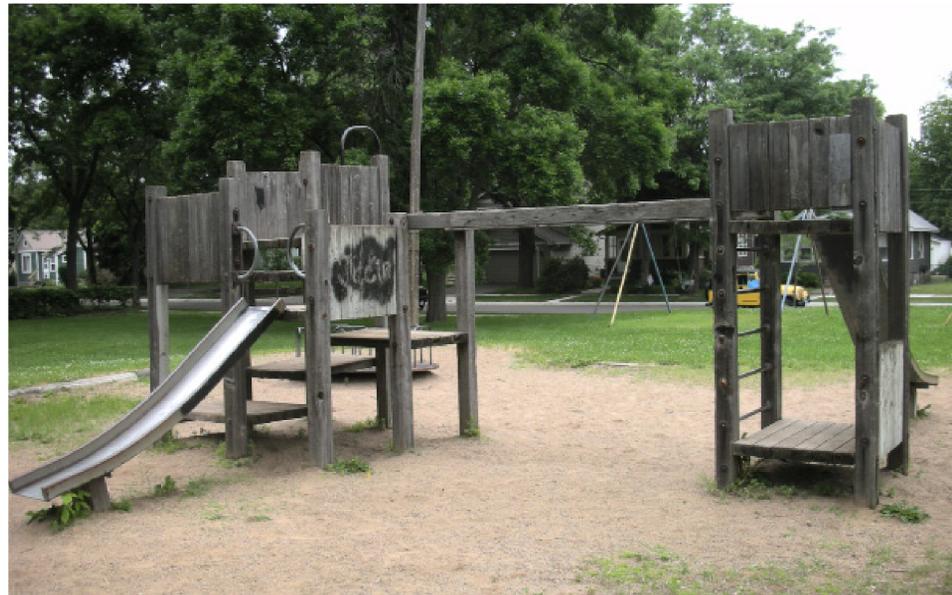
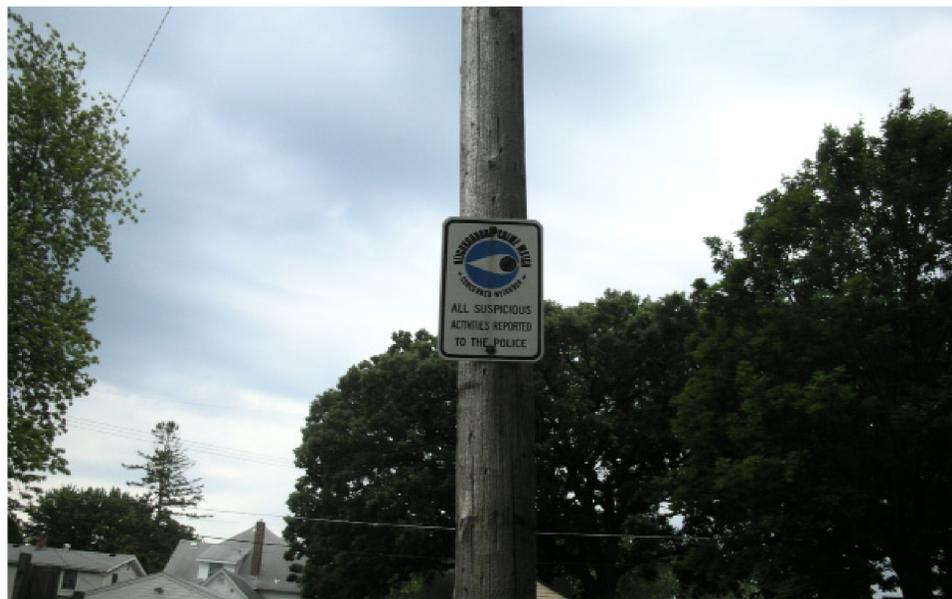
- Location of the previous play area.
- Light post - Does the light work? Consider replacement, move overhead wires.
- All Play equipment/swings and wood curbs to be removed and/or replaced.
- There are no benches, picnic tables, or trash receptacles located within the park.
- Sand play surface not ADA compliant.
- Minimal shade. Zone 2 could benefit from additional trees.

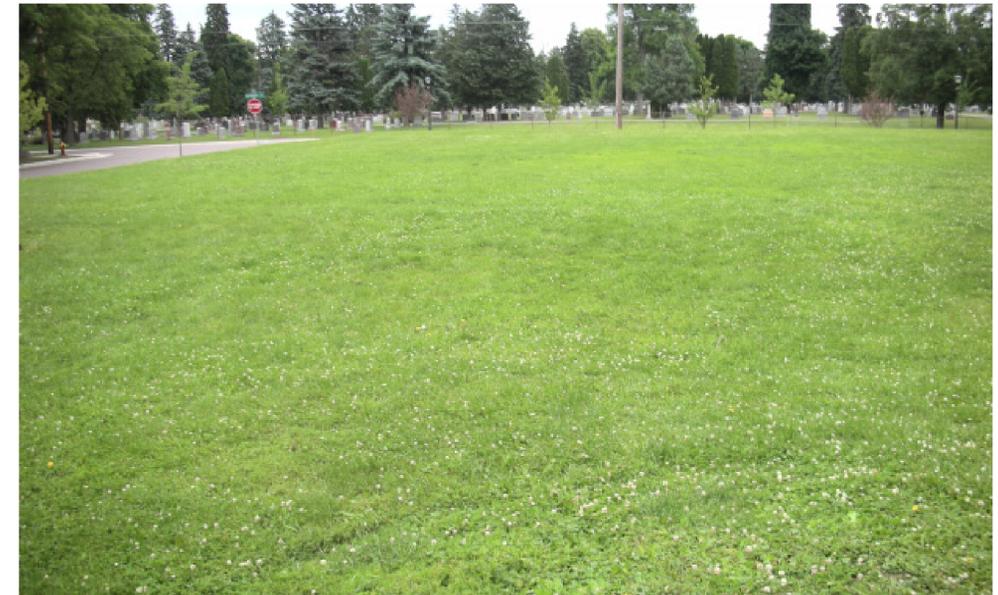
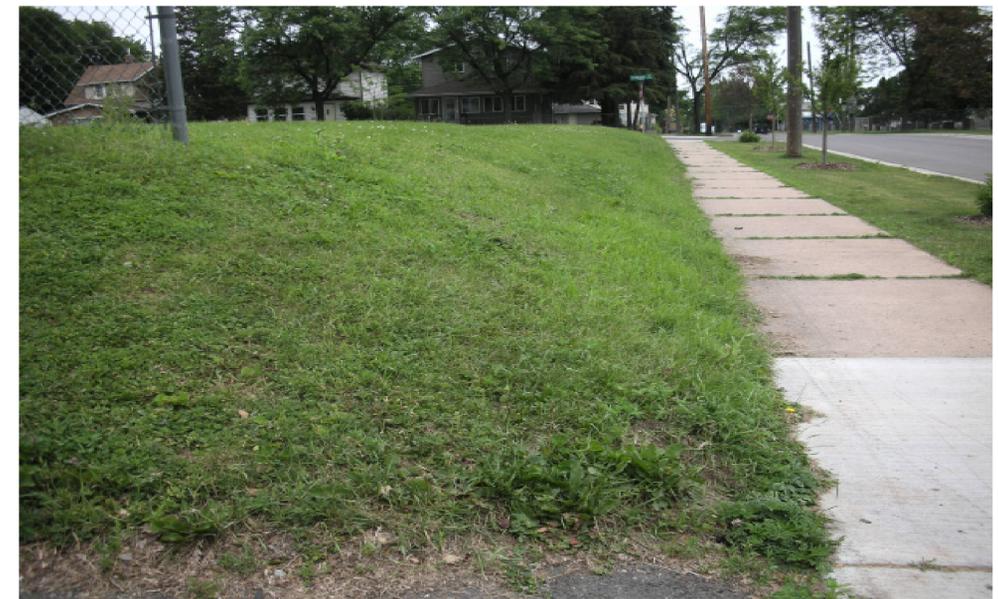
- Slopes along the north and east sides discourage access into the park.
- Relatively flat grade provides ideal space for active recreation to compliment the play area.
- Open view into the cemetery.
- Fences to the north and east have been removed. Nothing to prevent kids, balls, or other objects from rolling into the street.
- Provides buffer between Chatsworth Street and the play area.
- Zone 3 also lacks shade and could benefit from additional trees along the south/alley fence.

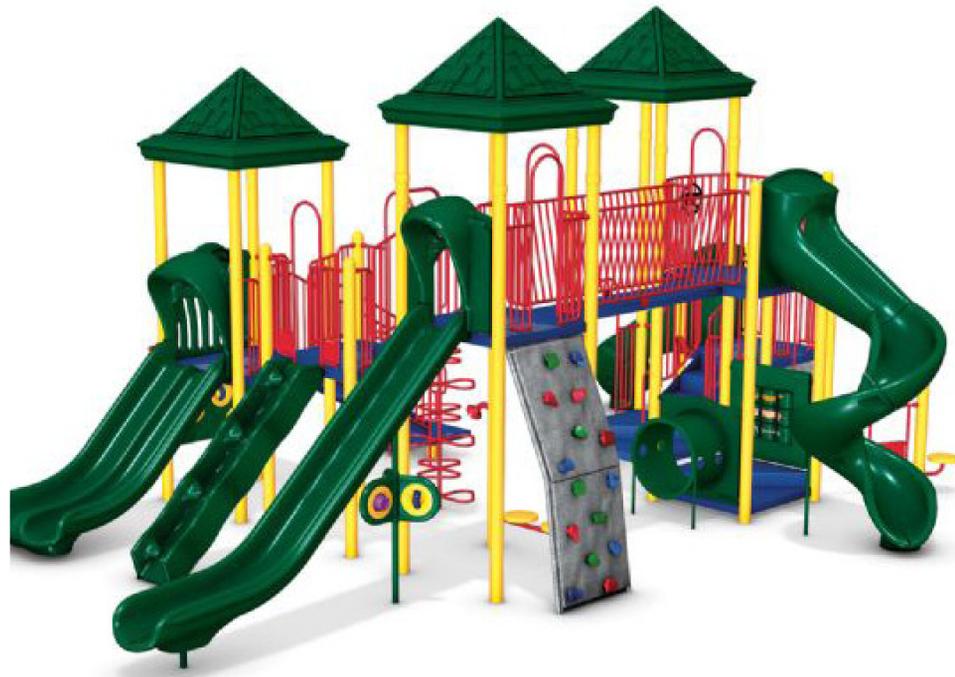
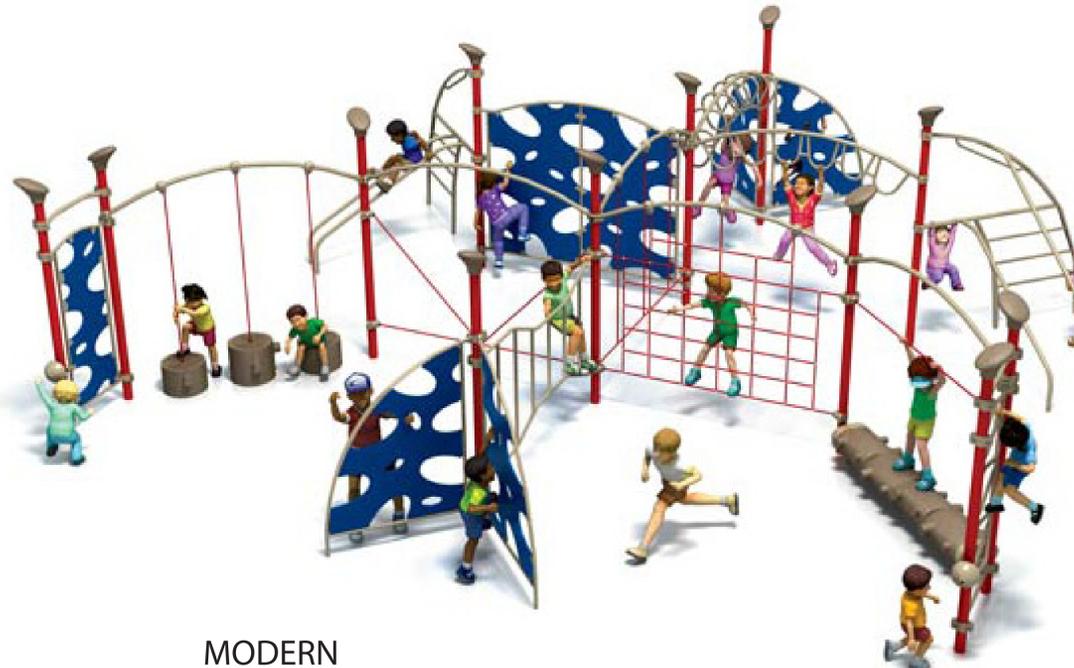
TRADITIONAL PLAY

- Familiar
- Provides for a variety of age groups
- Tend to provide shade
- Provides resting, hang-out points
- Large variety of play opportunities

- Impedes visibility
- Common
- High amount of plastic leads to colors fading
- A lot of flat surfaces

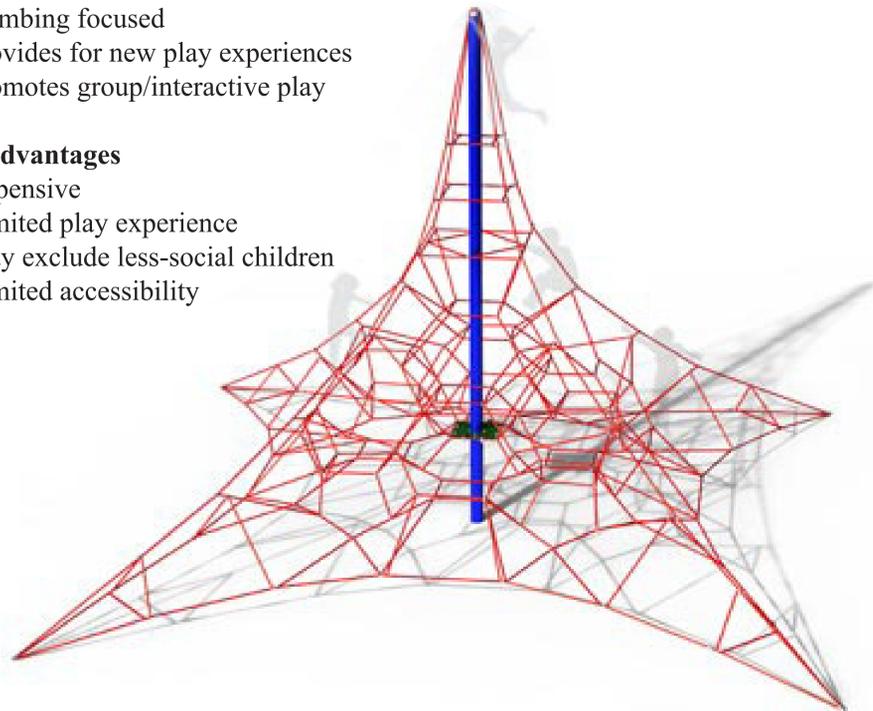
NET CLIMBERS

- Minimal flat surfaces
- High visibility
- Climbing focused
- Provides for new play experiences
- Promotes group/interactive play

- Expensive
- Limited play experience
- May exclude less-social children
- Limited accessibility
