**Cultural Resource Analysis, Alternative Urban Areawide
Review (AUAR) for the Proposed Minnesota United Midway
Project, City of St. Paul, Ramsey County, Minnesota.
MNSHPO # 2016-1711**

Prepared for Stantec Consulting Services, Inc.

15 May, 2016

**John G. Hodgson
Principal Investigator
Phase One Archaeological Services Inc.
5618 Hempstead Road
Madison, Wisconsin, 53711**

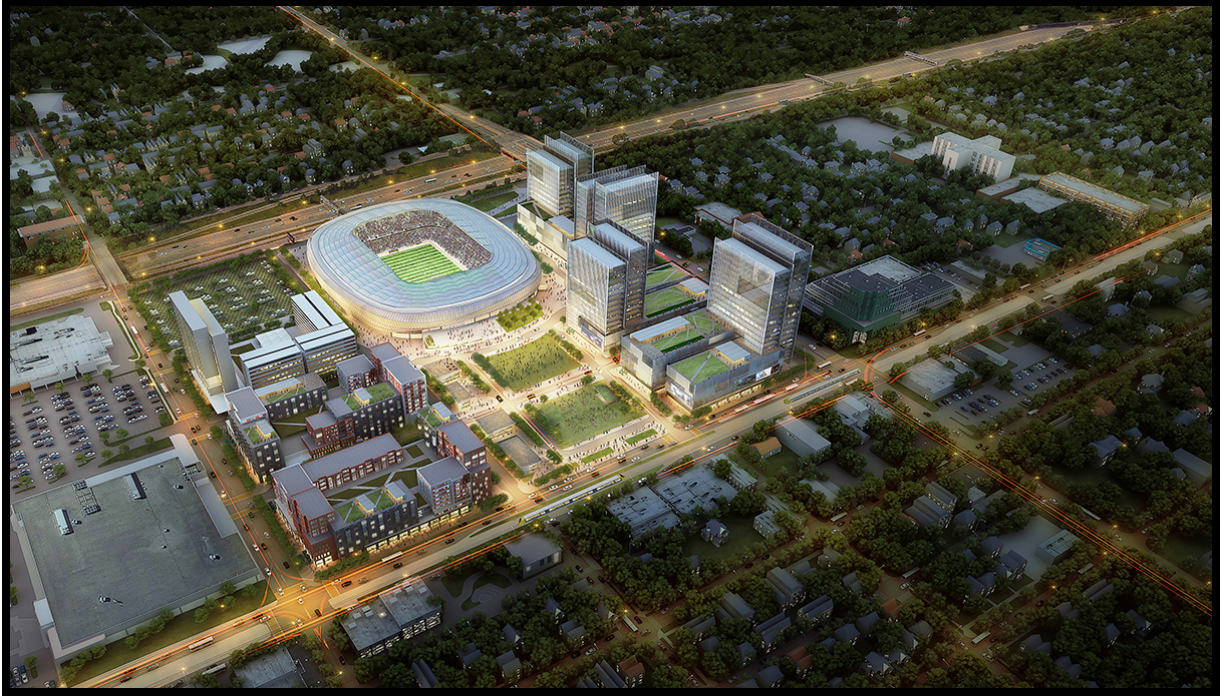
Figure Nine: Conceptual image with view to the southwest of the project area after development (Image courtesy of Stantec).

Depending on the final design plan, several standing structures within the immediate area of the proposed project area are of potential concern if the 5-10 story residential buildings are constructed as presented in Figures Seven and Nine. The structures recommended for further evaluation for a potential adverse effect and eligibility for the NRHP are outlined in the following section of the report.

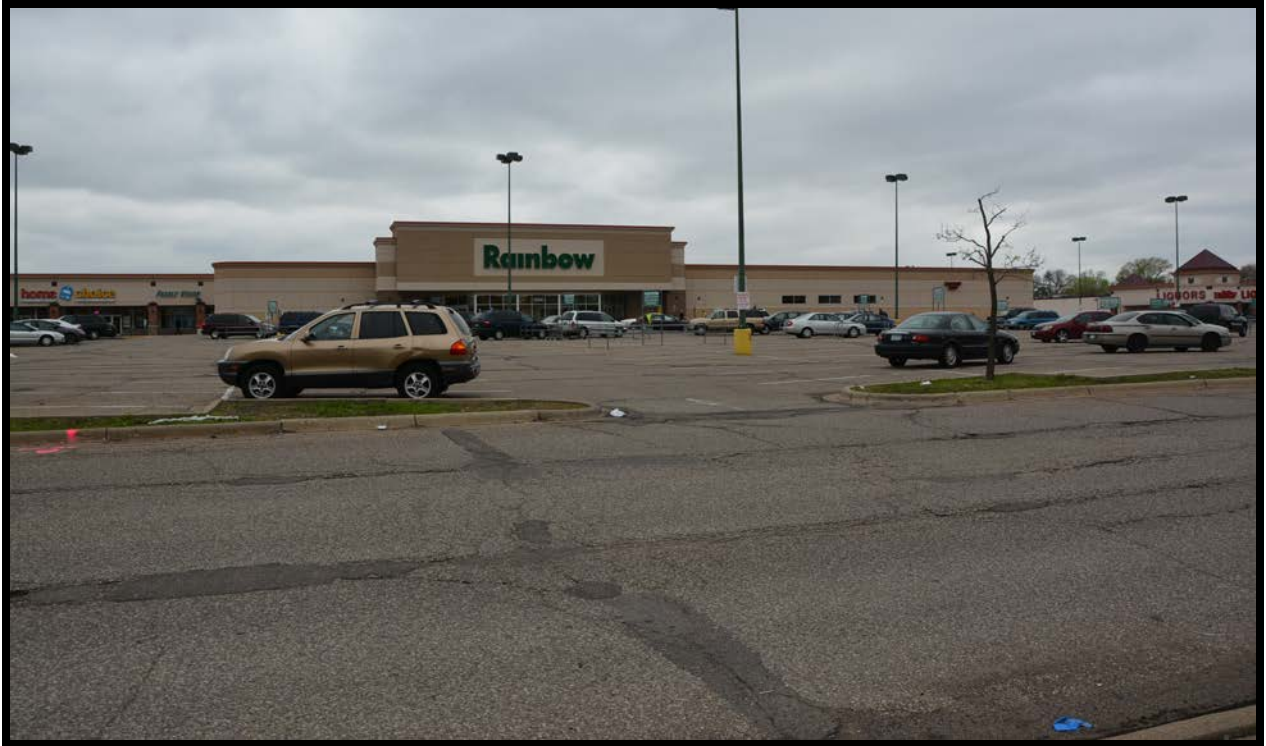
Figure Twelve: Front (northern) elevation of the Midway Center Shopping Mall (Structure 5 in Figure Five) showing post 1991 façade, paved parking areas and signage. View to south.

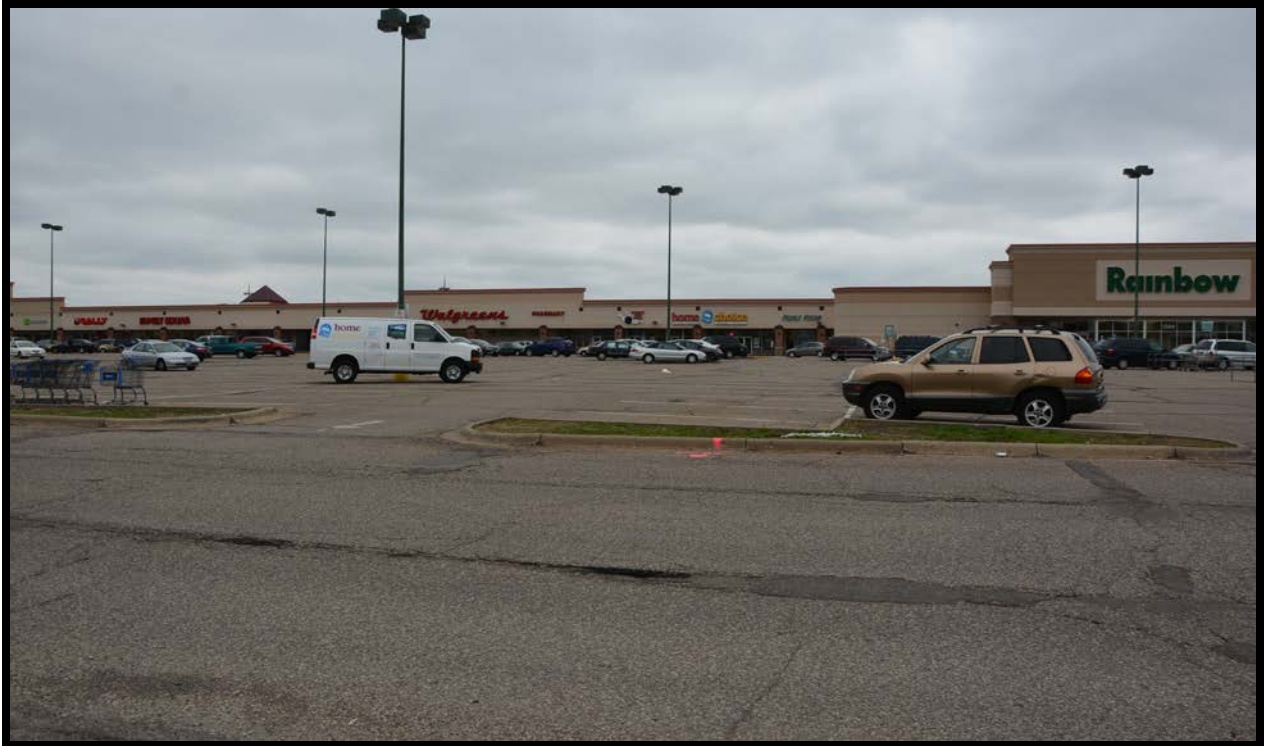
Figure Thirteen: Front (northern) elevation of the Midway Center Shopping Mall (structure 5 in Figure Five) showing post-1991 facade and signage. View to southeast.

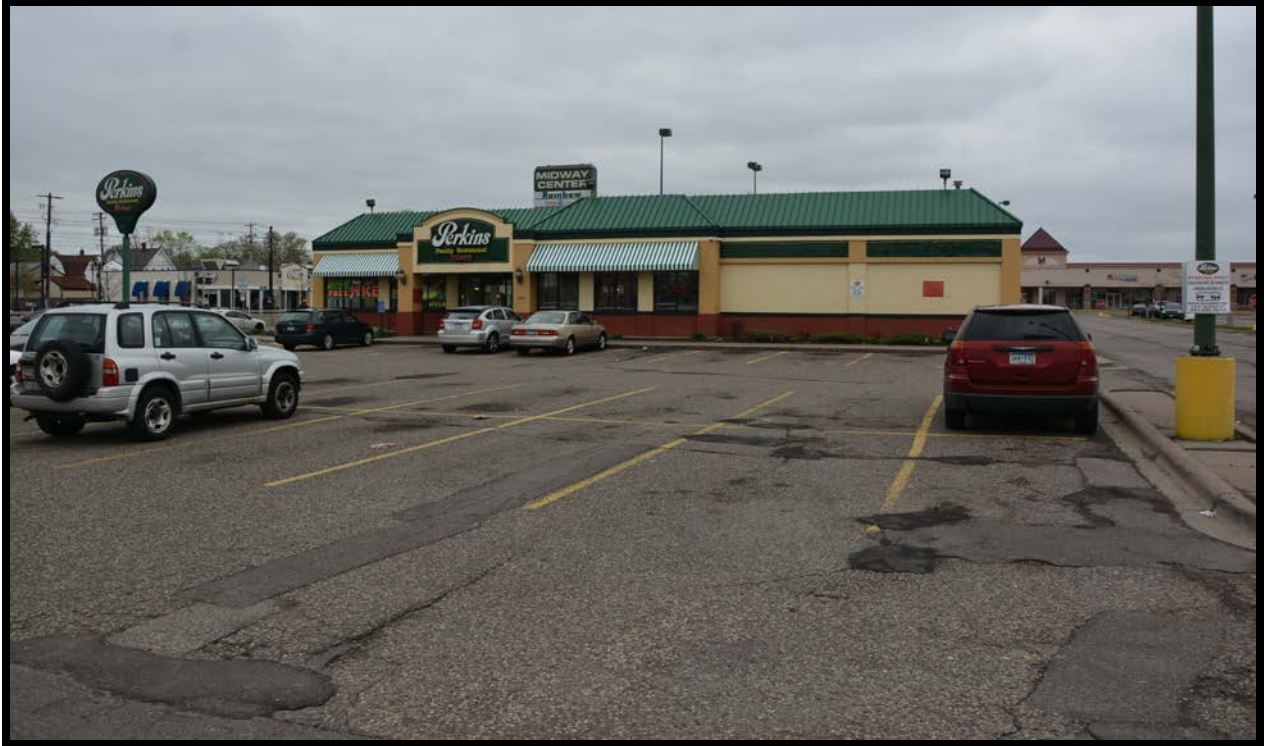
Figure Sixteen: Front elevation (west) of Structure 4 (Figure Five) View to east.

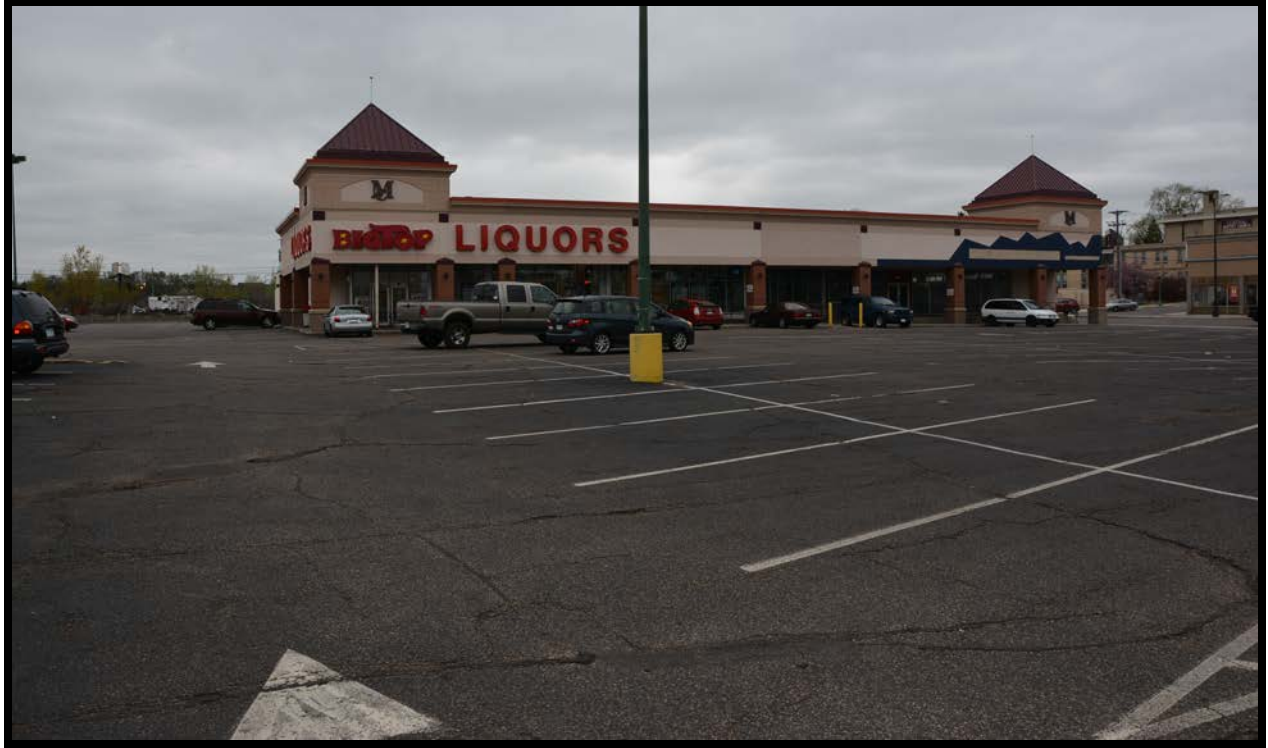
Figure Twenty-Four: Front (northern) elevation of Structure 2. View to south/southwest.

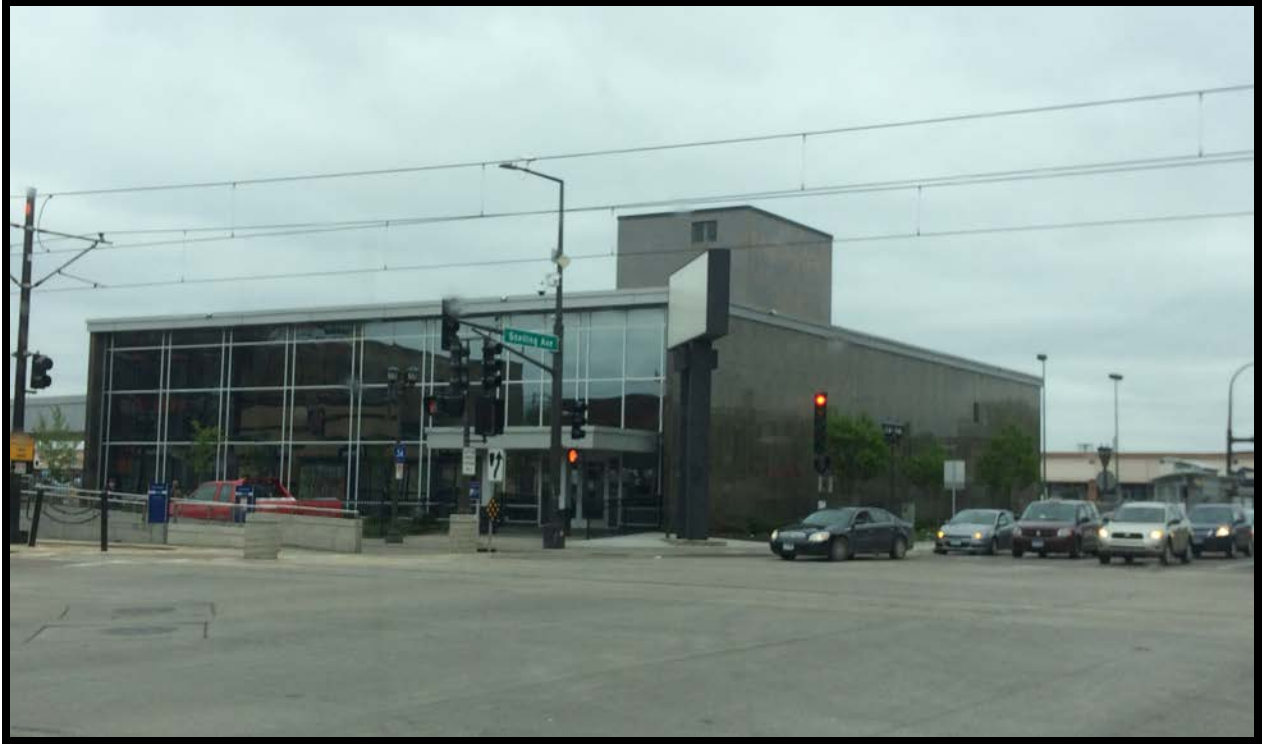
Figure Twenty-Six: Front (North) elevation of the former Midwest National Bank Building (Structure 1) . View to southeast from the intersection of Snelling and University Avenues.

The principle investigator recommends that the MNSHPO be contacted and consulted for the potential eligibility of the former Midwest National Bank Building (RA-SPC-2991), despite changes to the original building design and facades etc. this structure displays integrity characteristic of the modernist architectural style and warrants further evaluation to determine if the building is eligible for inclusion in the NRHP.

If not found to be eligible, it is recommended that the building be documented and recorded with professional quality photographs of the exterior and interior of the building etc. prior to demolition.

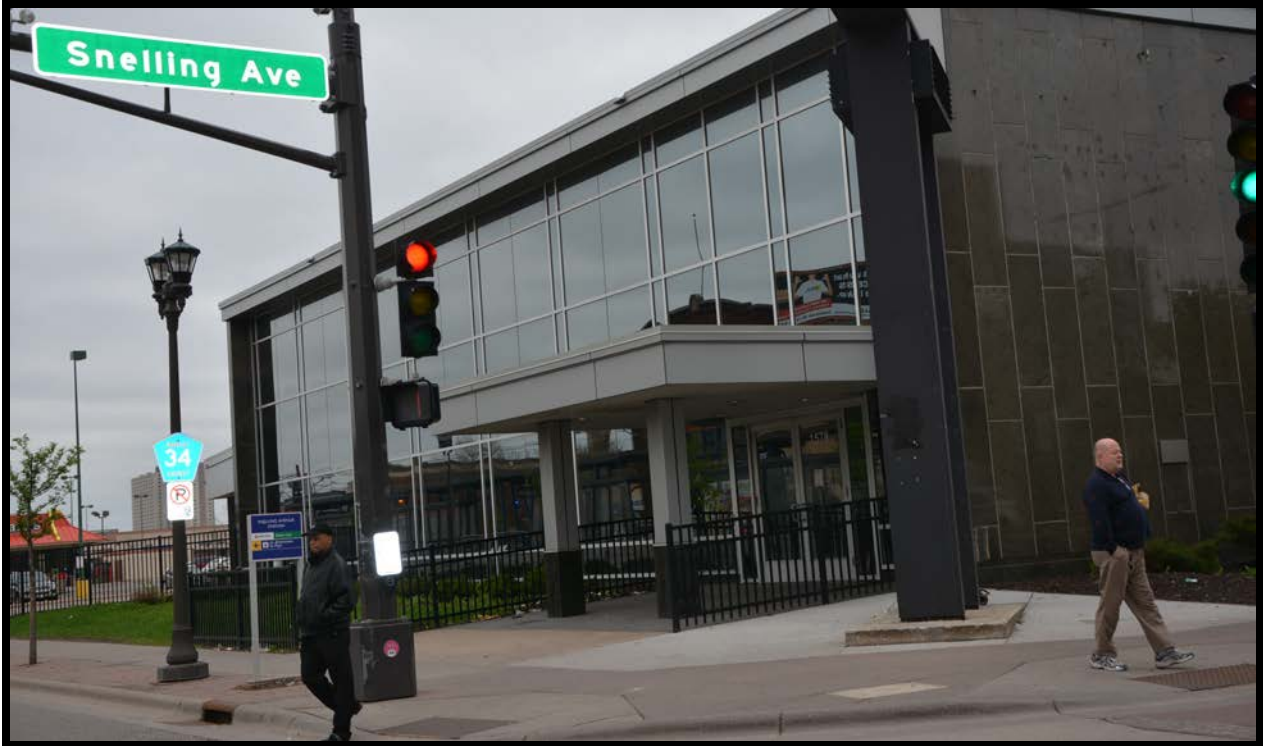
Figure Twenty-Seven: Front (North) elevation of the former Midwest National Bank Building (Structure 1) . View to southeast from the intersection of Snelling and University Avenues.

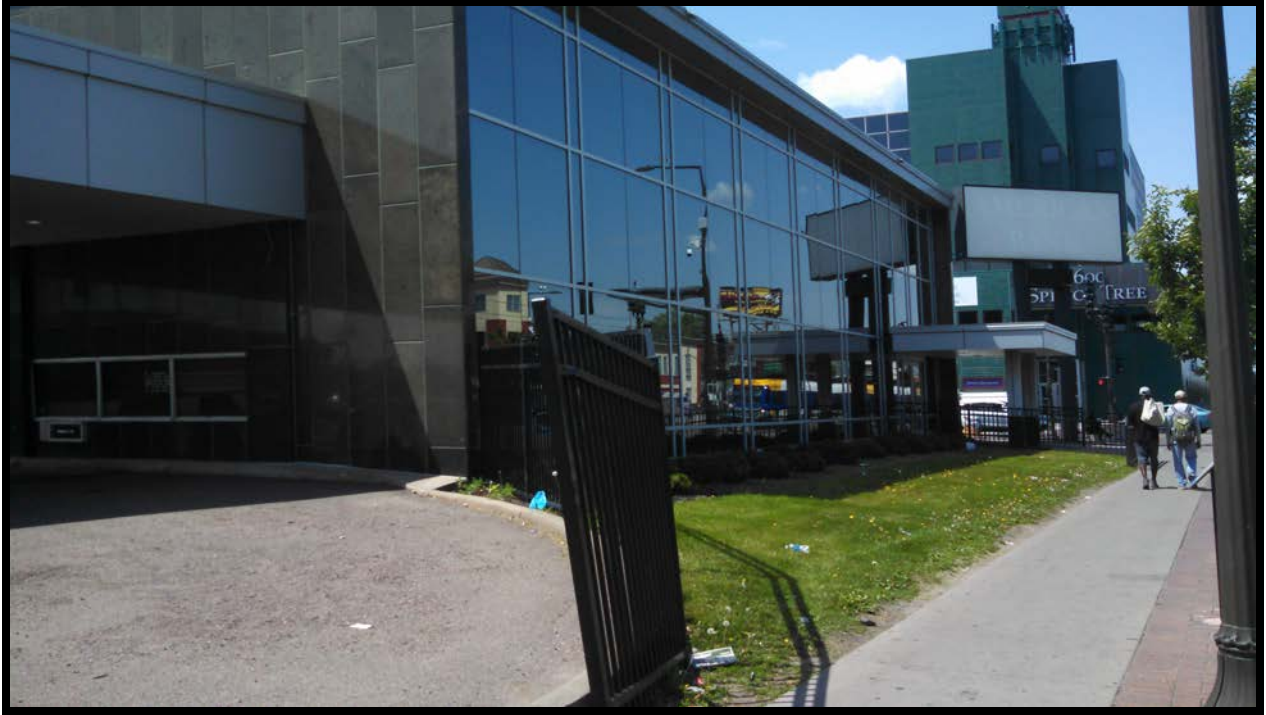
Figure Twenty-Eight: Detail of front (North) elevation of the former Midwest National Bank Building (Structure 1). View to west/southwest towards the intersection of Snelling and University Avenues.

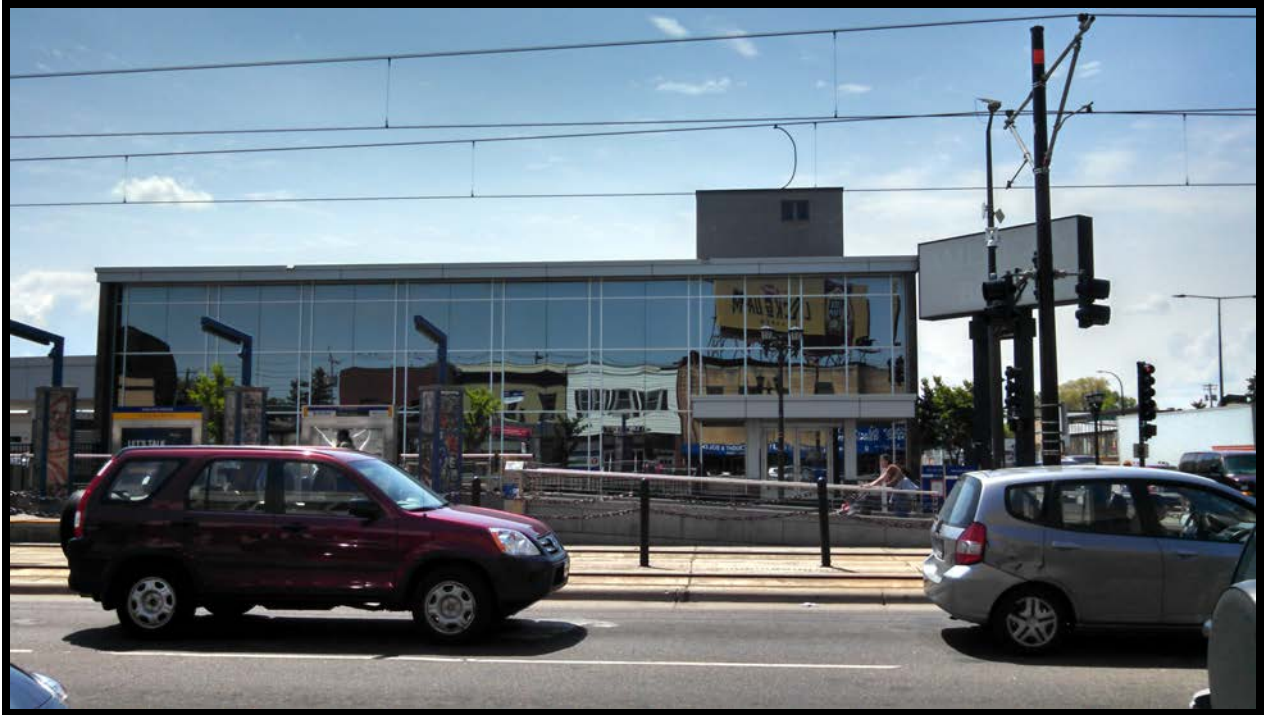
Figure Twenty-Nine: Front (North) elevation of the former Midwest National Bank Building (Structure 1). View to south with the intersection of Snelling and University Avenues to the right.

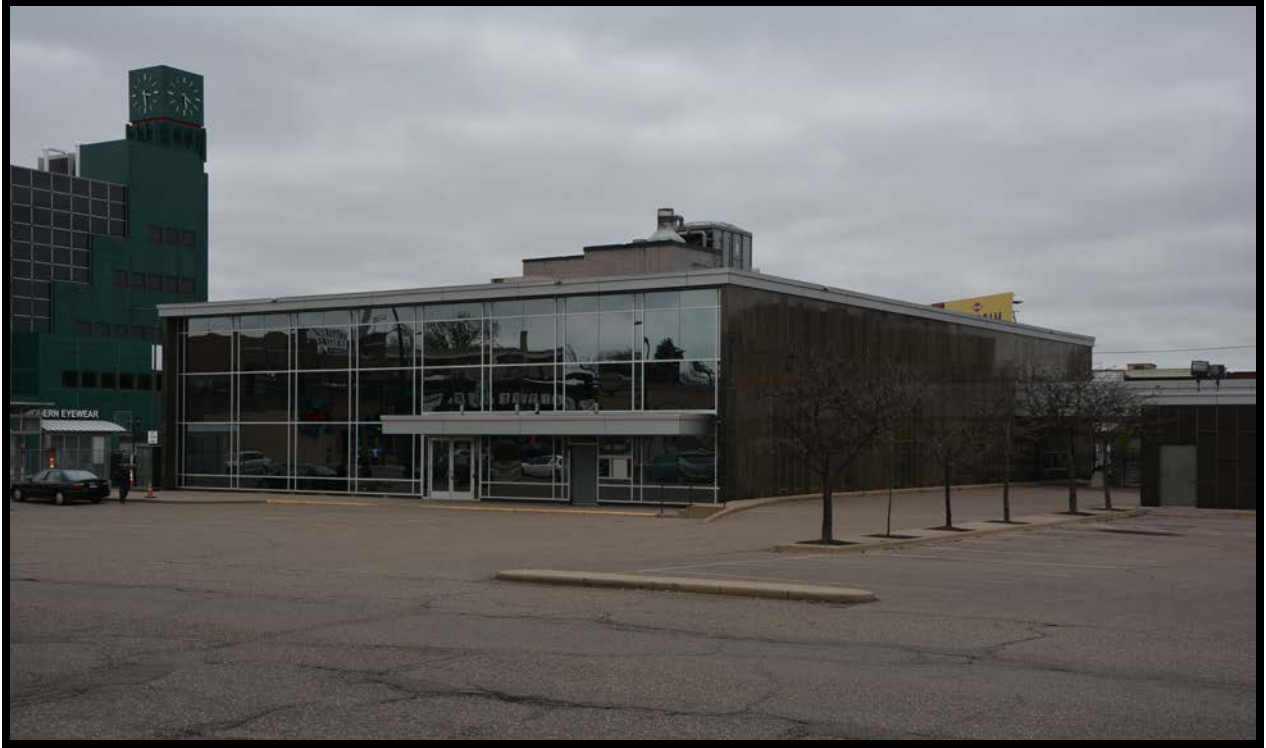
Figure Thirty: Rear (south) elevation of the former Midwest National Bank Building (Structure 1). View to northwest toward the intersection of Snelling and University Avenues.

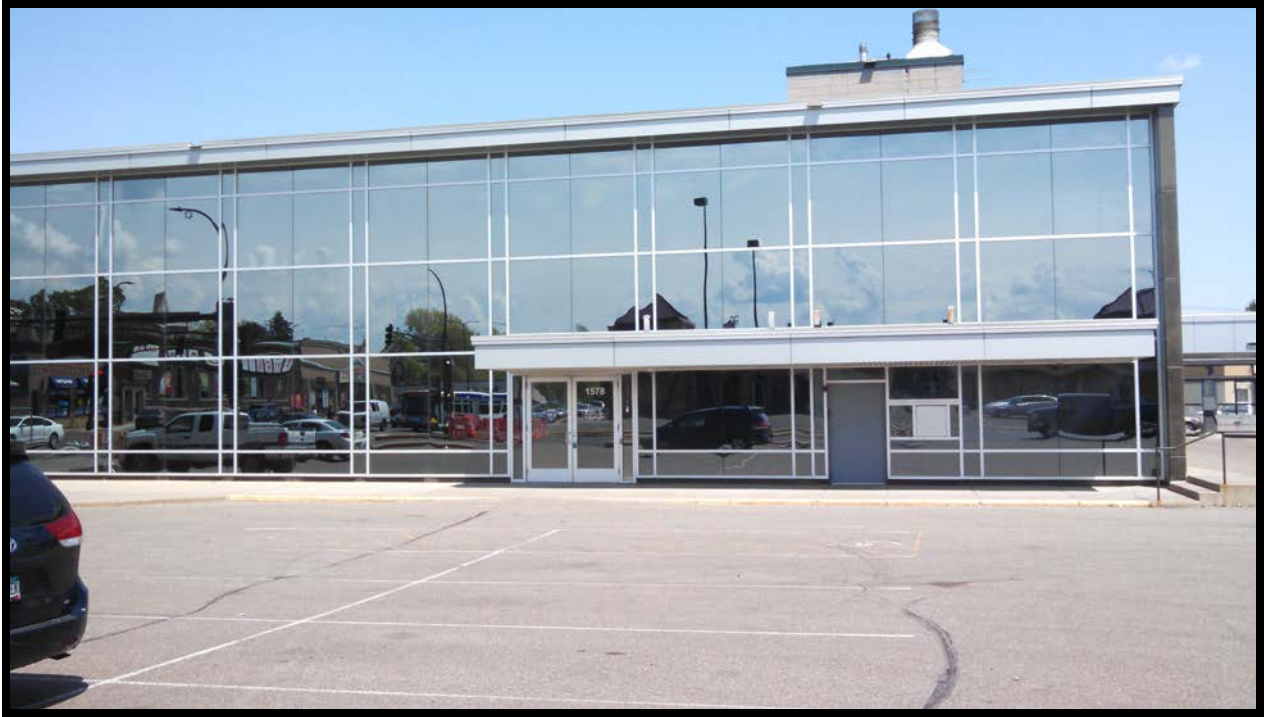
Figure Thirty-One: Detail of rear (south) elevation of the former Midwest National Bank Building (Structure 1). View to north toward the intersection of Snelling and University Avenues.

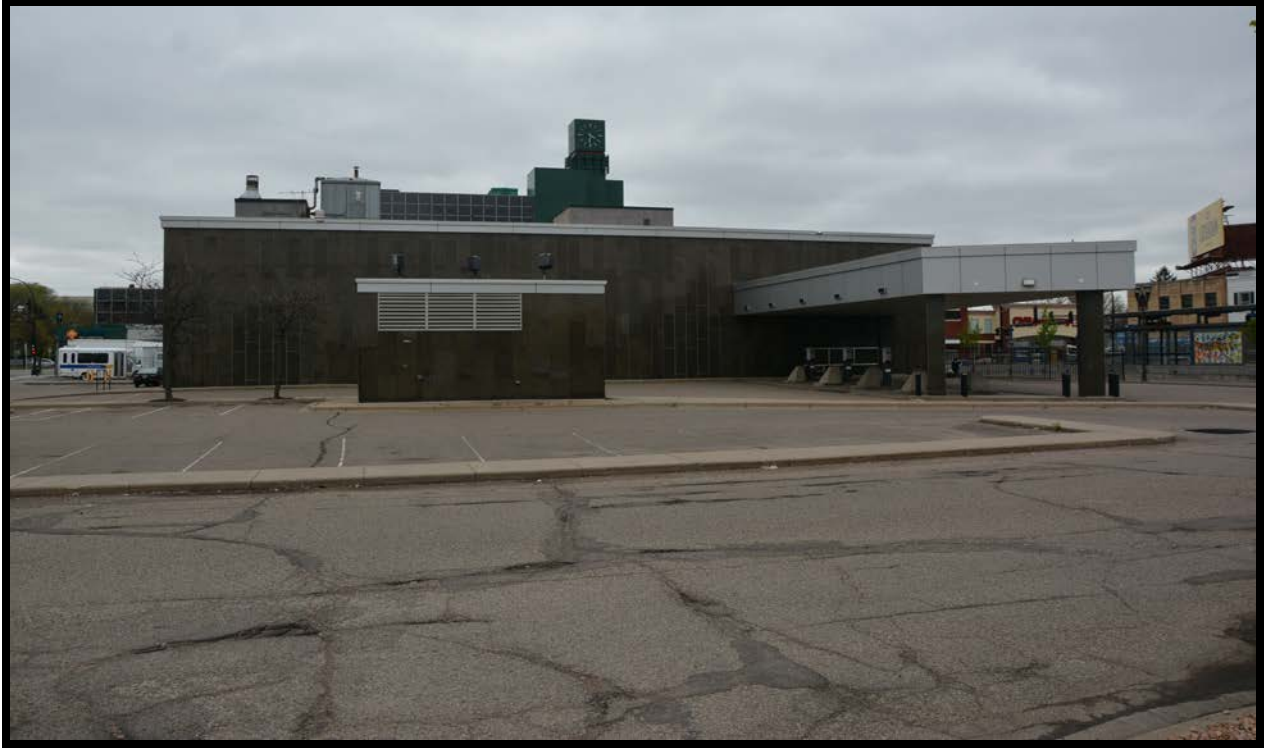
Figure Thirty-Two: Eastern elevation of the former Midwest National Bank Building (Structure 1). View to west showing drive-through lanes and parking area.

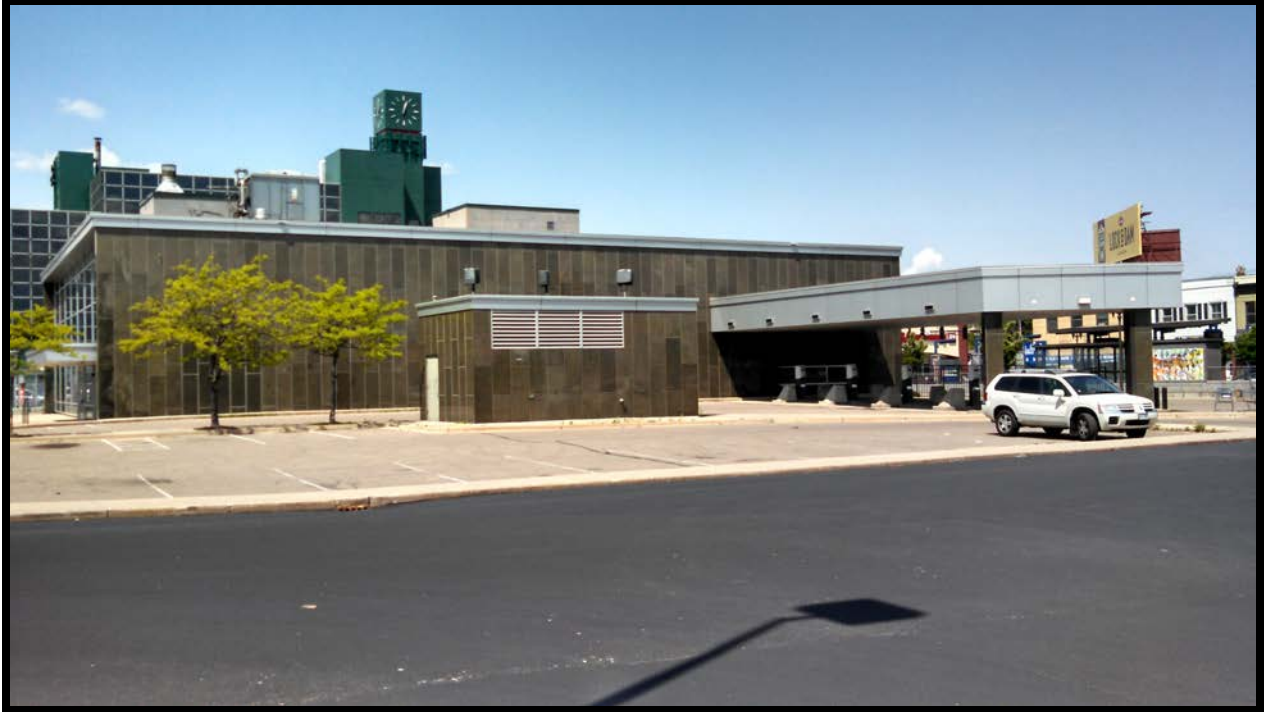
Figure Thirty-Three: Eastern elevation of the former Midwest National Bank Building (Structure 1). View to west/northwest showing drive-through lanes and parking area.

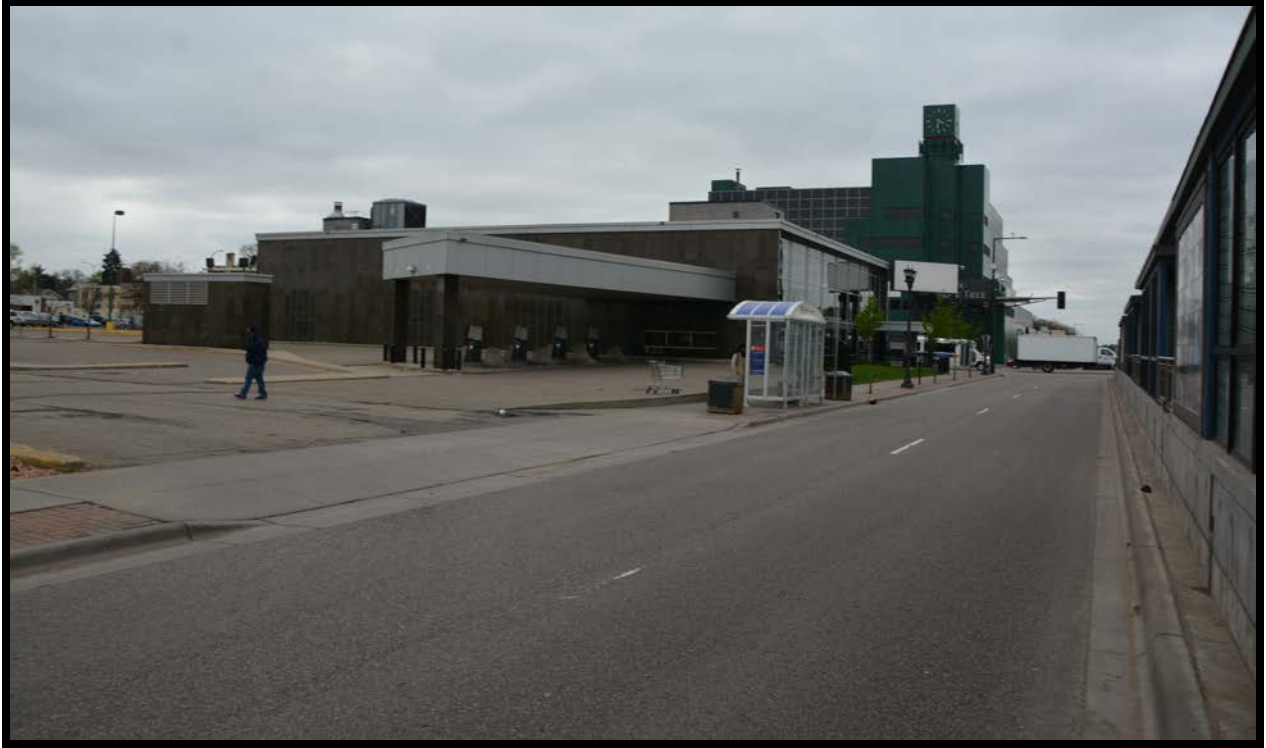
Figure Thirty-Four: Eastern and northern elevation of the former Midwest National Bank Building (Structure 1). View to southwest from University Avenue.

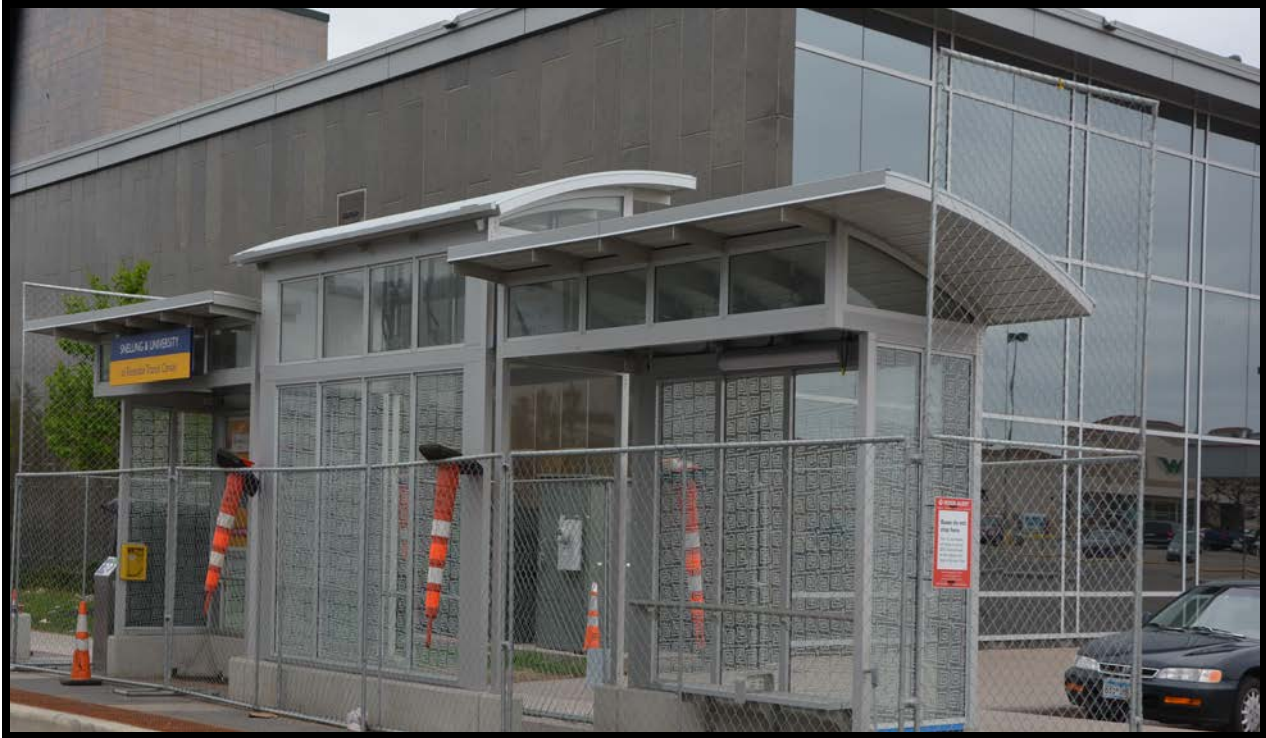
Figure Thirty-Five: Western elevation of the former Midwest National Bank Building (Structure 1). View to northeast from Snelling Avenue.

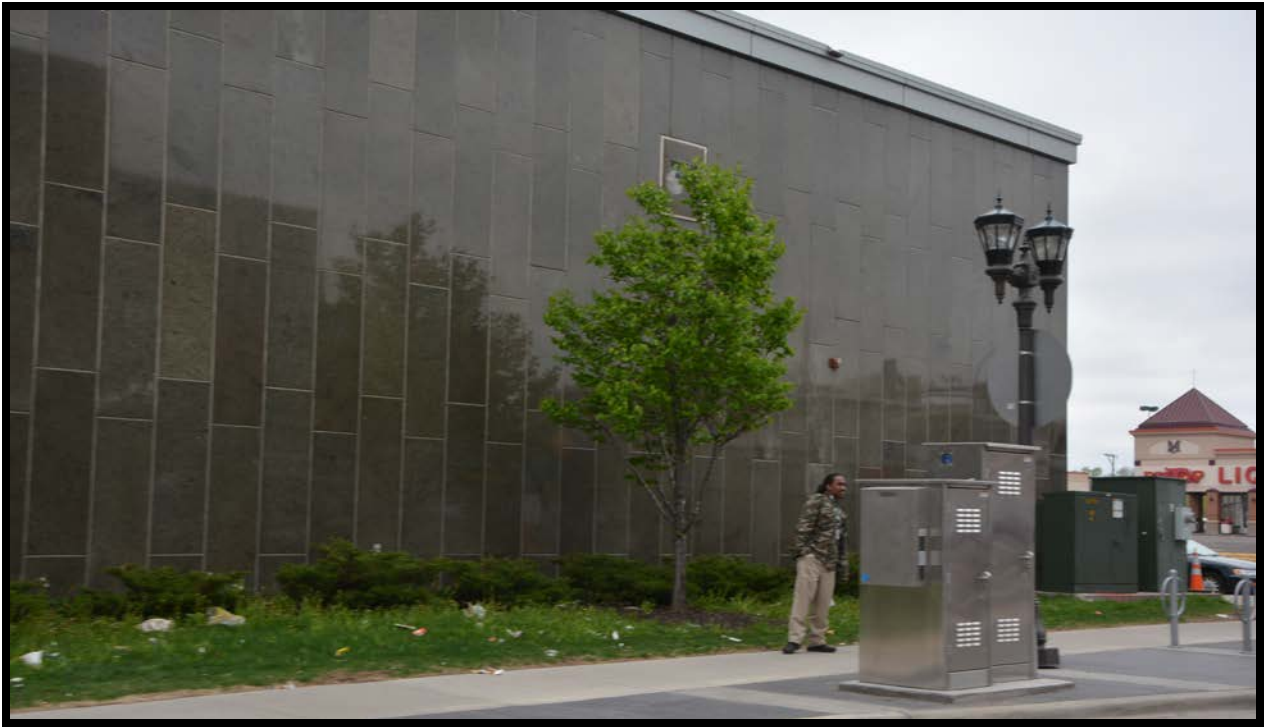
Figure Thirty-Seven: Southern areas of the western elevation of the former Midwest National Bank Building (Structure 1). View to southeast from Snelling Avenue.

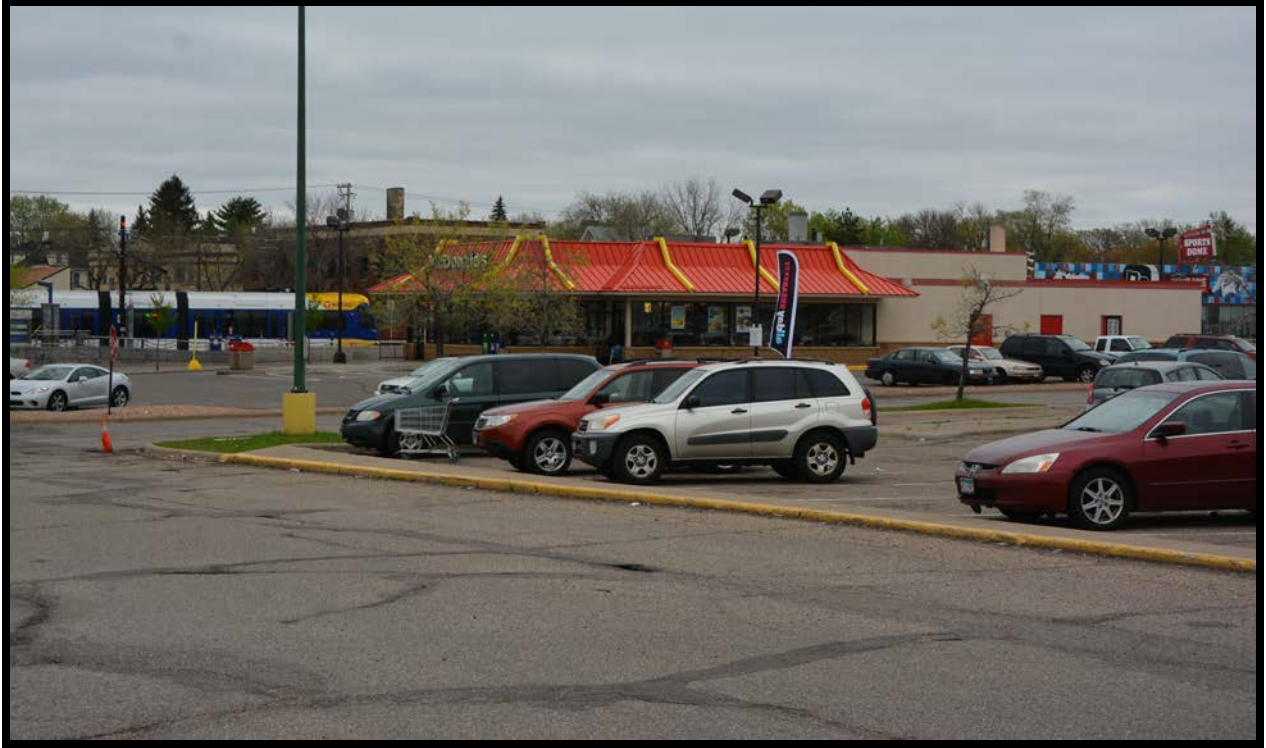
Figure Thirty-Eight: Southern elevation of Structure 3. View to northeast.

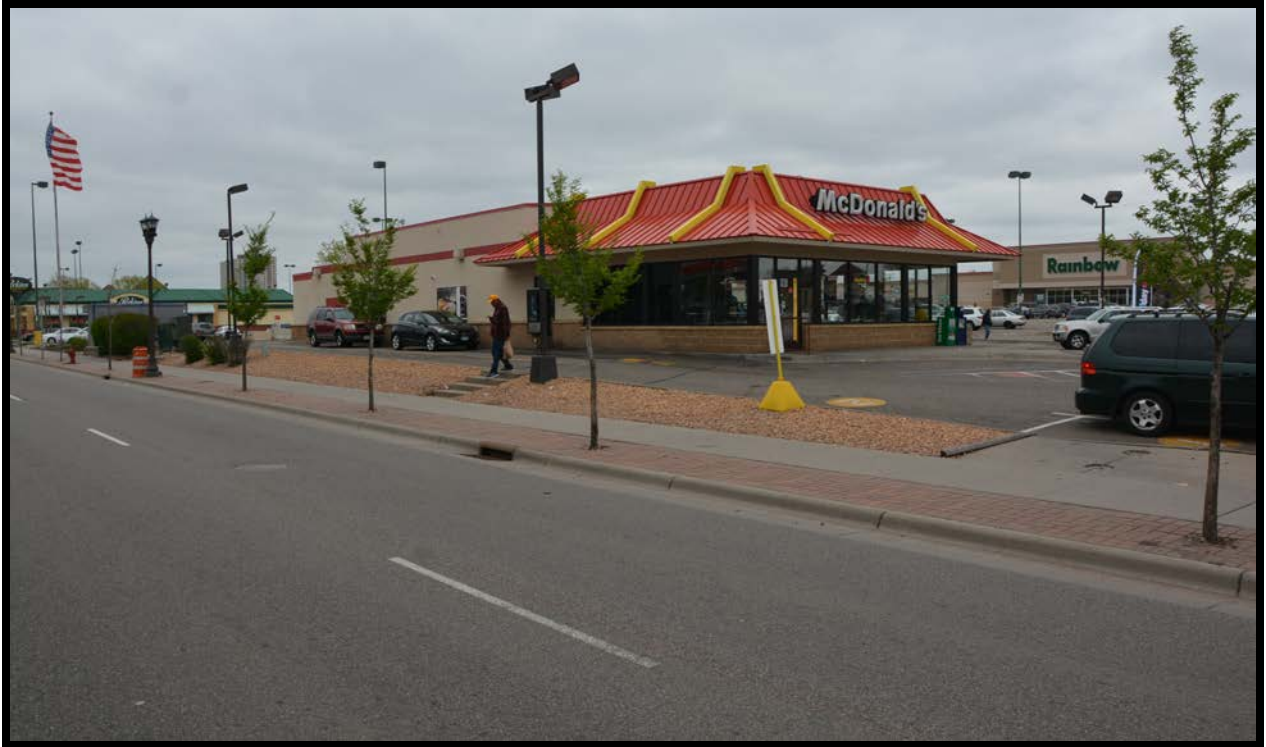
Figure Thirty-Nine: Northern and western (front) elevations of Structure 3. View to southeast.

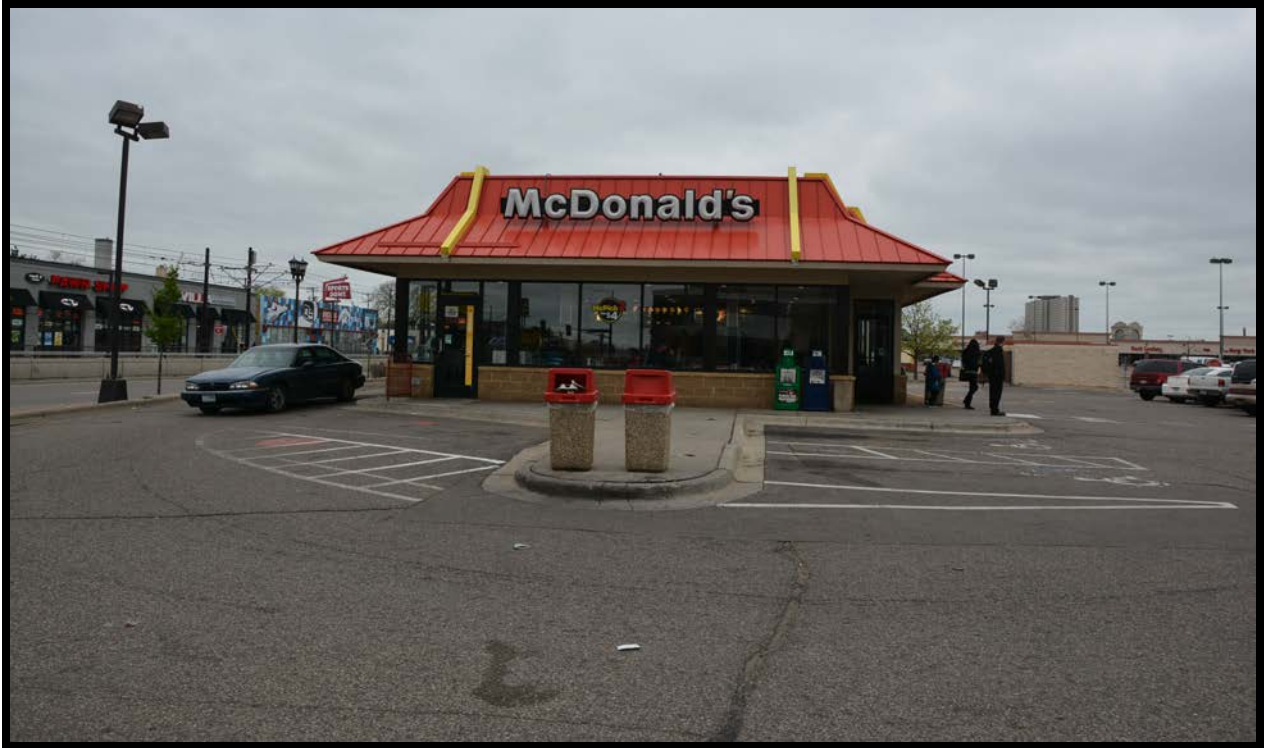
Figure Forty: Western (front) elevation of Structure 3. View to east.

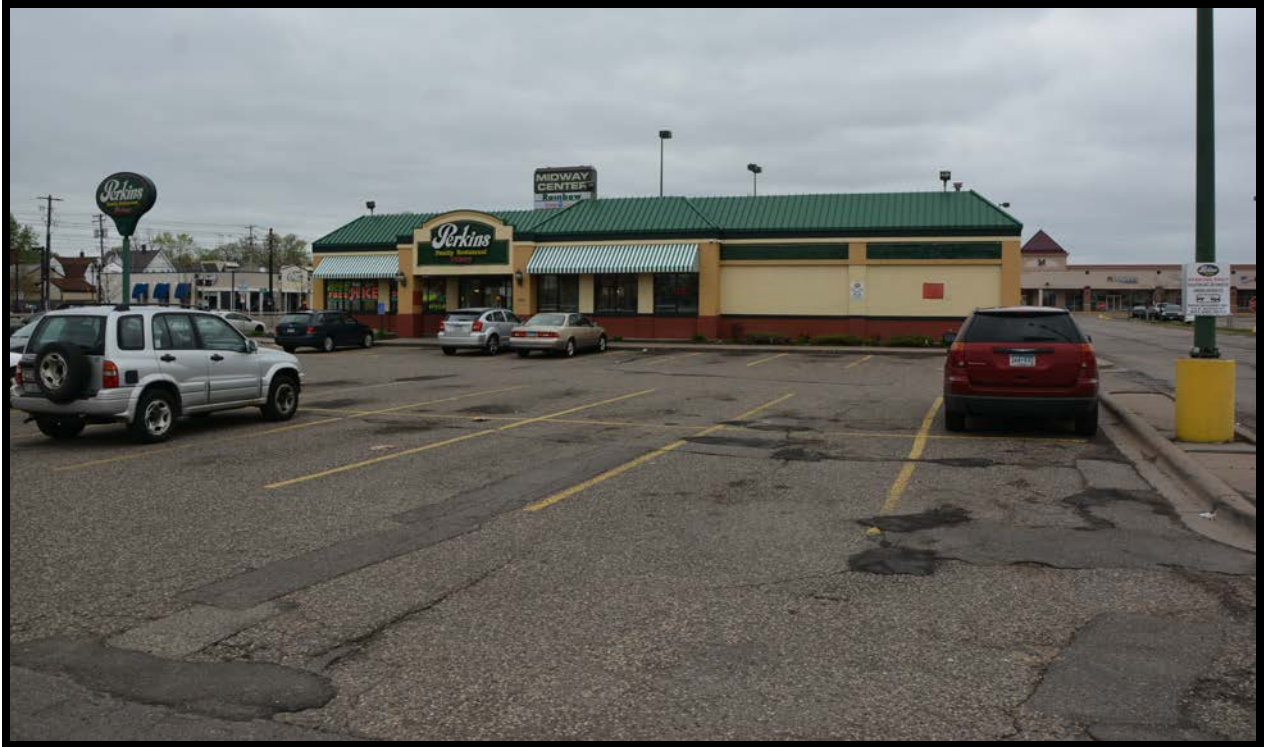
Figure Forty-One: Western (front) elevation of Structure 4. View to east.

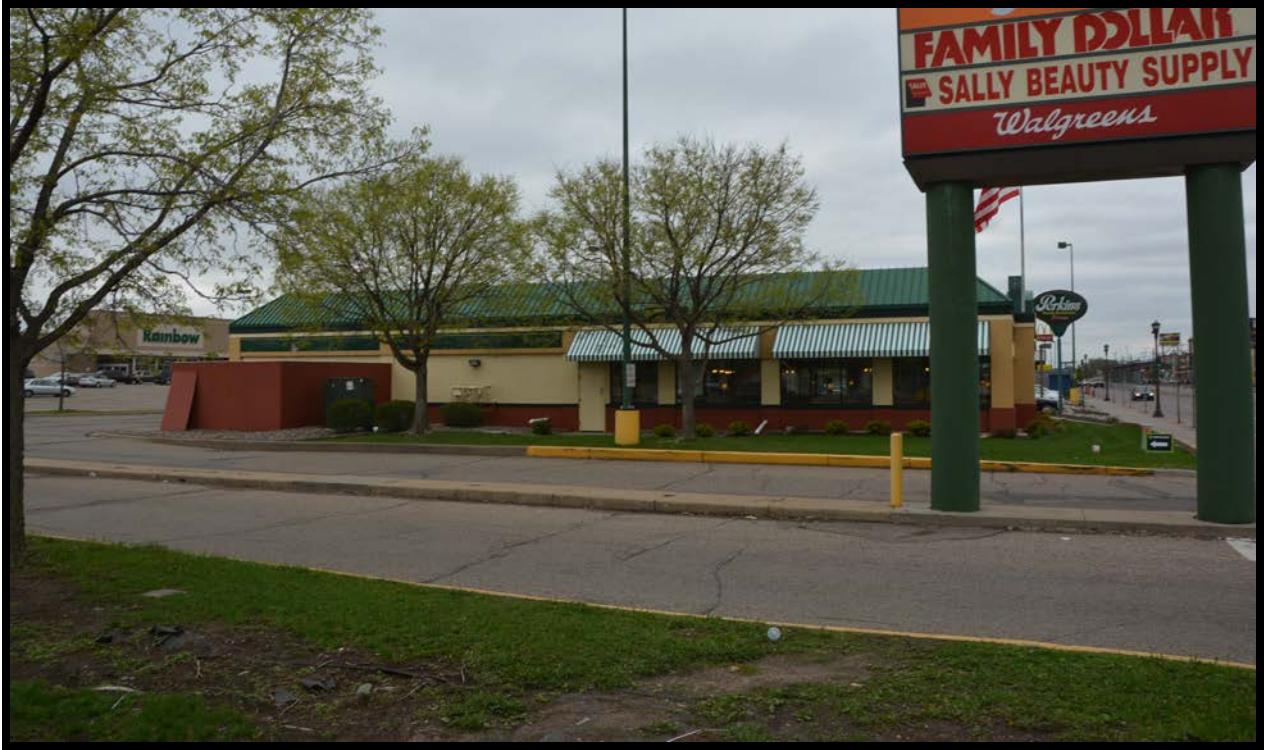
Figure Forty-Two: Eastern (rear) elevation of Structure 4. View to west.

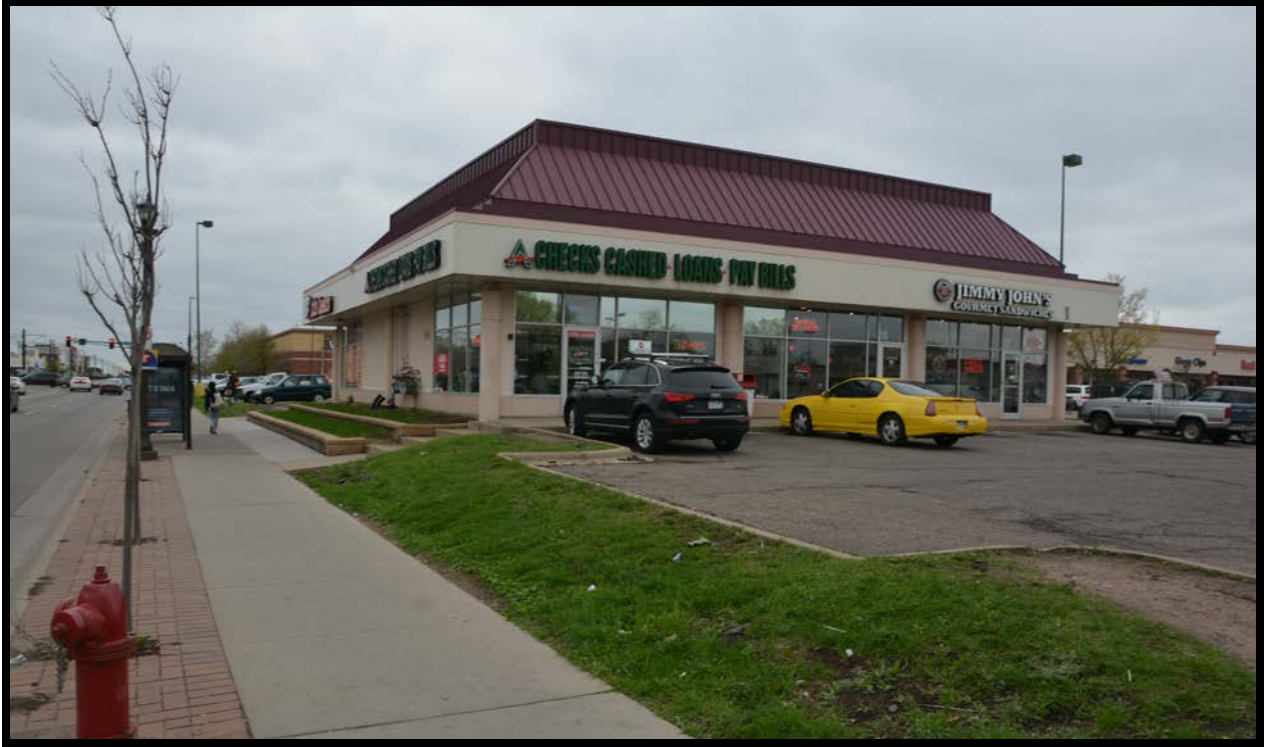
Figure Forty-Three: Western elevation of Structure 6. View to east/southeast.

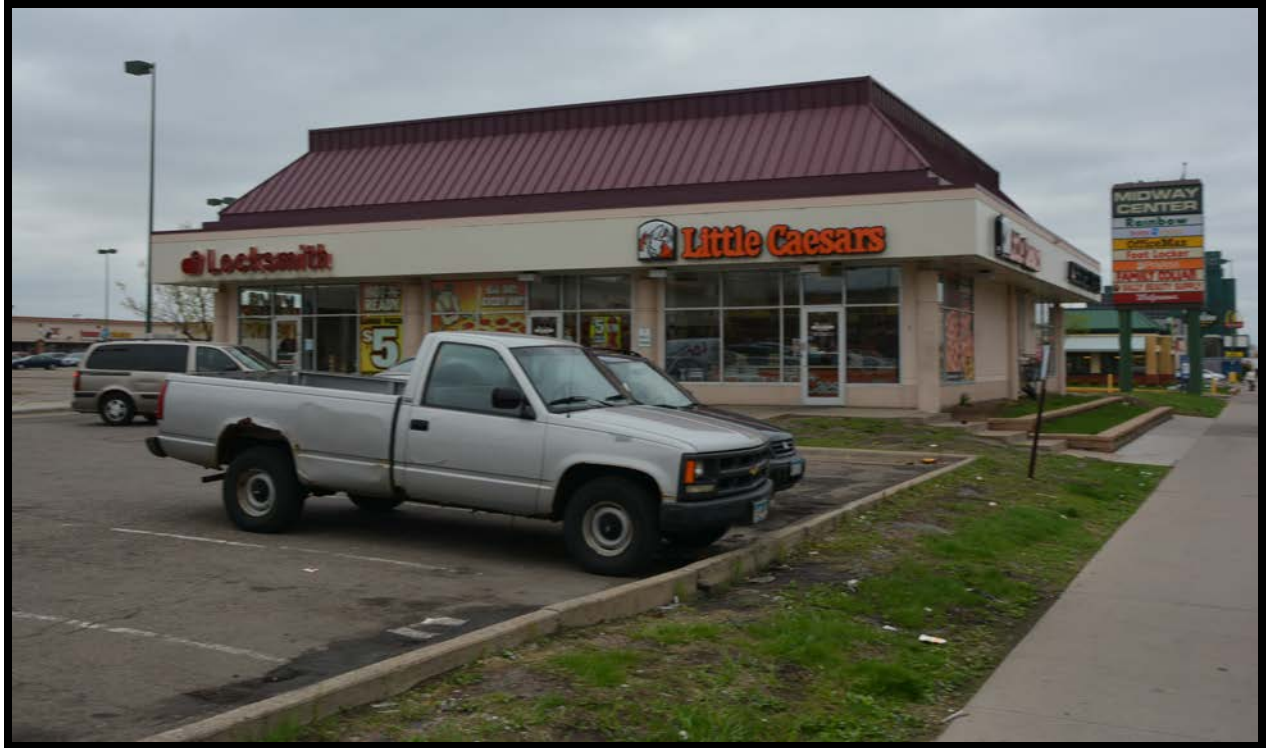
Figure Forty-Four: Eastern elevation of Structure 6. View to west/southwest.
