**Cultural Resource Analysis, Alternative Urban Areawide
Review (AUAR) for the Proposed Minnesota United Midway
Project, City of St. Paul, Ramsey County, Minnesota.
MNSHPO # 2016-1711**

Prepared for Stantec Consulting Services, Inc.

15 May, 2016

**John G. Hodgson
Principal Investigator
Phase One Archaeological Services Inc.
5618 Hempstead Road
Madison, Wisconsin, 53711**

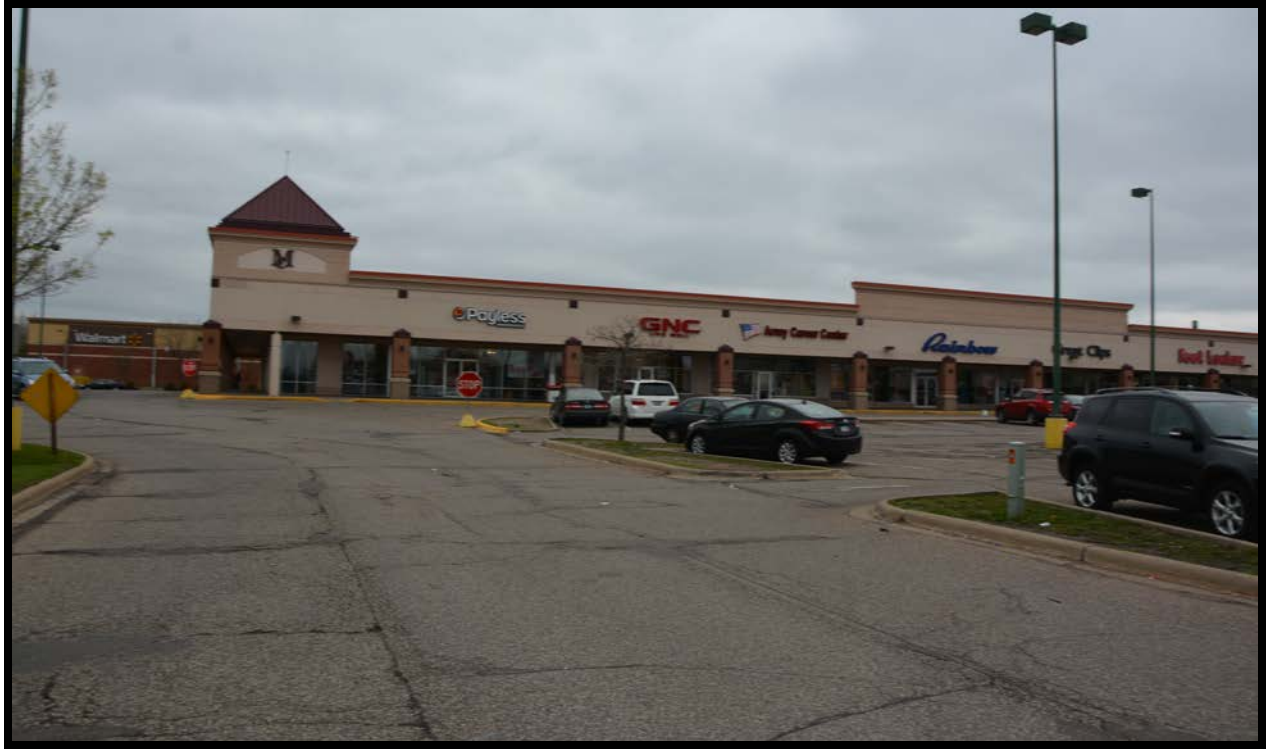
Figure Forty-Five: Front elevation (western) of the eastern wing of Structure 5. View to east/southeast.

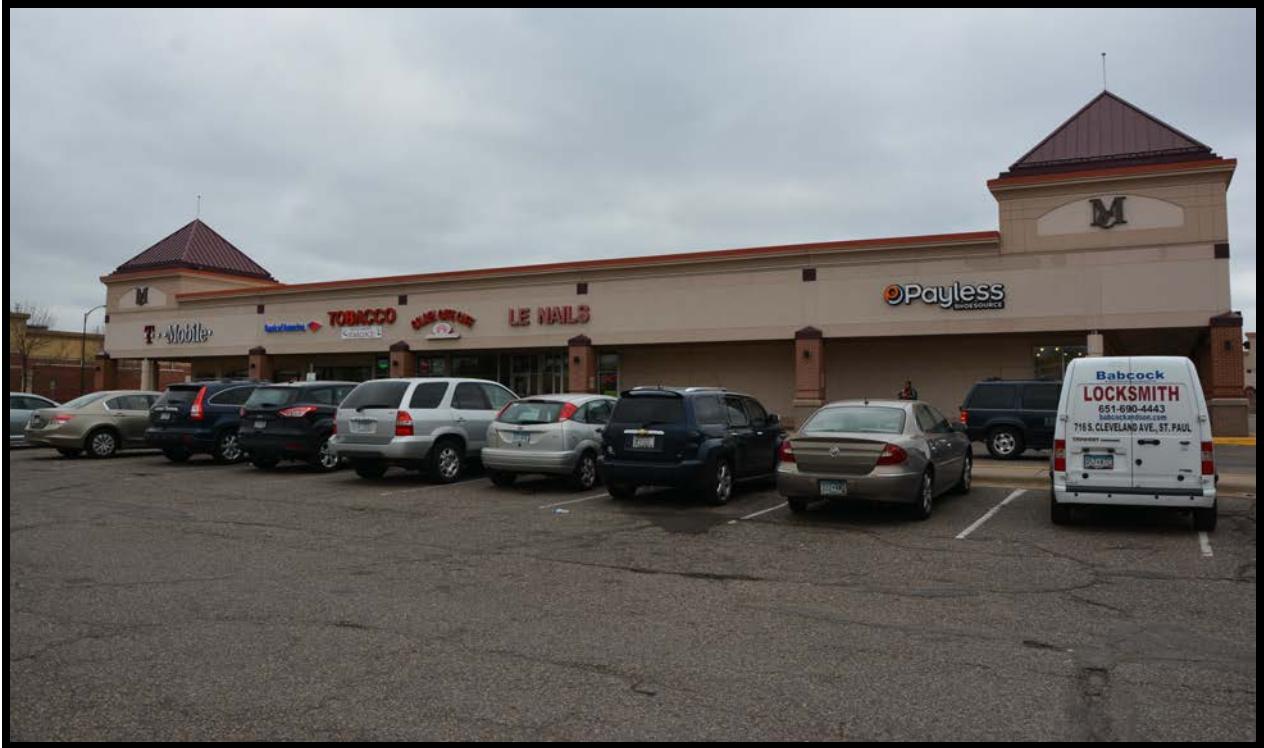
Figure Forty-Six: Northern elevation of the eastern wing of Structure 5. View to south.

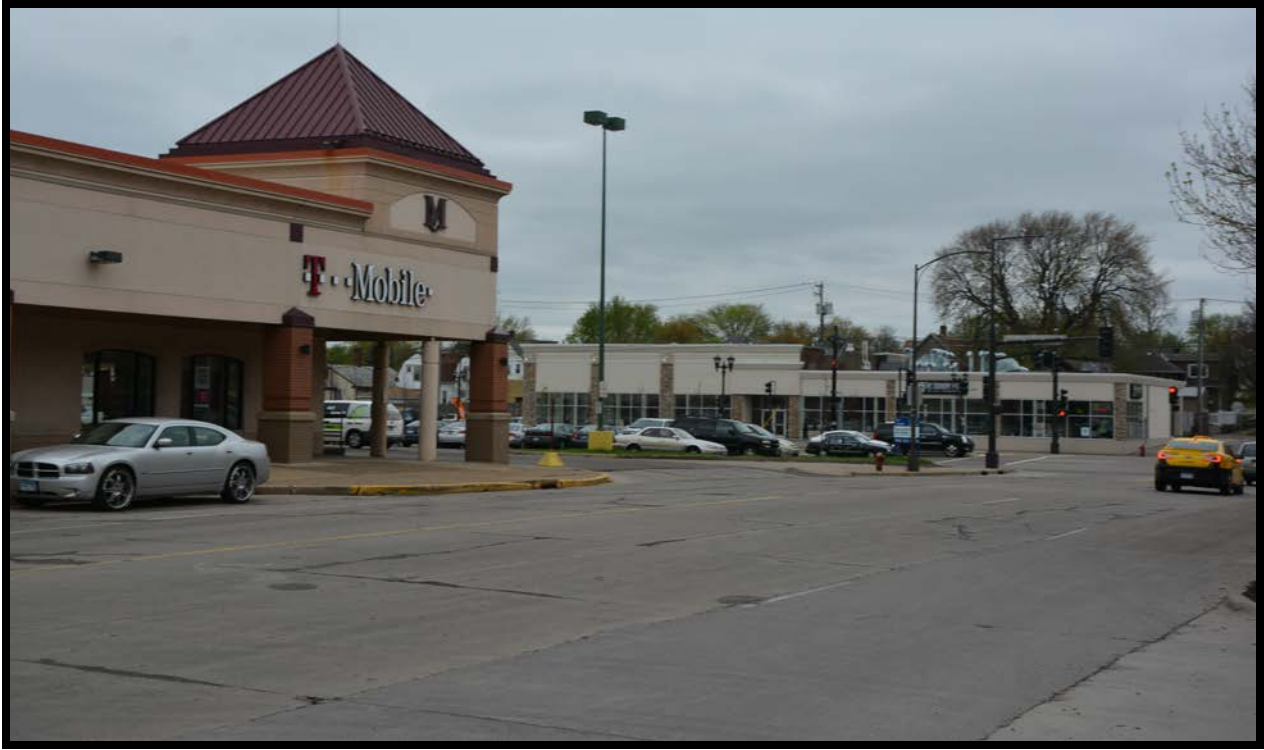
Figure Forty-Seven: Eastern elevation of the eastern wing of Structure 5. View to north/northwest from Pascal St.

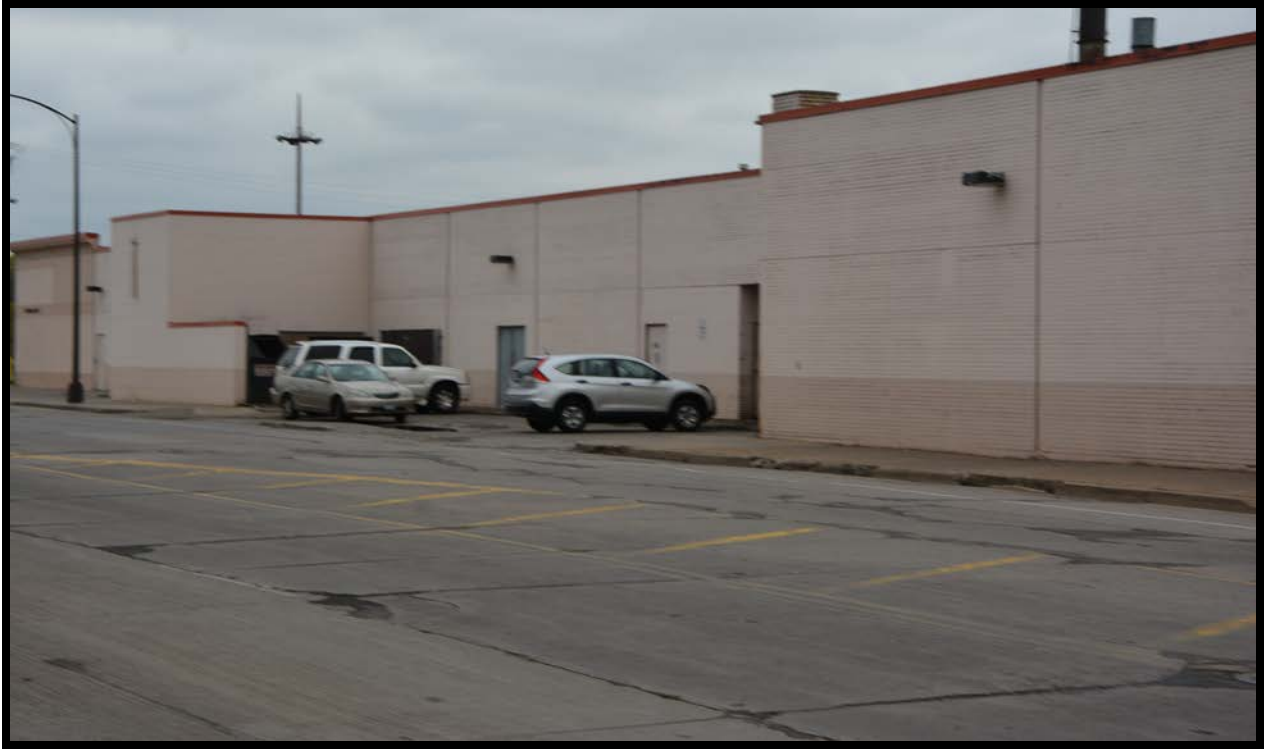
Figure Forty-Nine: Eastern elevation of the eastern wing of Structure 5. View to southwest on Pascal St.
