2016 Water Quality & Quantity Monitoring Program

Monitoring Report

June 2017

**PREPARED BY:
WSB & ASSOCIATES, INC.
701 XENIA AVENUE SOUTH, SUITE 300
MINNEAPOLIS, MN 55416**

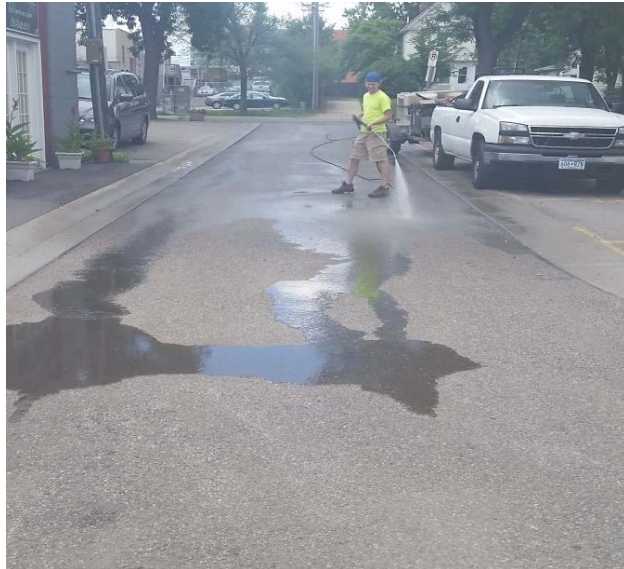
Photo 13-6: Pressure washing maintenance

Following the sweeping, the entire alley was pressure washed (**Photo 13-6**). Additional spraying was completed in areas that were observed to have heavier sediment accumulation prior to maintenance. Additional maintenance photos are provided in the **Appendix D**.

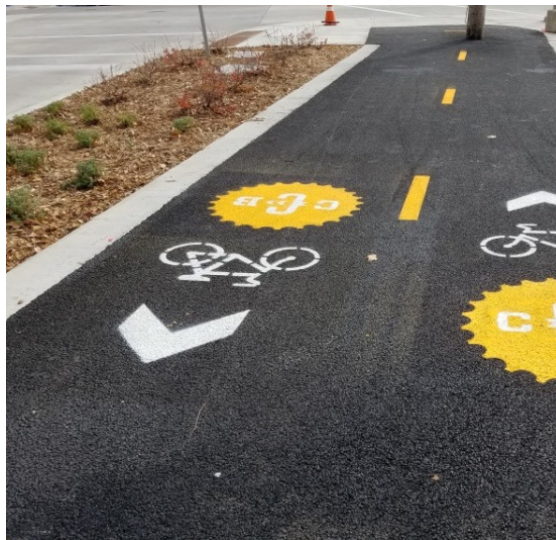
Photo 13-7: Capital City Bikeway (CCB) – Jackson Street/Kellogg Avenue

The Jackson Street Pervious Bike Path (**Photo 13-7** and **13-8**) is a section of the Capital City Bikeway (CCB), a system of off-street bicycle trails in downtown St. Paul. The CCB Jackson Street section is eight blocks long and consists of approximately 2,750 square yards of pervious asphalt. The asphalt material selected for construction meets the MnDOT Specification 2360 S-158 for porous asphalt. In November 2016, infiltration testing was performed on the recently completed pavement section stretching from Kellogg Avenue to 7th Street. Construction of the final section between 7th Street and 11th Street was not finished at the time of infiltration testing. The site and infiltration test locations are depicted on **Figure 13-3**.

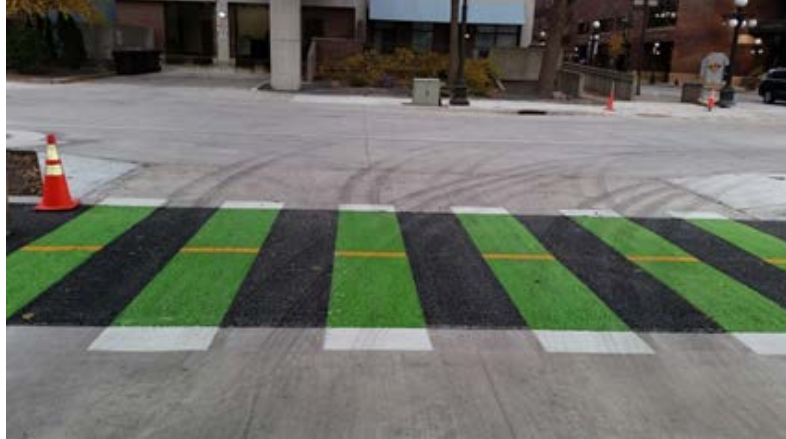
Photo 13-9: Test Locations JS-1 and JS-2

- Locations JS-1 and JS-2 (Photo 13-9) were located in parking ramp entrances which were observed to have some sediment and debris accumulation from vehicular traffic. Those locations had greater infiltration rates than locations JS-8, JS-9, JS-10, and JS-11, which were not located in heavy vehicular traffic areas, but in close proximity to large areas of impervious concrete.

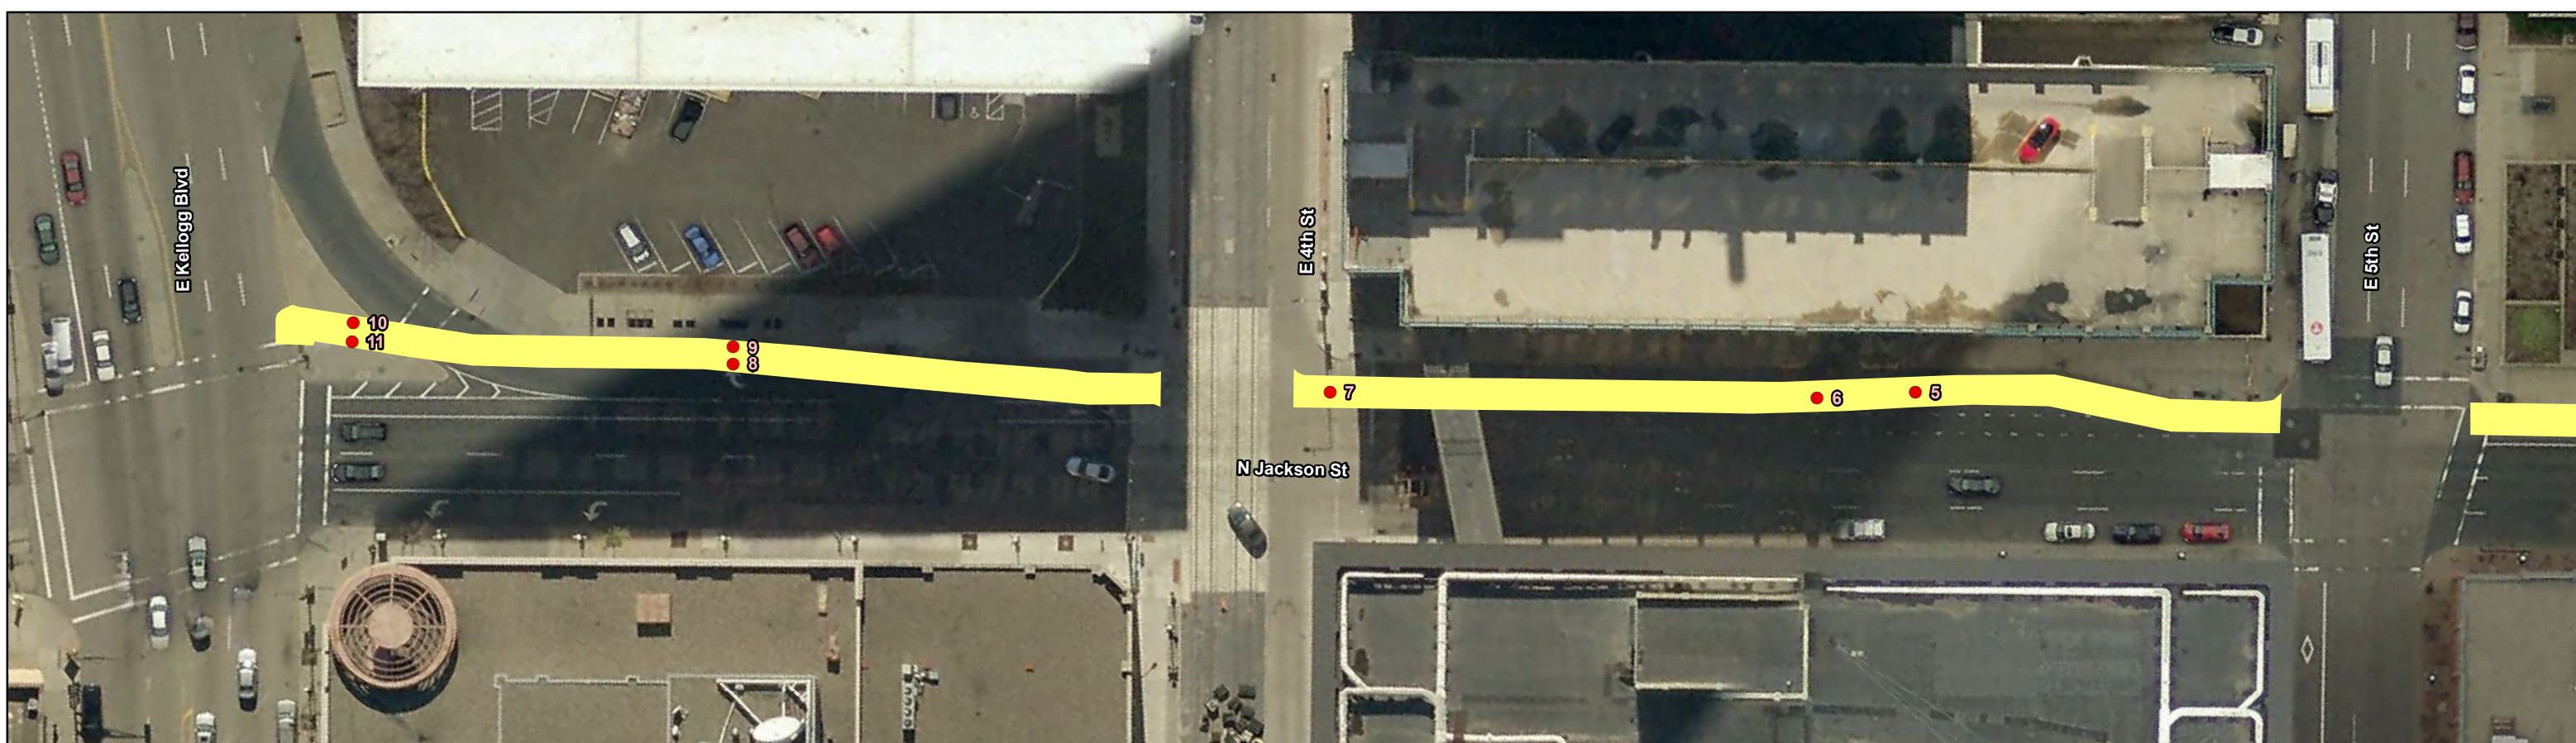
Figure 13-3 Jackson Street
Pervious Pavement Test Locations
2016 Water Quantity and Quality Monitoring Program
City of St. Paul, MN

The infiltration test results from the 11 locations are summarized in **Table 13-3**. The infiltration test locations are depicted on **Figure 13-3**.

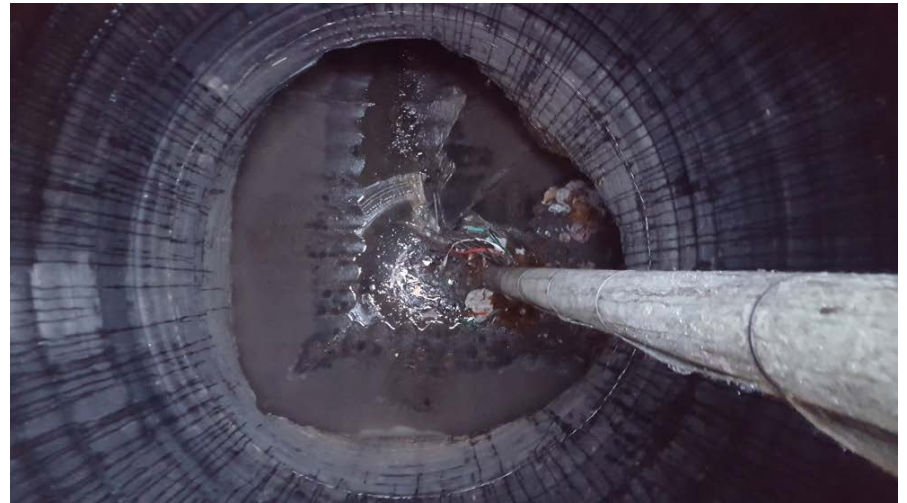
Arundel BMP Inspections

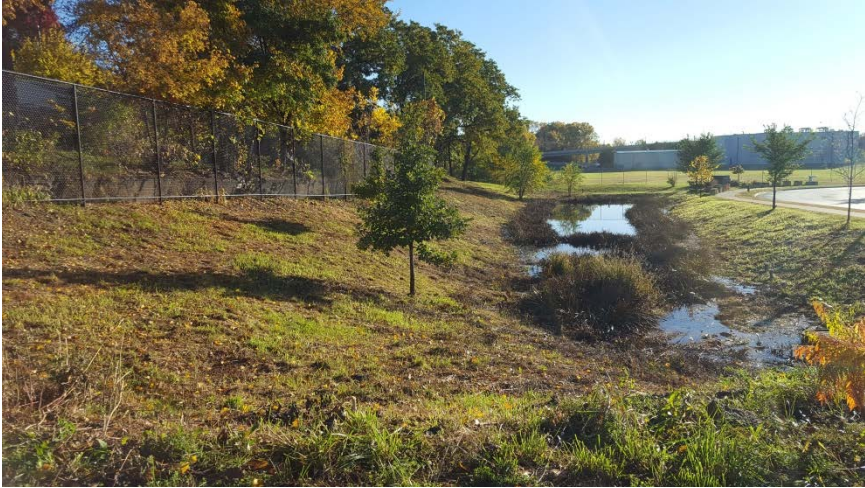
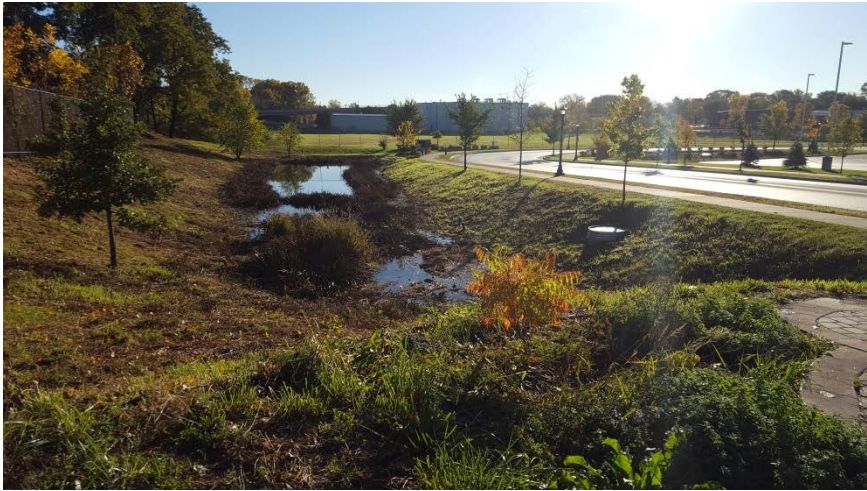
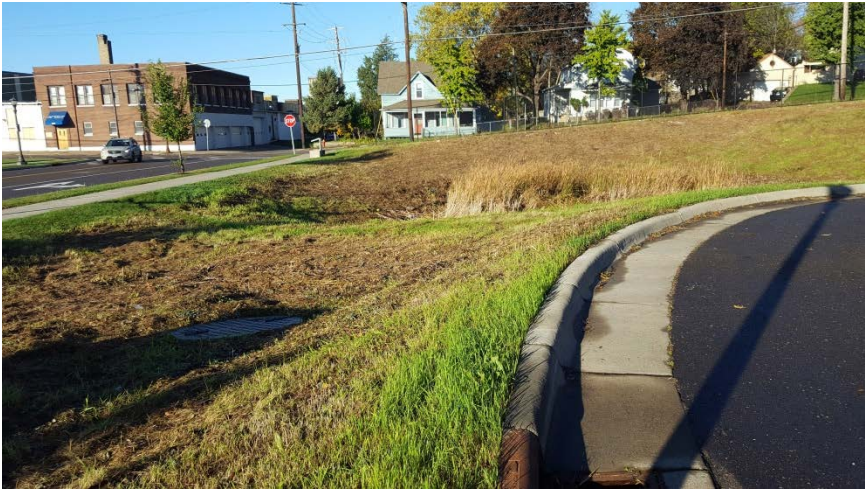
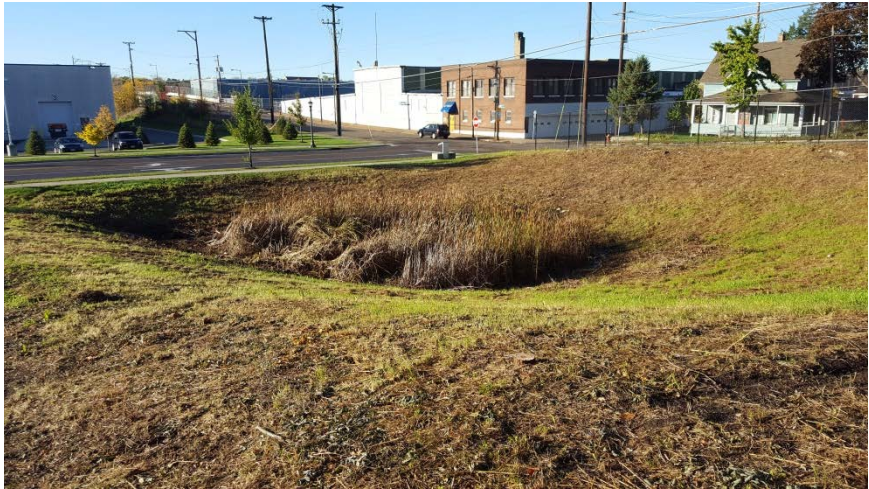
Beacon Bluff BMP Inspection 11/15/2016

(SAFL Baffle – Top L, Rain Garden – Top R, West Pond – BTM L, and Underground Chamber – BTM R)

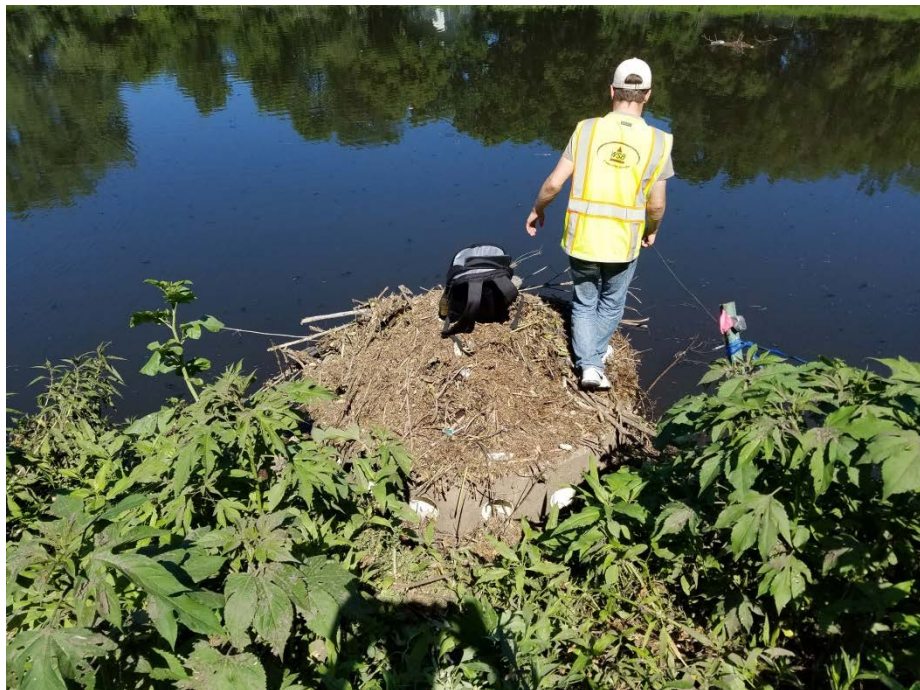
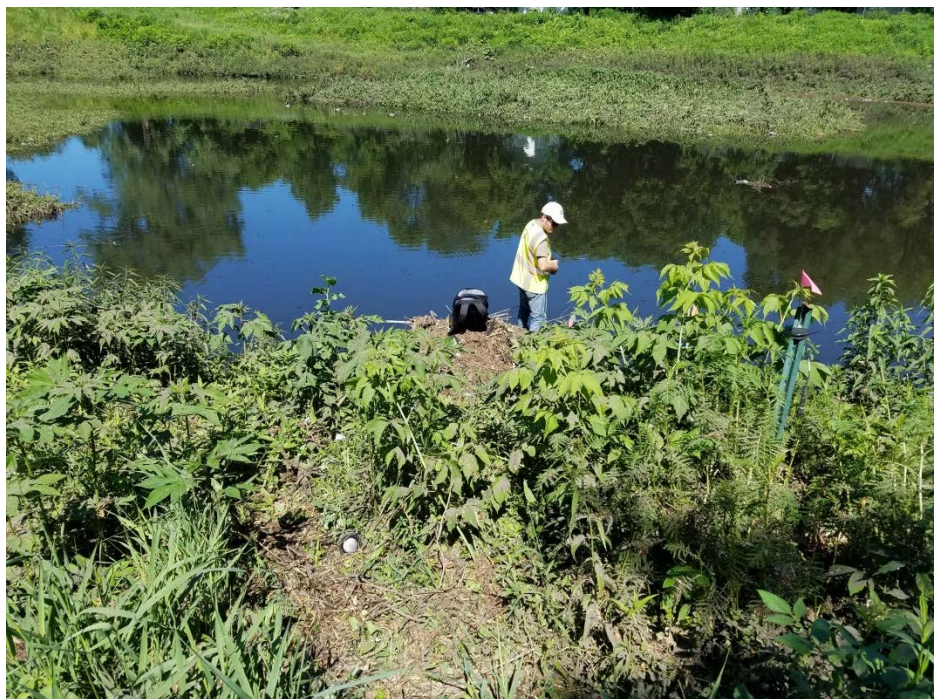
Flandrau-Hoyt

(Debris on OCS)

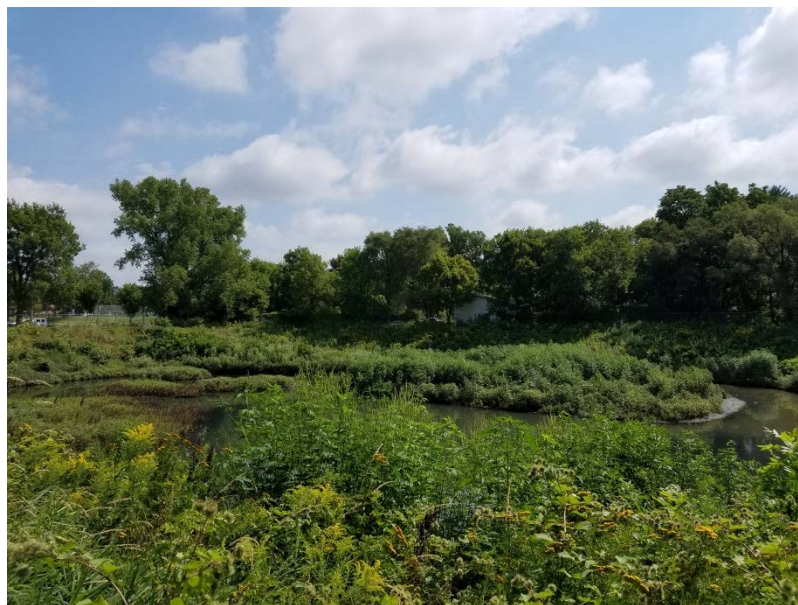
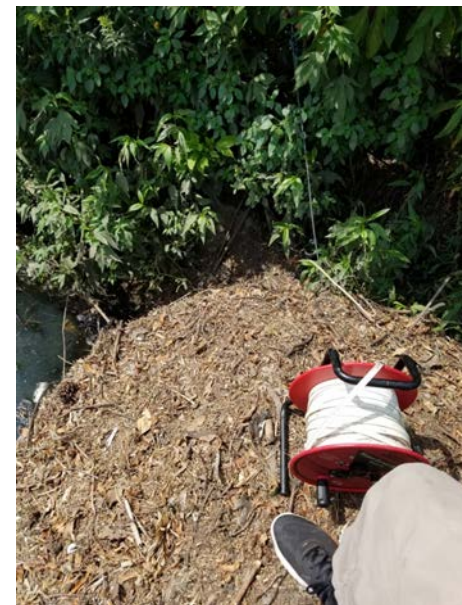
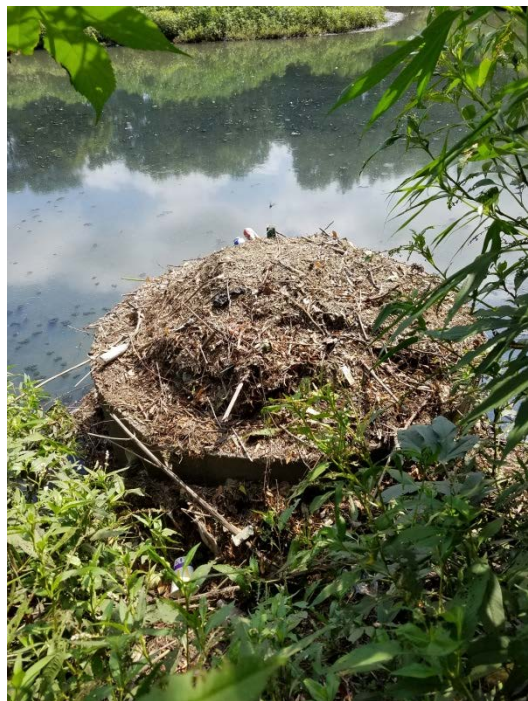
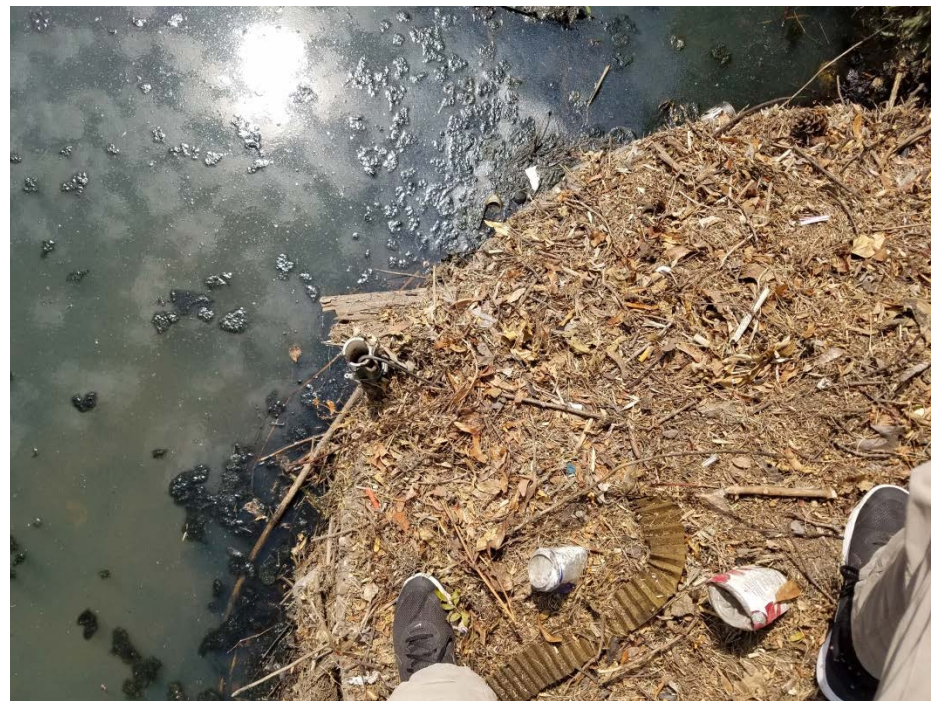
Flandrau-Hoyt

8/2/2016
(Debris on OCS)

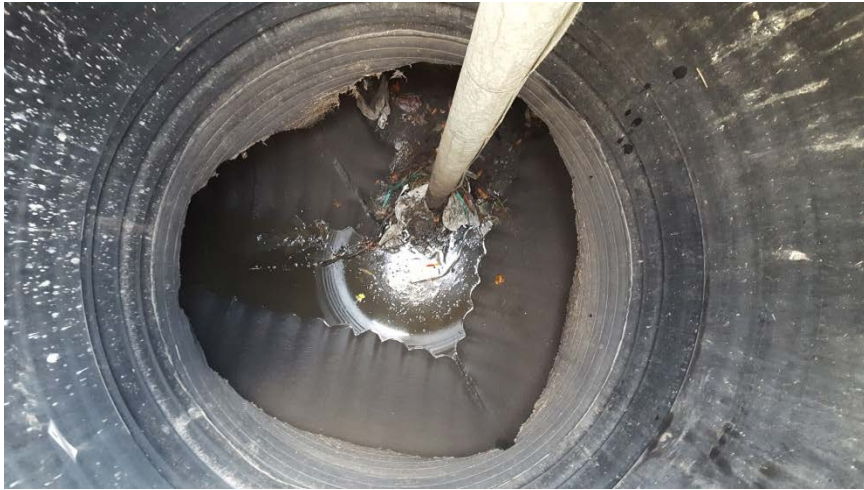
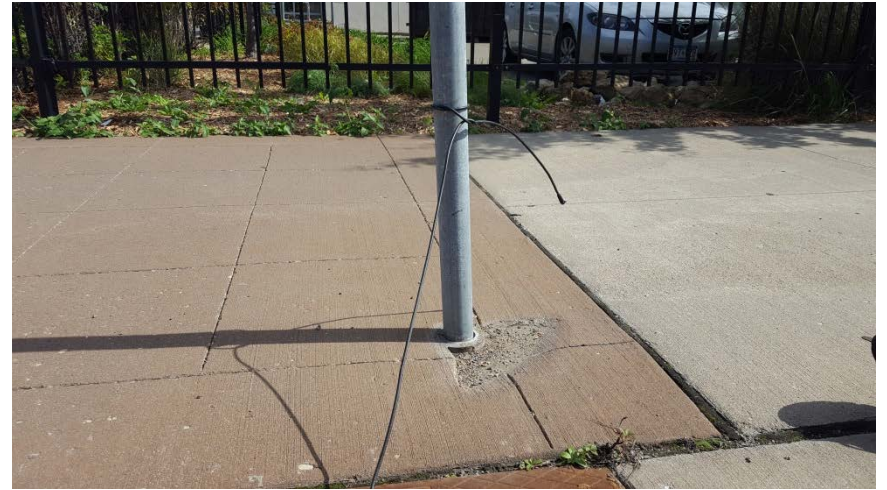
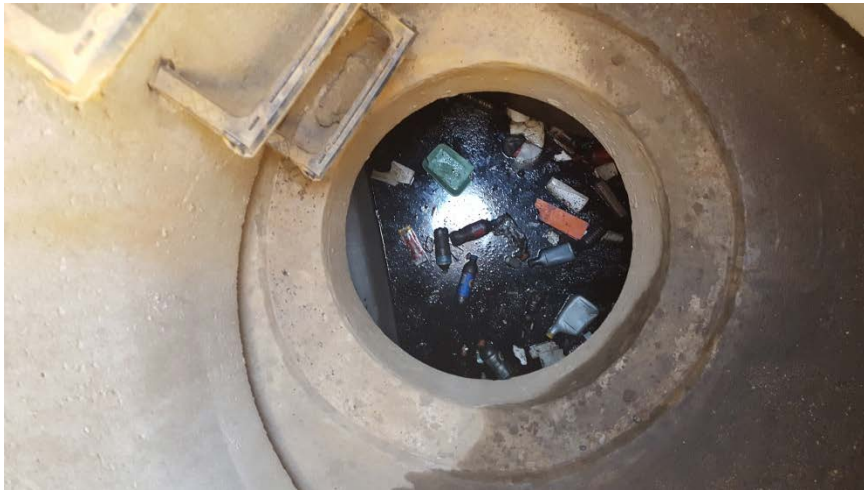
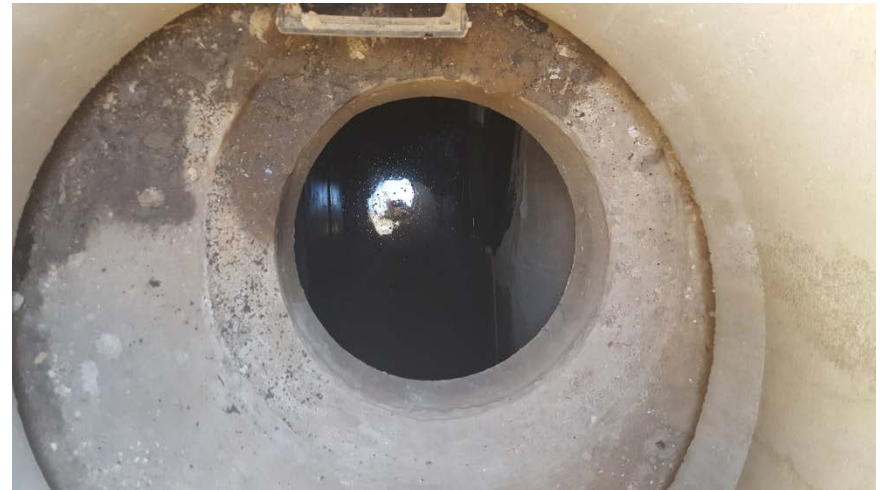
Saint Albans BMP Inspection 9/20/2016

(BMP Pipe – Top L, Vandalized Equip – Top R, Pre-treatment – BTM)

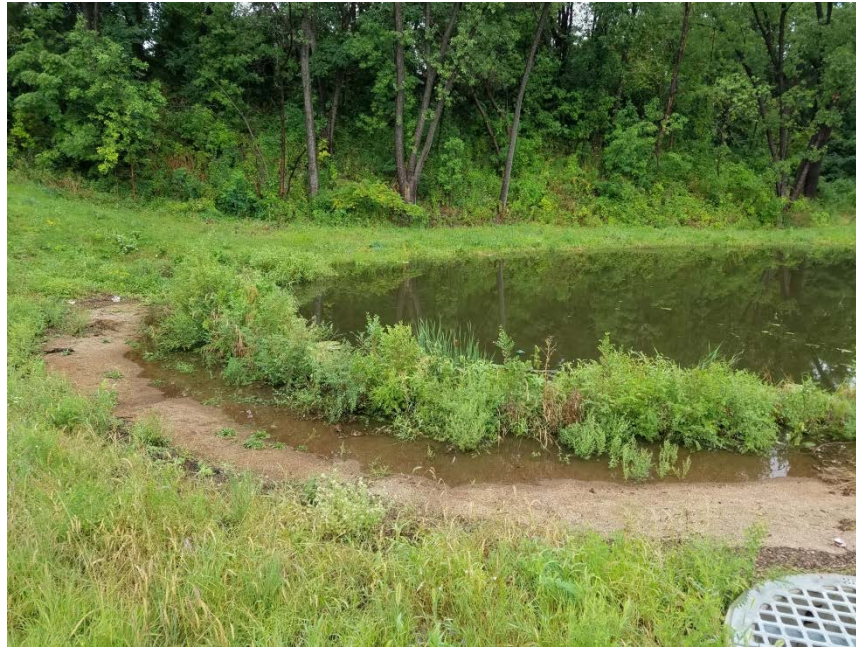
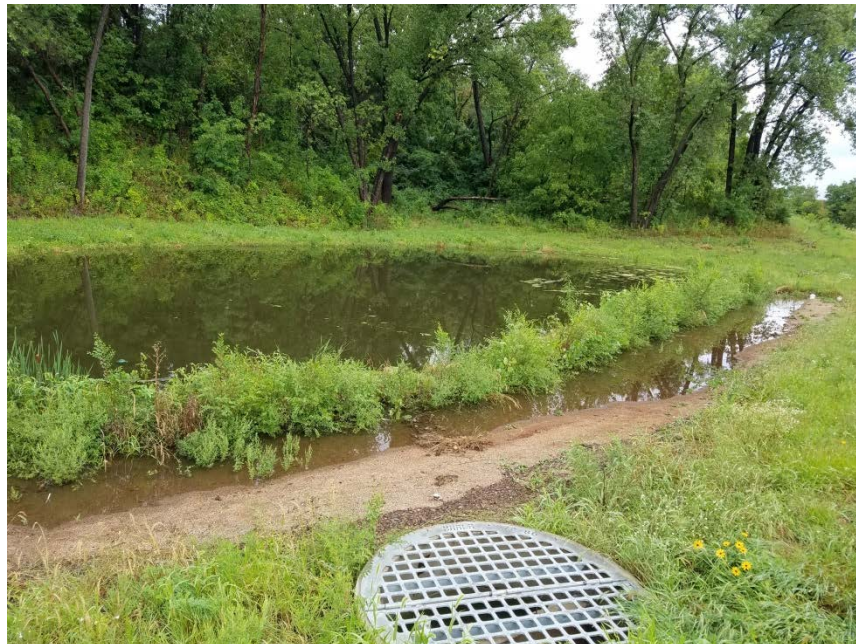
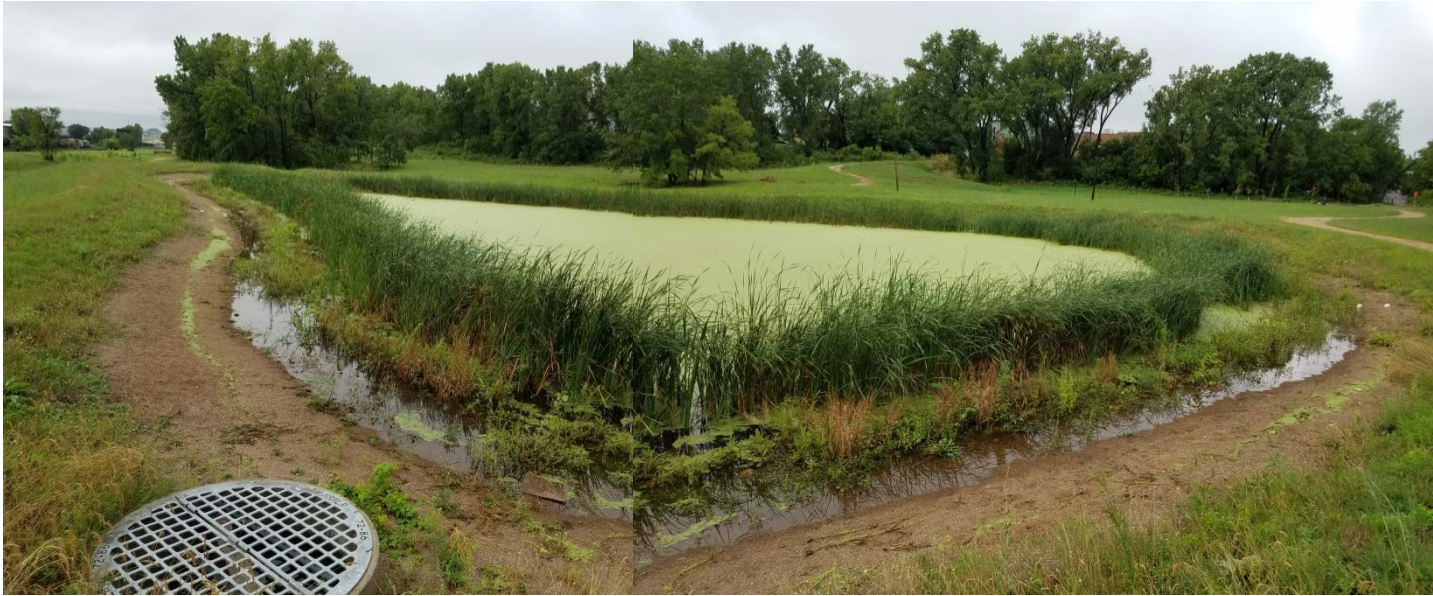
Magnolia Pond after large rain event, 8/11/2016

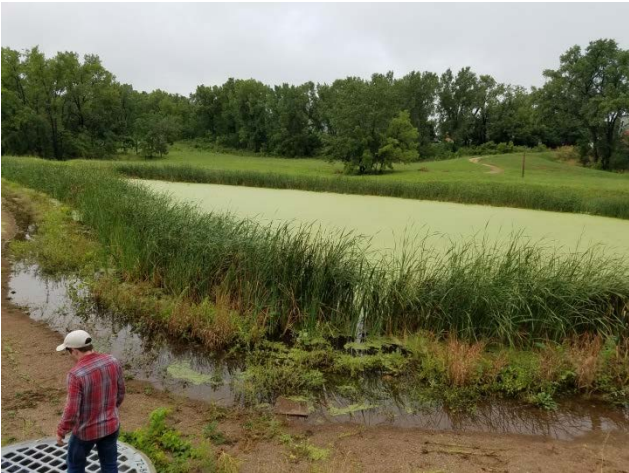
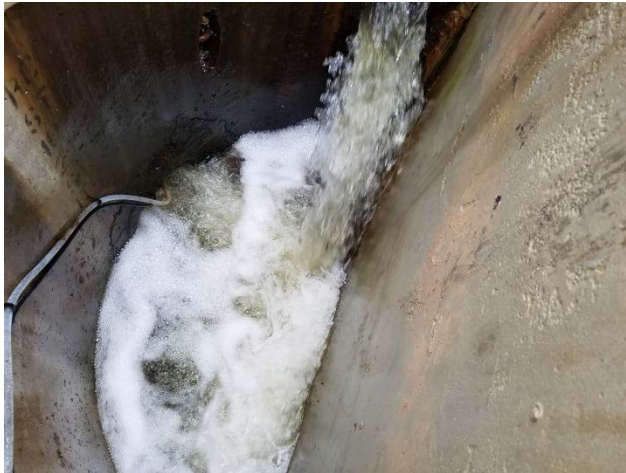
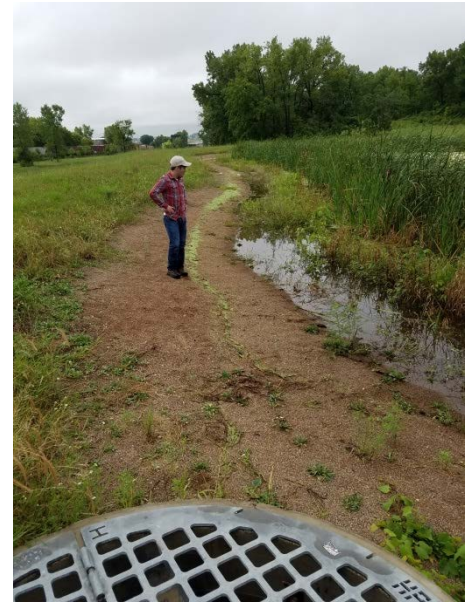
Maryland Pond after large rain event, 8/11/2016

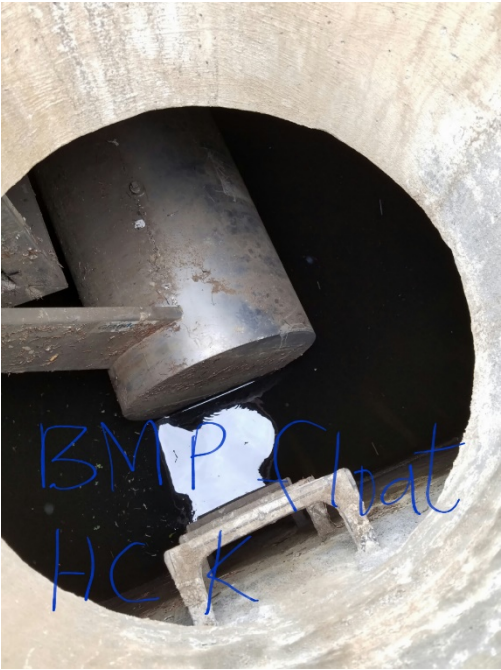
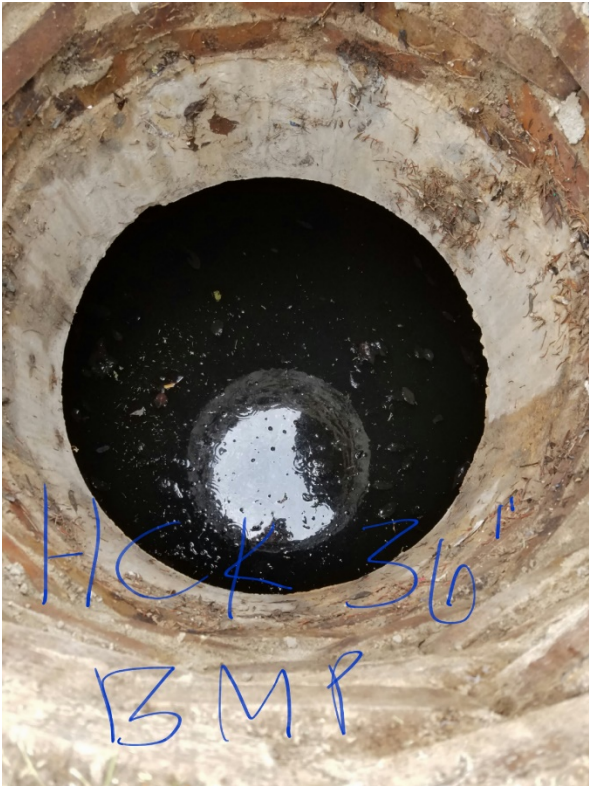
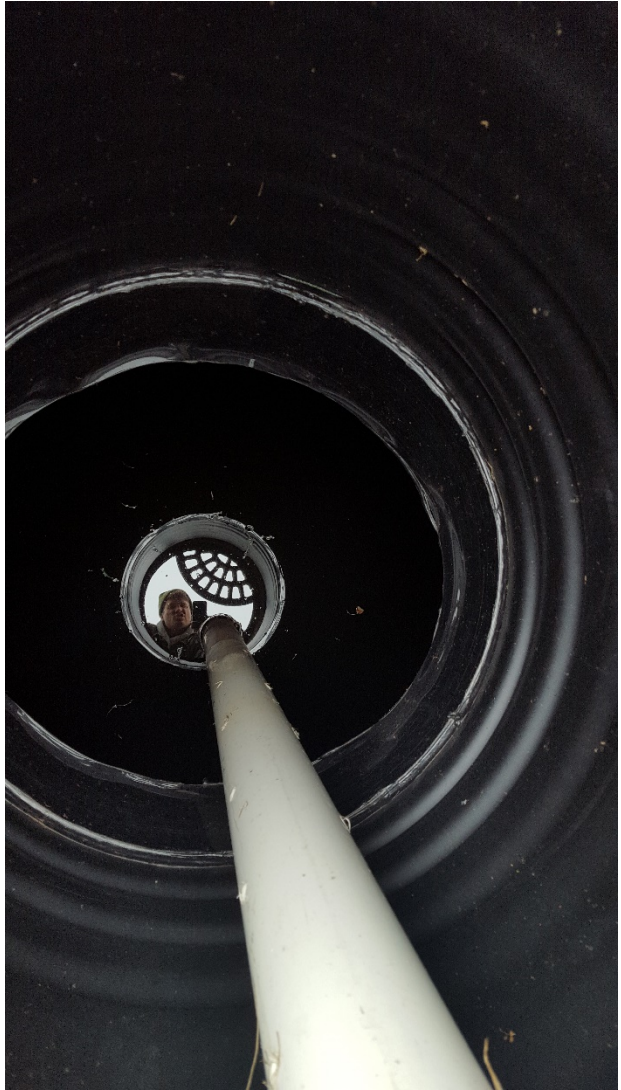
Hillcrest Knoll Park 5/20/2016

(Float/Gate Valve – L, Pre-treatment – M, BMP Chamber – R)

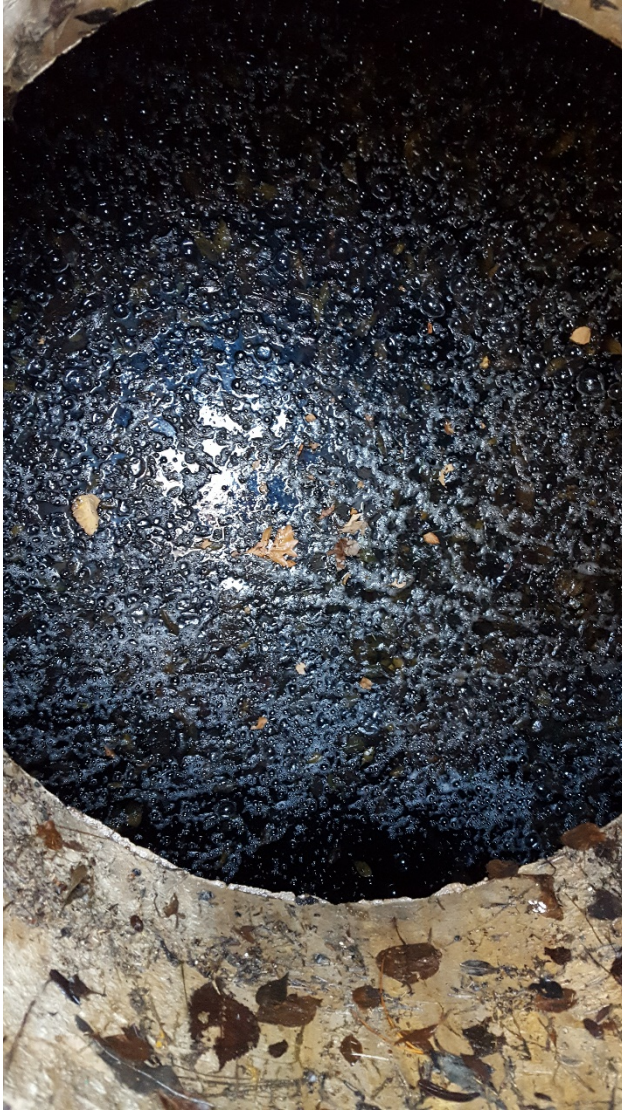
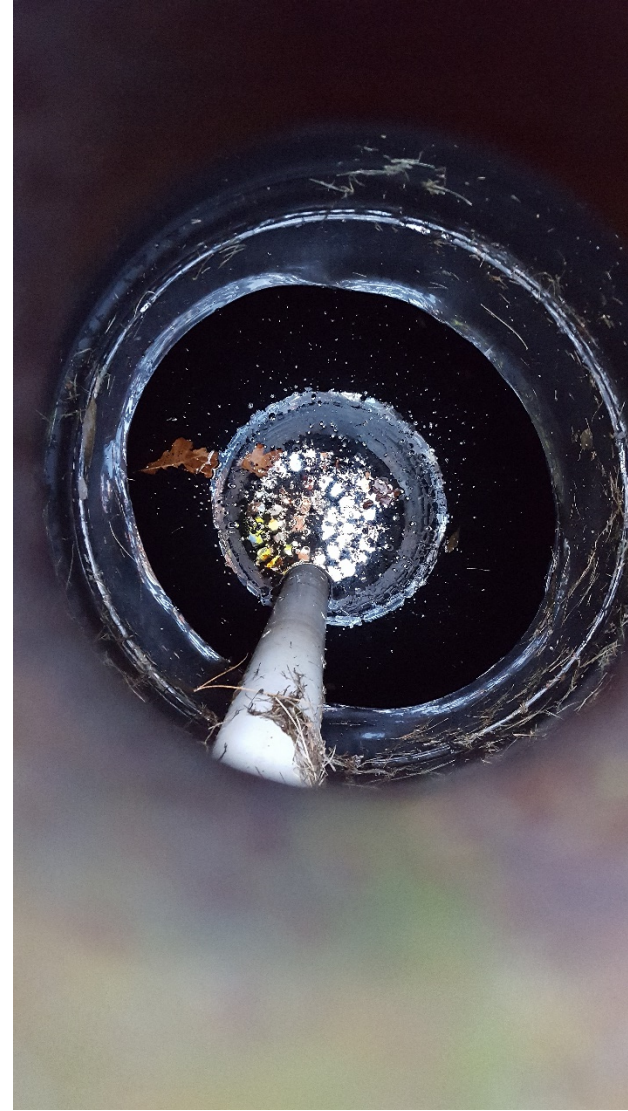
Hillcrest Knoll Park 11/15/2016

(Pre-treatment – L, BMP Chamber – R)
