# 2017 Water Quality & Quantity Program

## Monitoring Report

April 2018

Project No. 01610-10

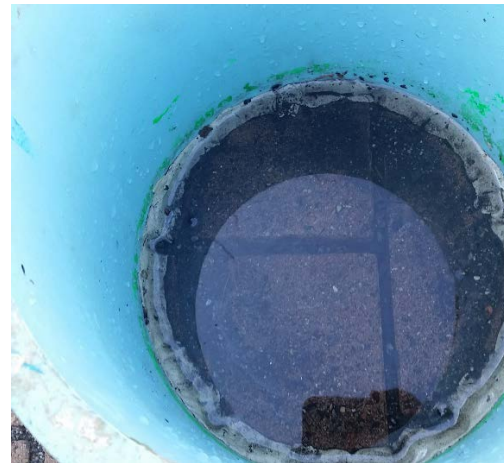
- The overall site infiltration rate decreased from 3.33 in/hr in 2016 to 1.19 in/hr in 2017
- No infiltration was observed at Location D, which is consistent with 2015 and 2016 testing
- Infiltration rates at Locations A, B, and E (**Photo 14-3** and **14-4**) decreased from 2016 to 2017, while Location C remained the same

**Photo 14-4: Location E Infiltration Test**

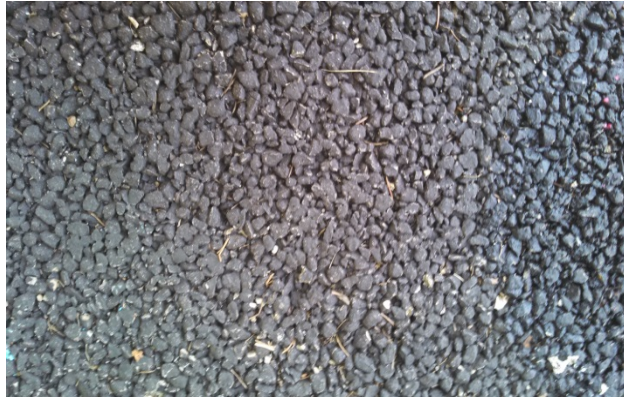
**Photo-14-6: Hamline Midway Library porous asphalt**

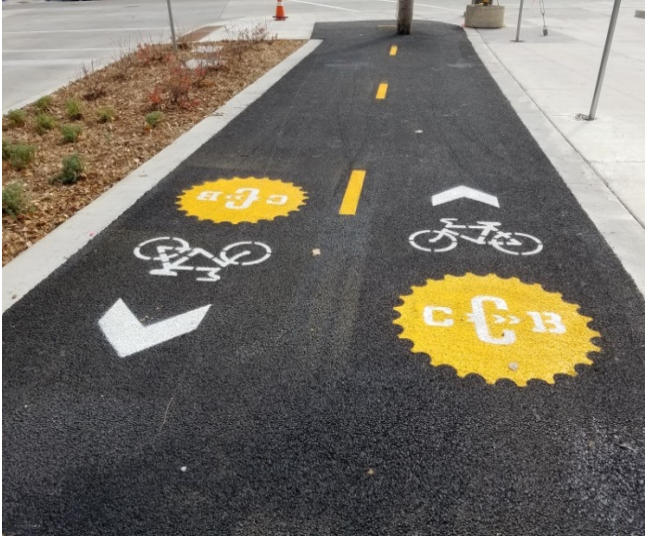
Photo 14-9: Capital City Bikeway (CCB) –  
Jackson Street/Kellogg Avenue

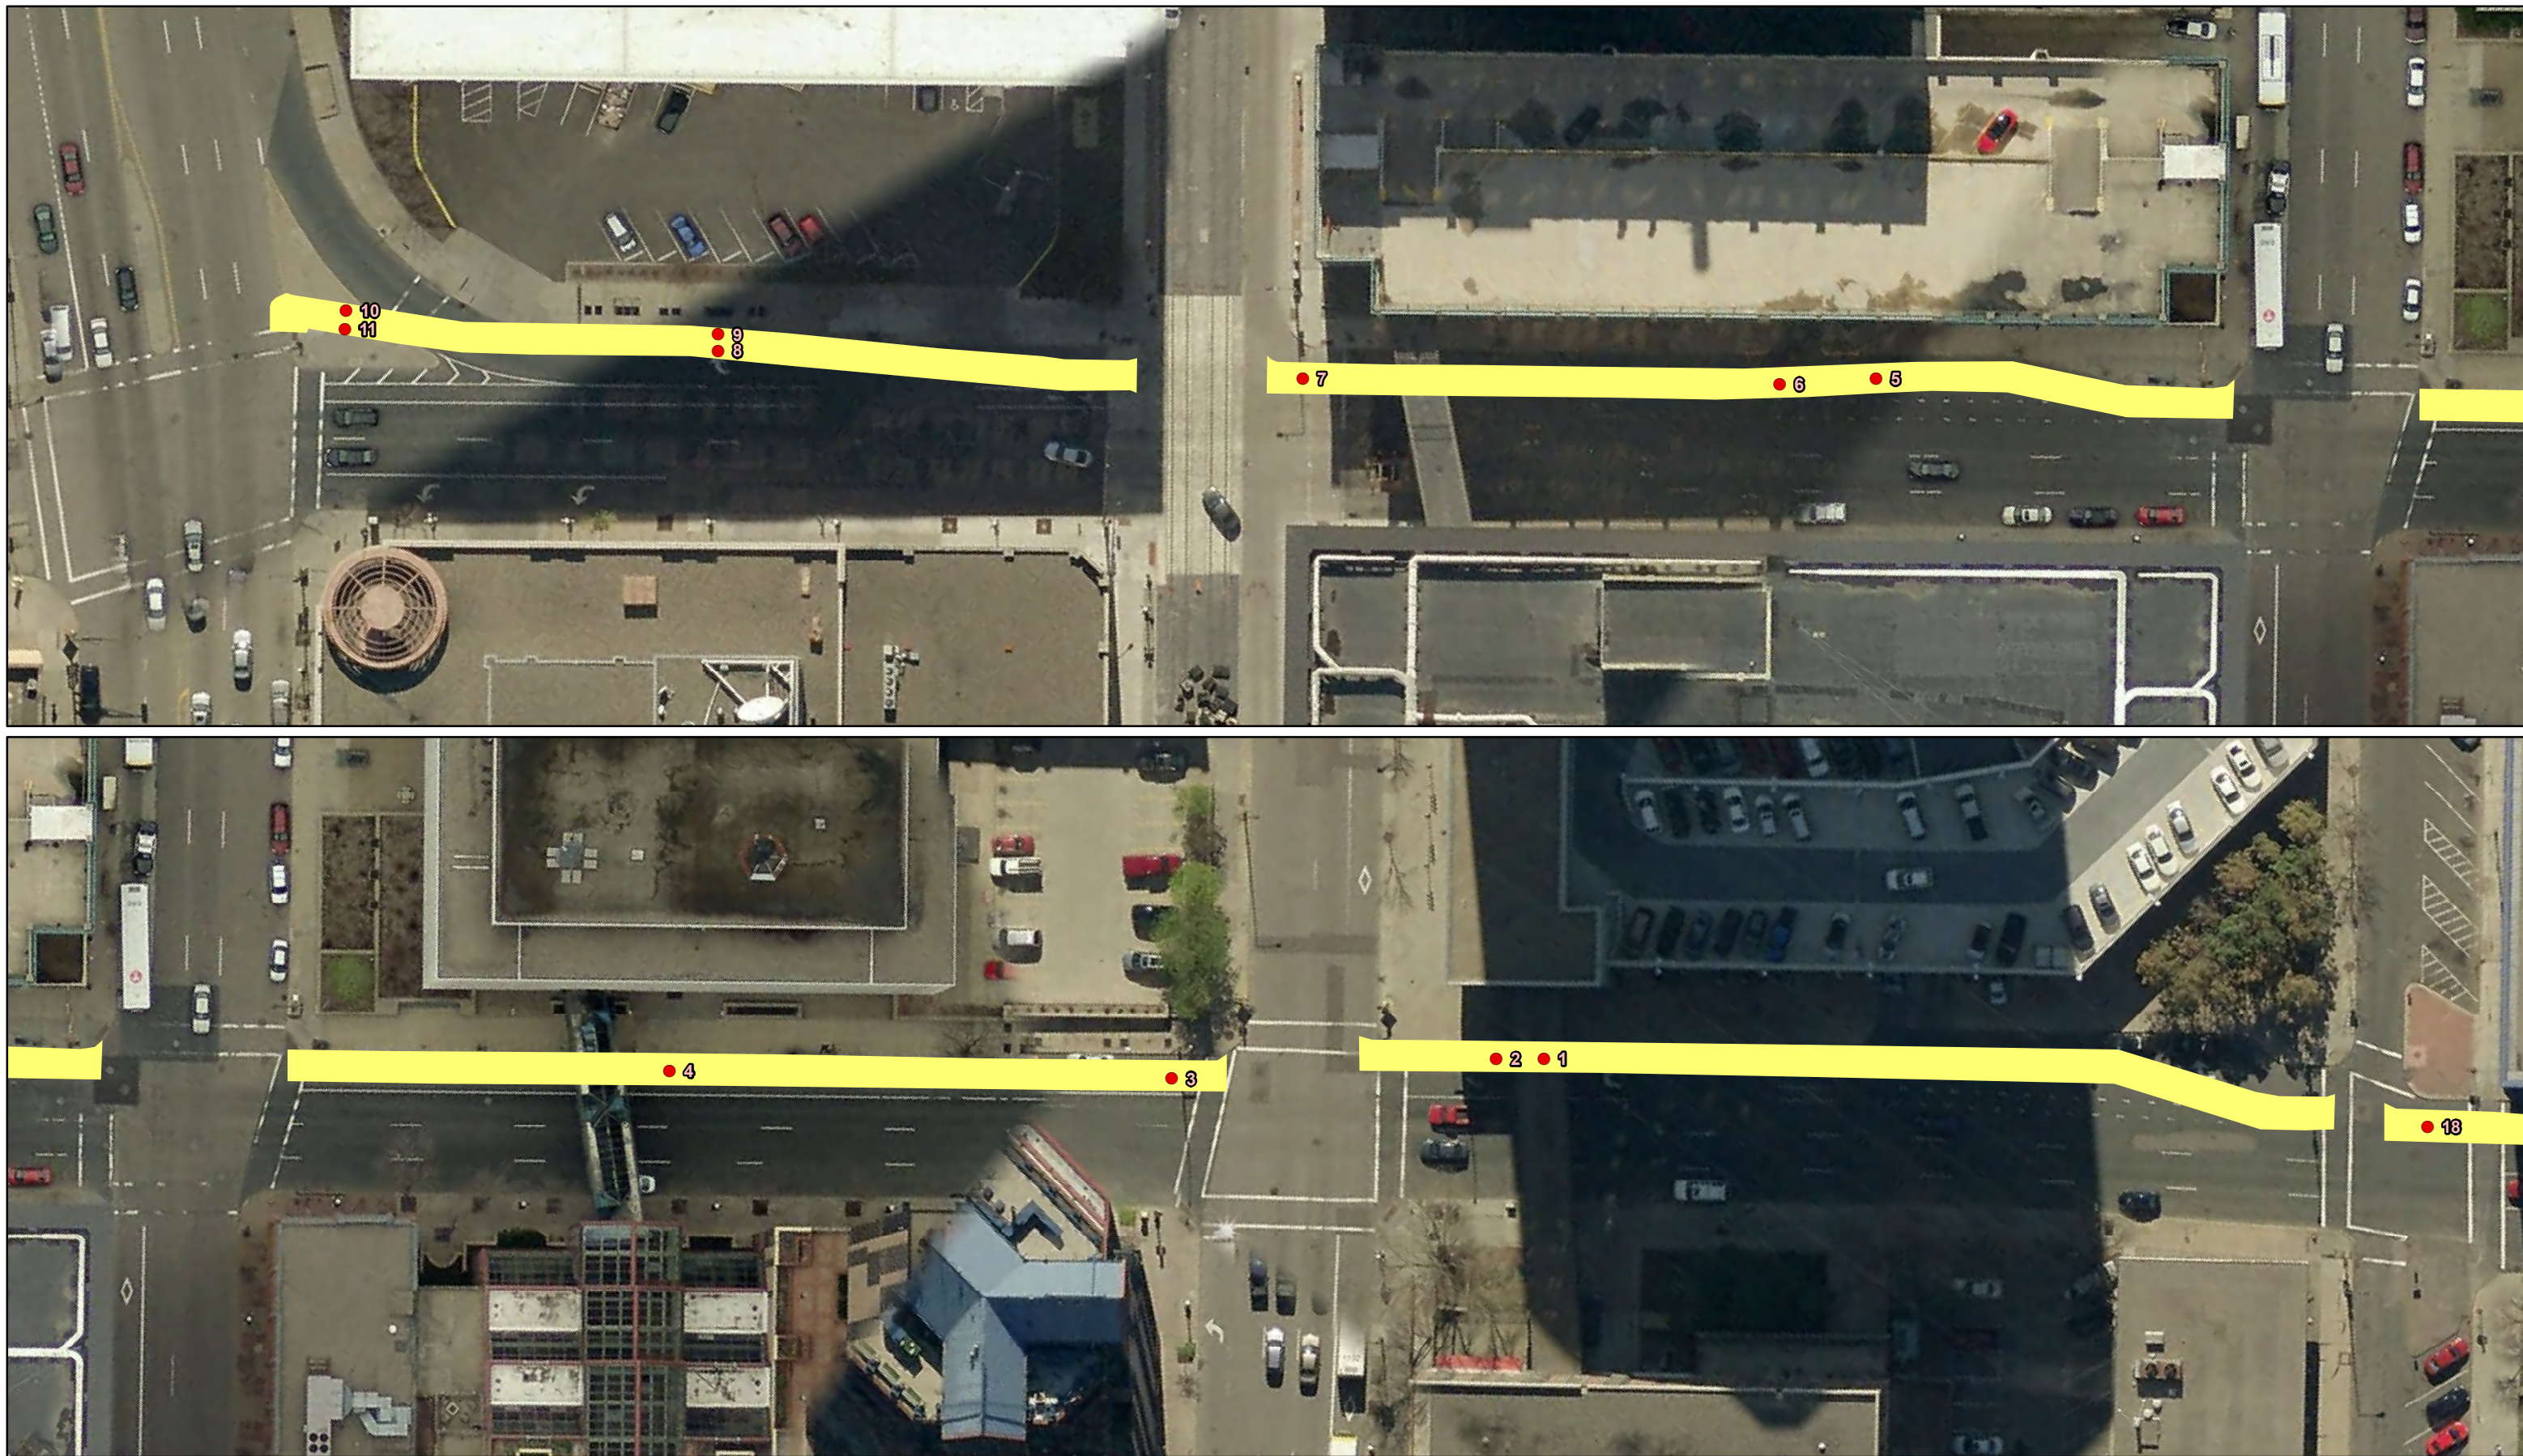
**Figure 14-3 Jackson Street**  
**Pervious Pavement Test Locations**  
2017 Water Quantity and Quality Monitoring Program  
City of St. Paul, MN

The site was tested for infiltration in June 2017 and November 2017. The infiltration test results from the 18 locations are summarized in **Table 14-4** and **Chart D.3** in **Appendix D**, which includes all infiltration test results completed to-date. **Table 14-4** is color coded to identify the site traffic characterizations described above. The infiltration tests results are also summarized in **Table 14-5**, which presents an average infiltration rate based on the monitoring location traffic characterization. The infiltration test locations are depicted on **Figure 14-3**.

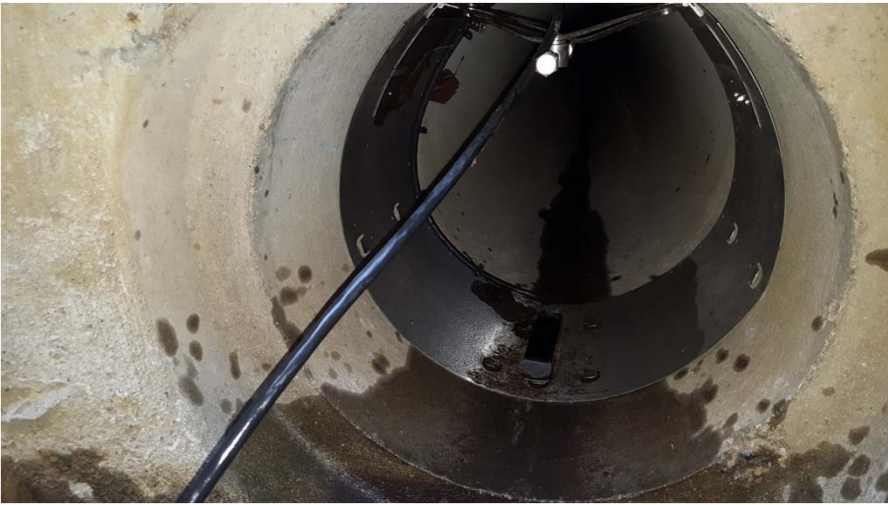
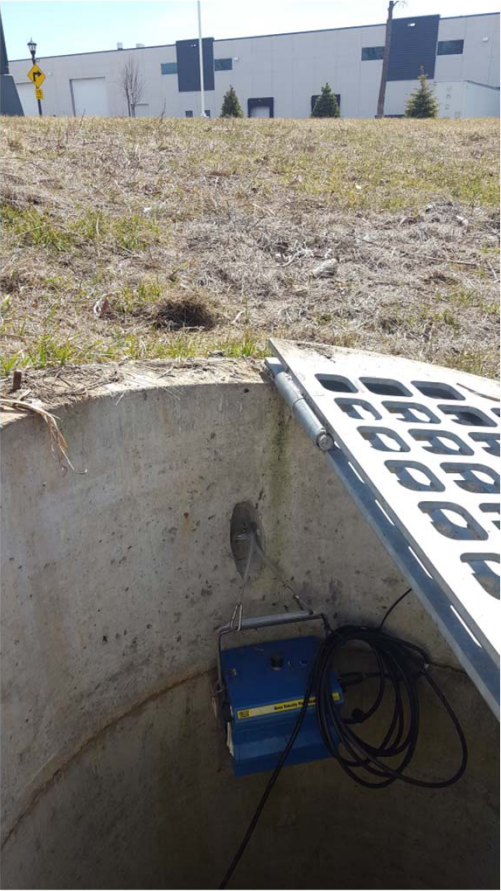
West Pond Outlet Installation  
3/28/17

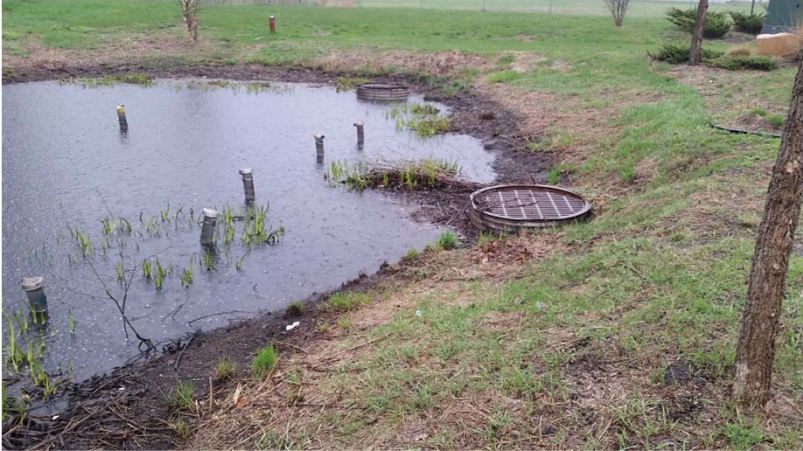
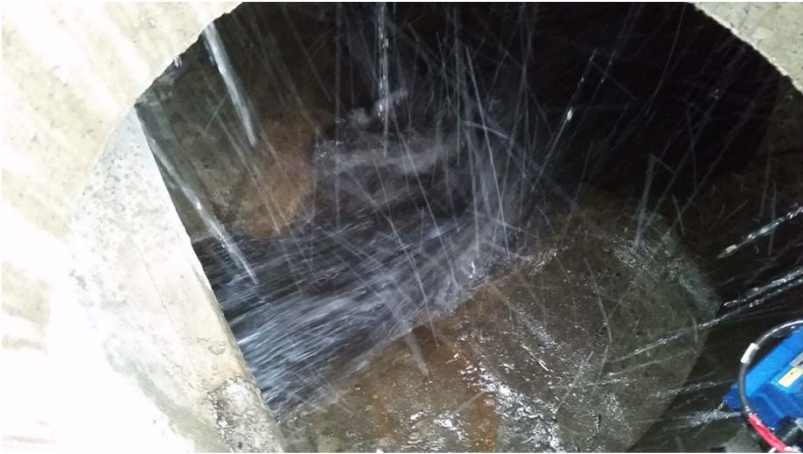
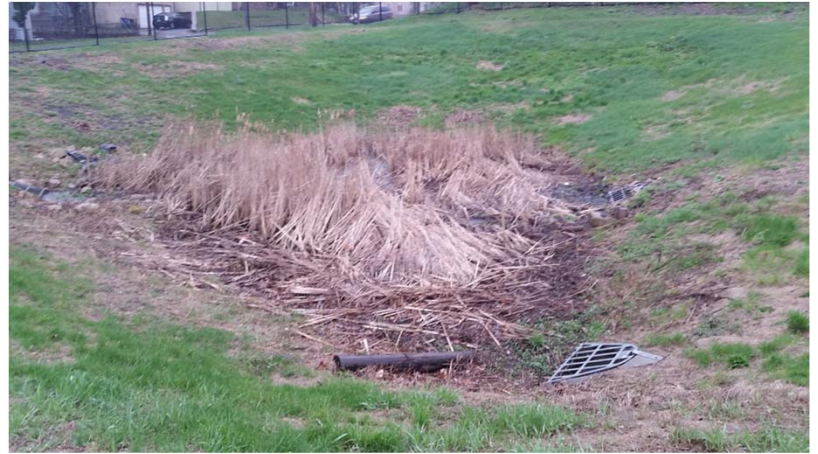
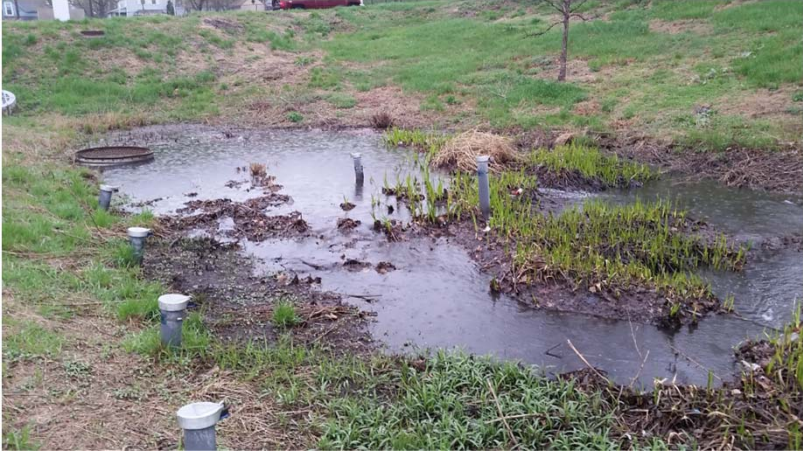
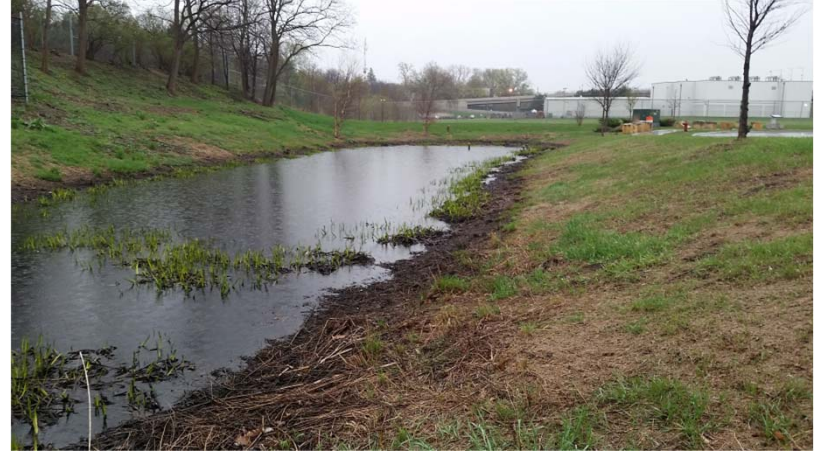
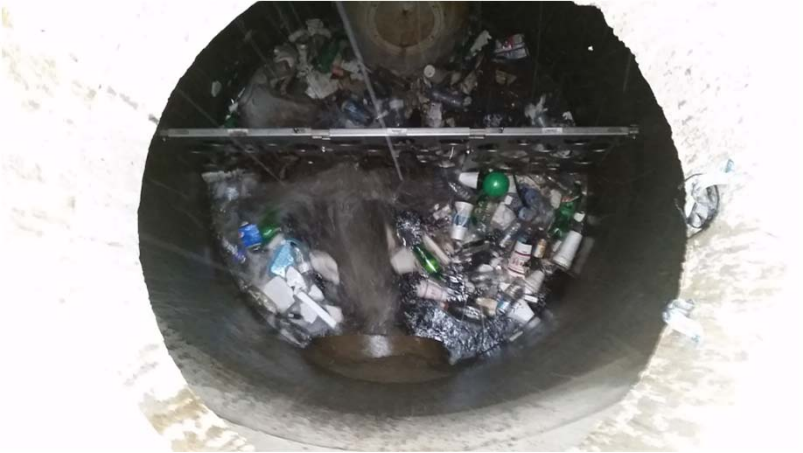
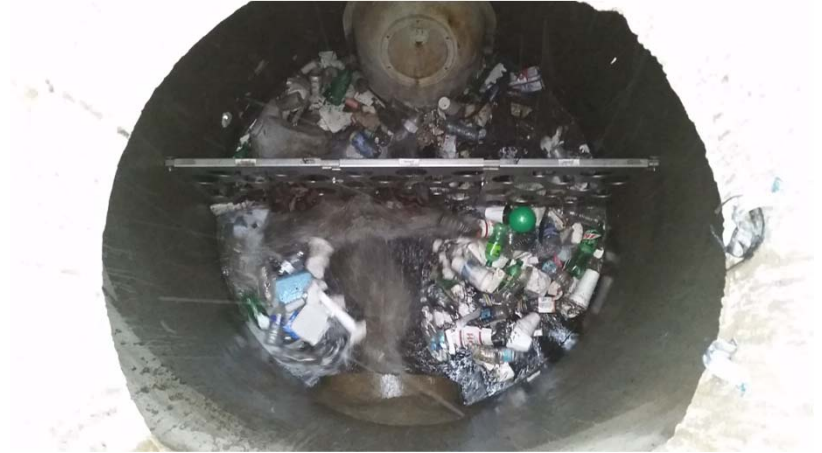
Beacon Bluff - 4/19/17 Rain Event

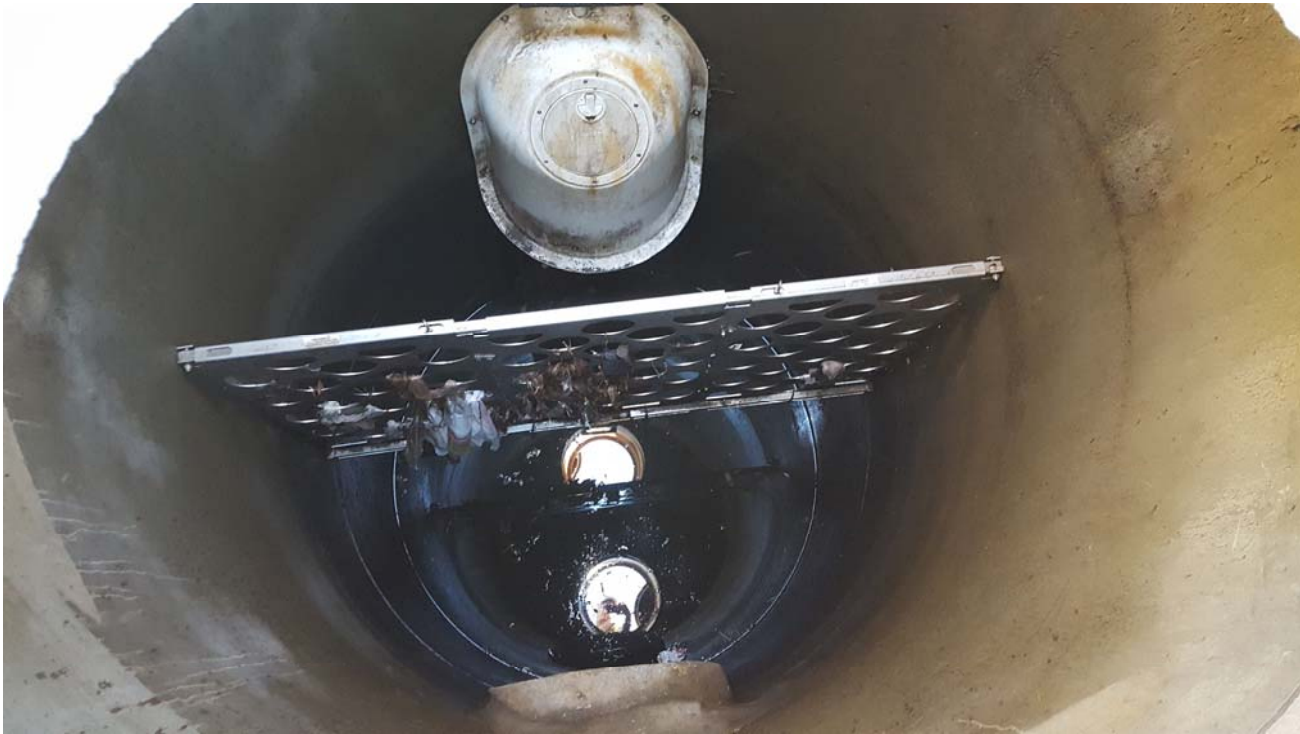
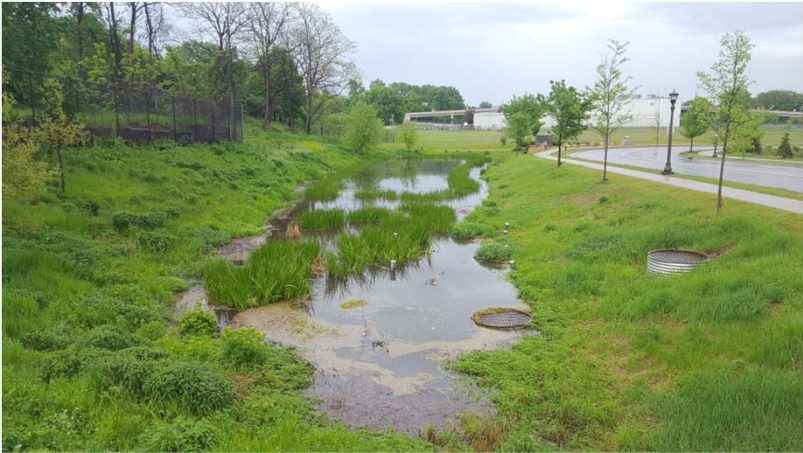
Beacon Bluff Pre-treatment  
5/11/17

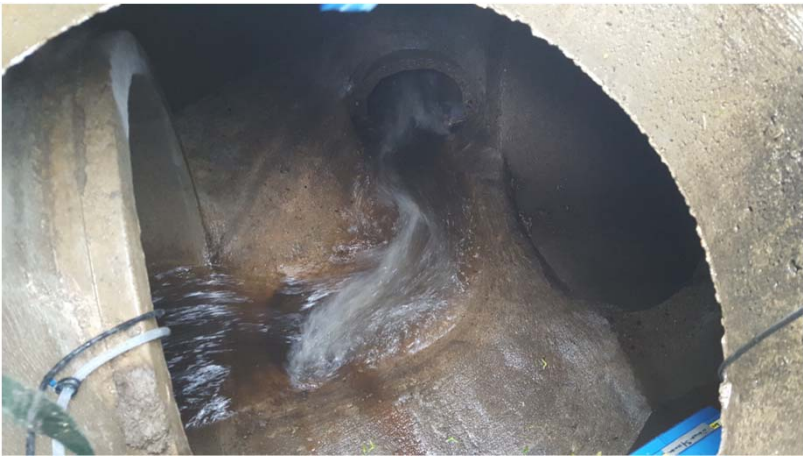
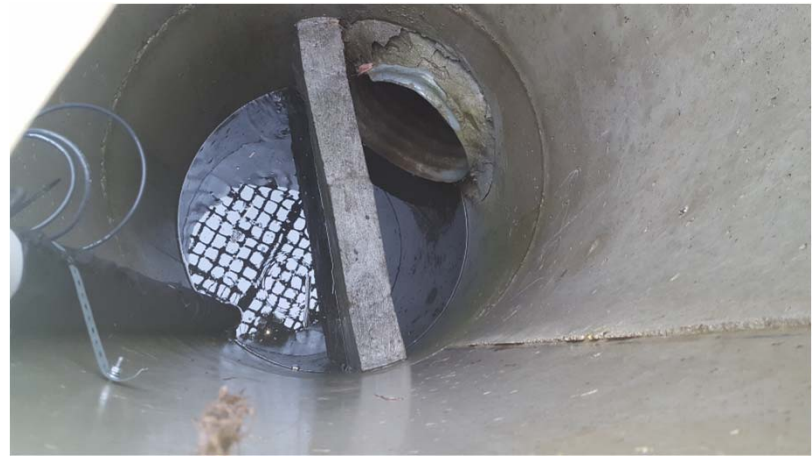
Beacon Bluff Post-Rain Event 5/16/17

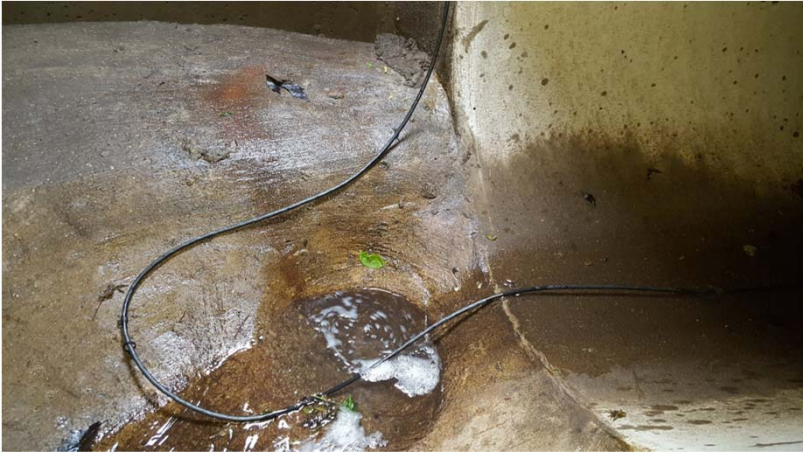
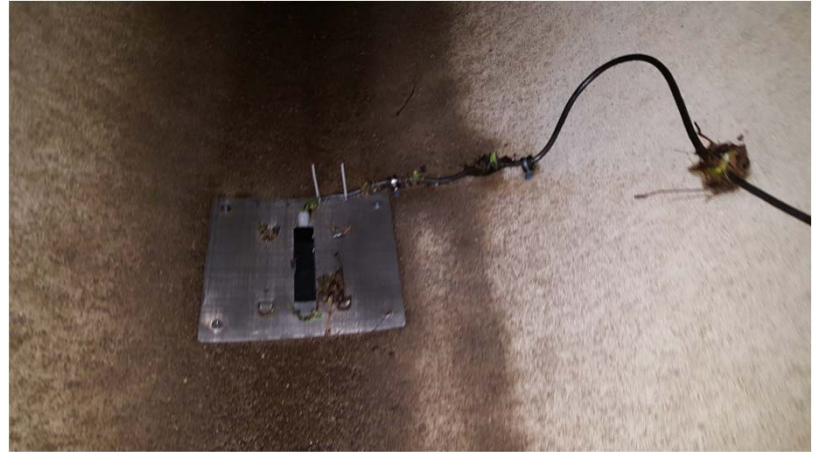
Photos indicating water levels and damage after at 1.54" rain even on 5/17/17  
Beacon Bluff

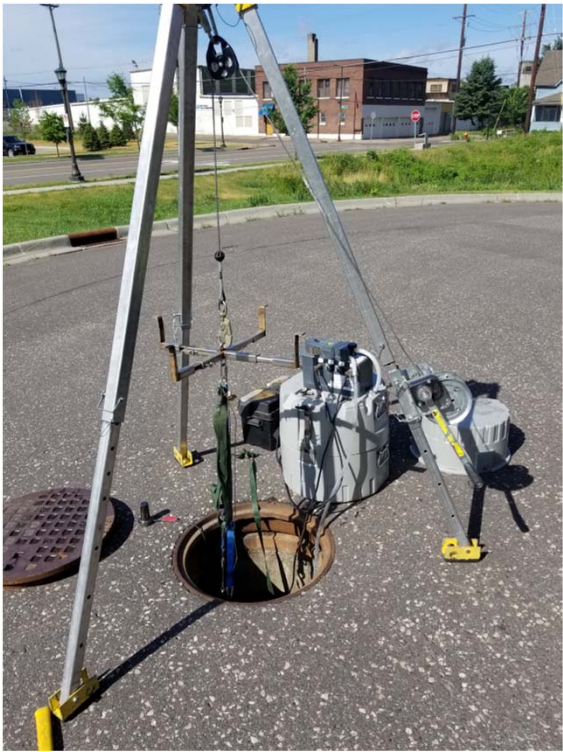
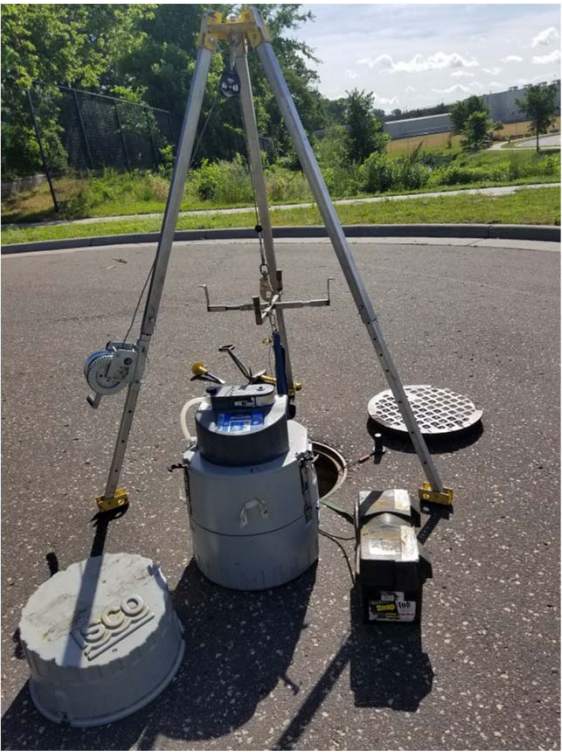
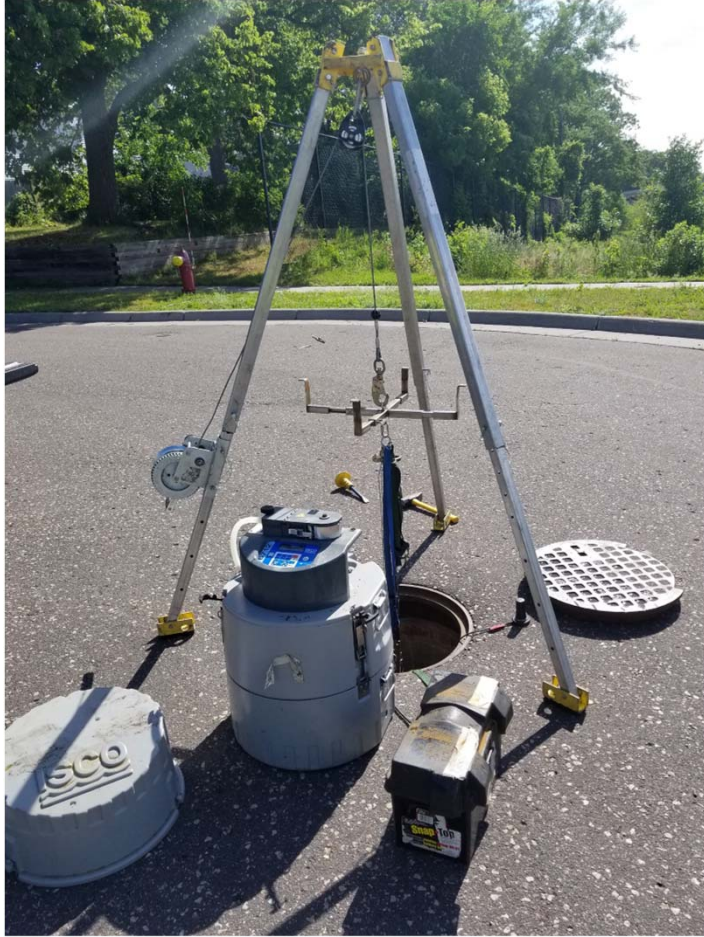
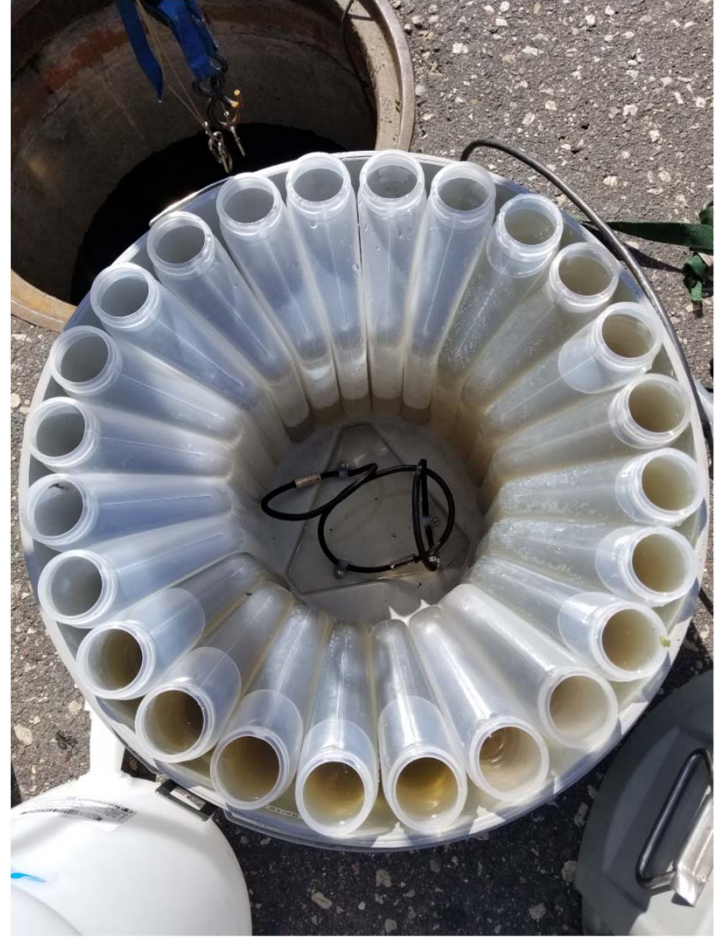
Photos of equipment – Beacon Bluff  
6/14/17

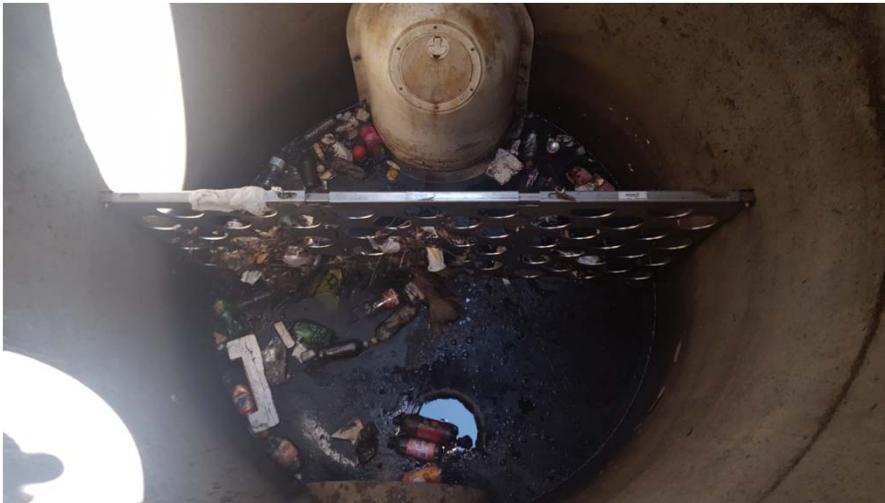
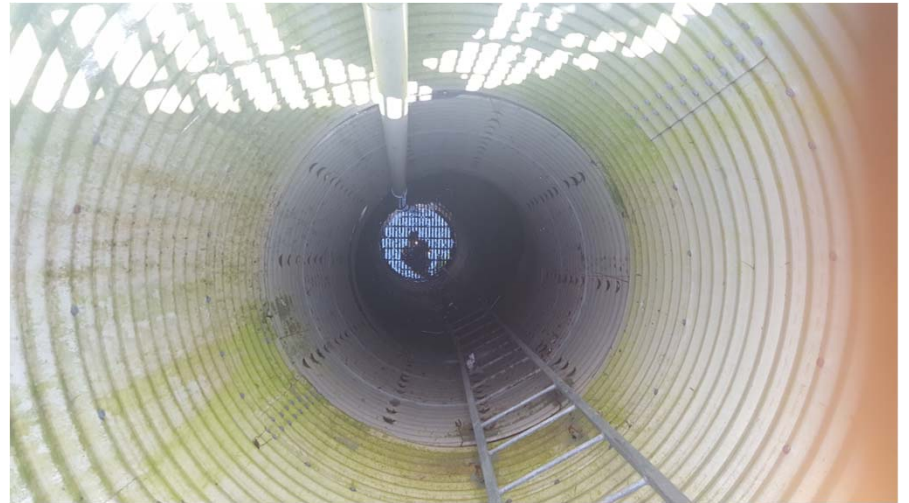
## Beacon Bluff Pre-treatment and BMP 7/17/17

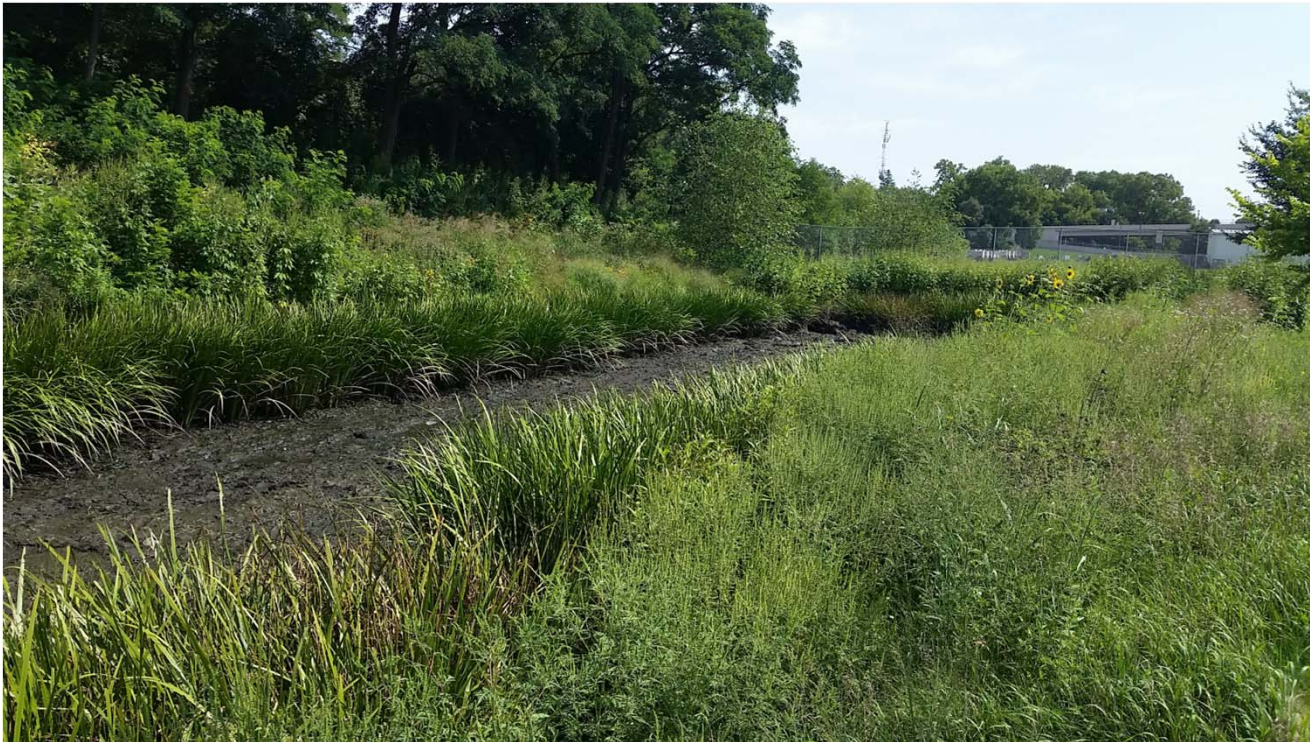
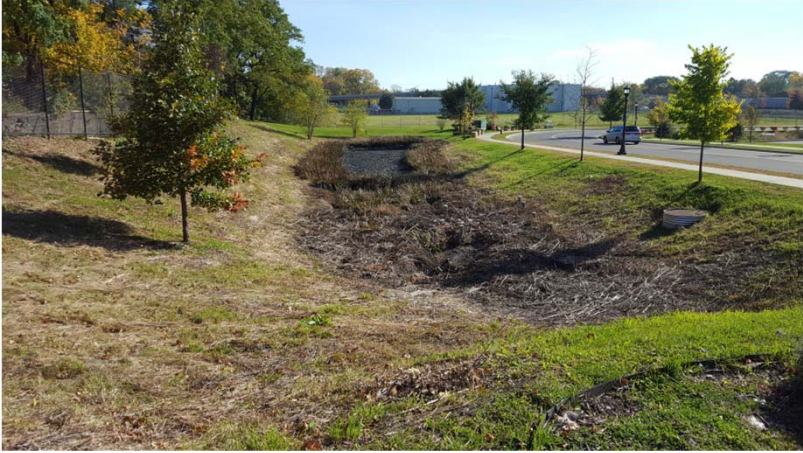
Beacon Bluff Rain Garden  
8/21/17

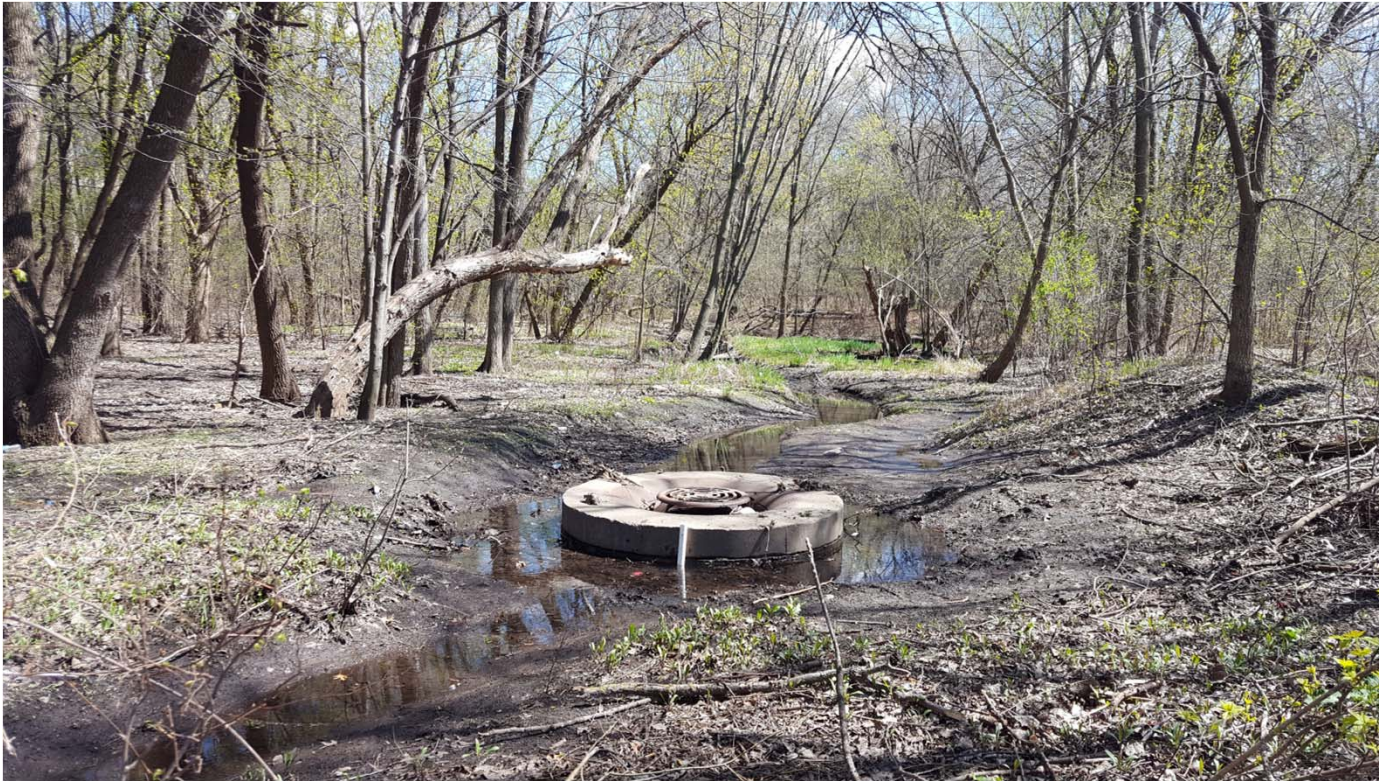
## Case Logger Install – 4/21/17

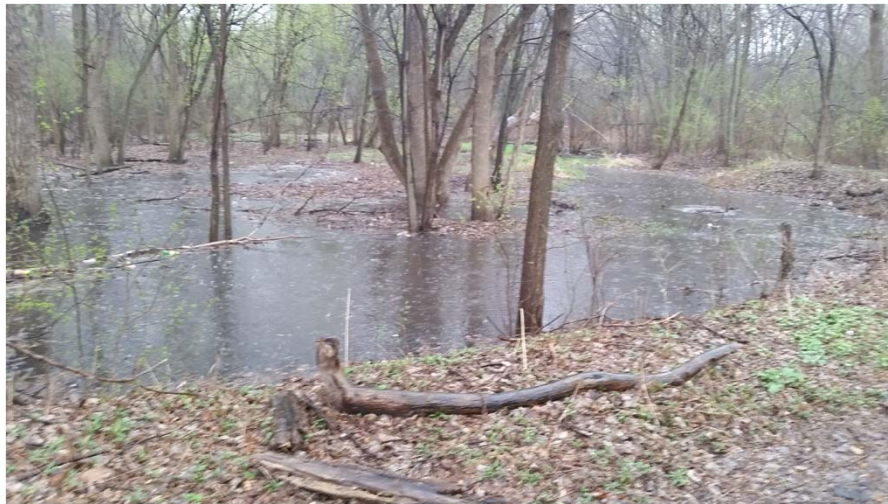
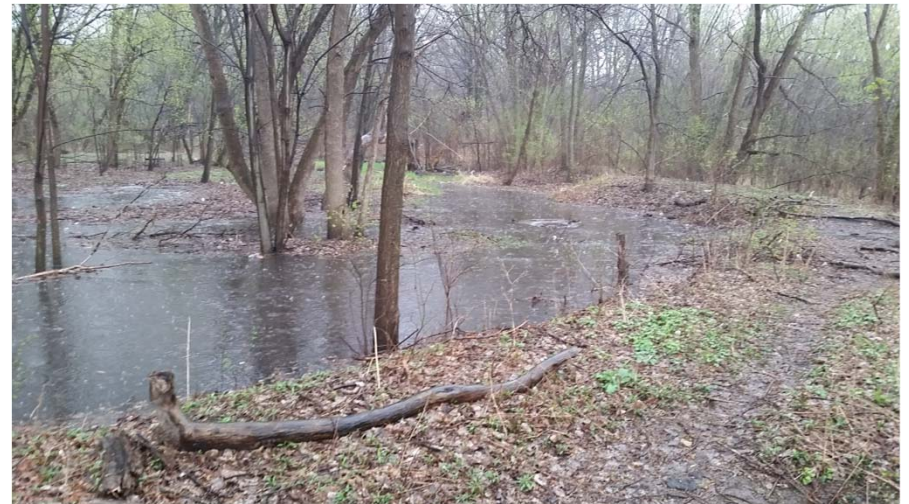
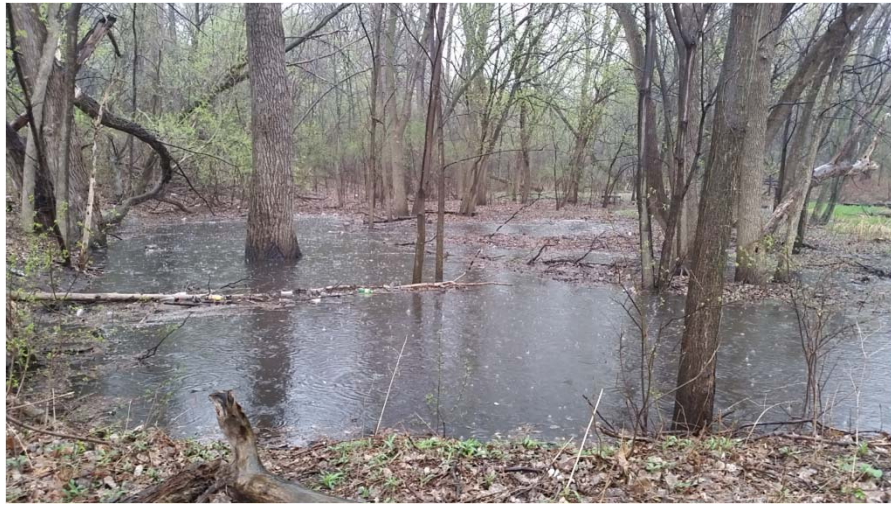
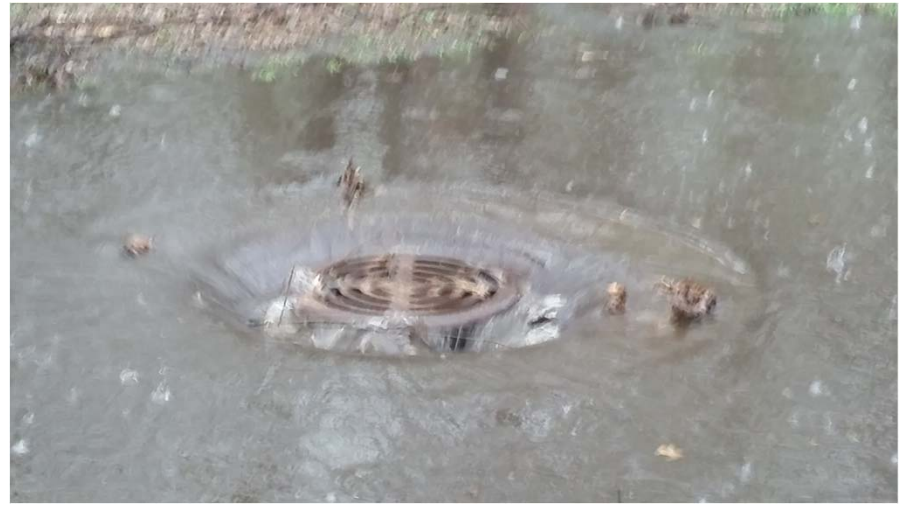
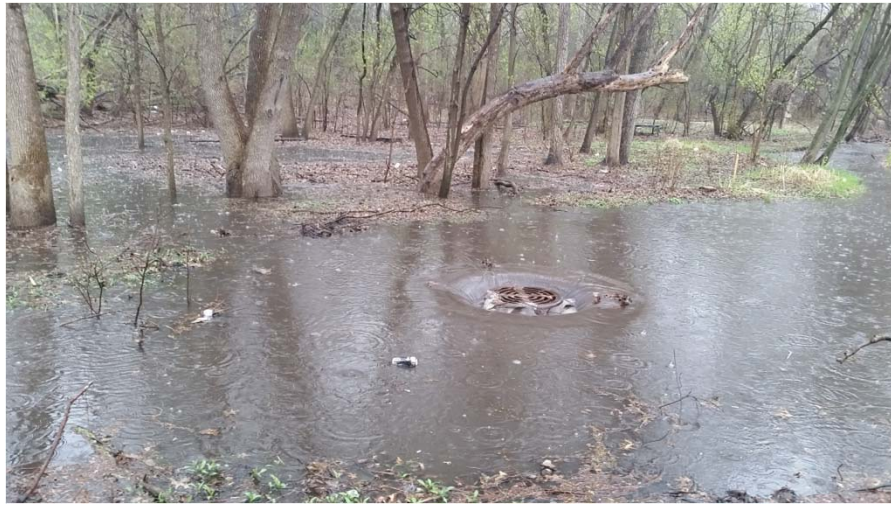
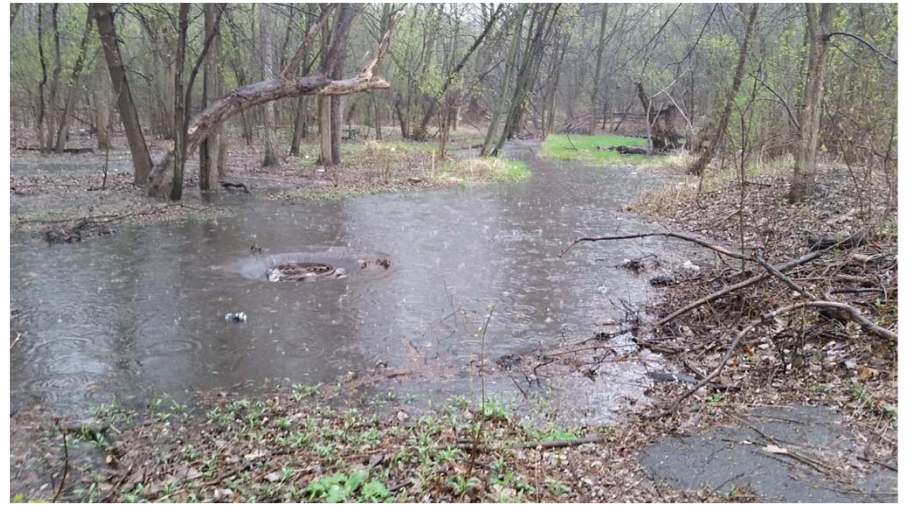
Sackett Playground Floodplain – 4/19/17 Rain Event
